A Survey of Selected Rivers for
the Galway City Transport
Project with Potential for
Margaritifera (Moorkens, 2014a)

A SURVEY OF SELECTED RIVERS FOR THE GALWAY CITY TRANSPORT PROJECT WITH POTENTIAL FOR *MARGARITIFERA*

September 2014

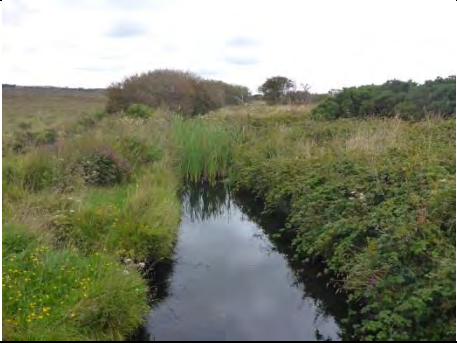
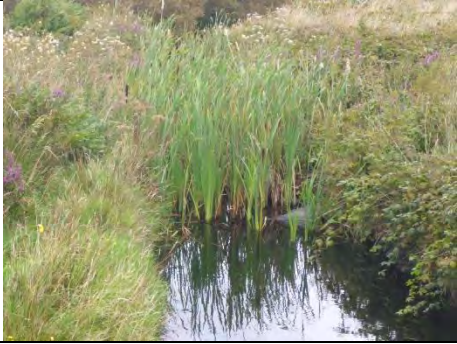
Table 1 Details of survey sites and results		
Site 1	Flat gradient, ponded river coming from Lough Inch. Extensive Typha and reed beds within the channel. Very muddy, organic substrate. Several muddy drains entering the main channel at intervals. No potential pearl mussel habitat and likely damage to habitats further downstream through sedimentation	
Lough Inch River		
M21386 24558 at bridge		
Surveyed 200m u/s and d/s bridge

Upstream of bridge	Upstream of bridge	Downstream of bridge

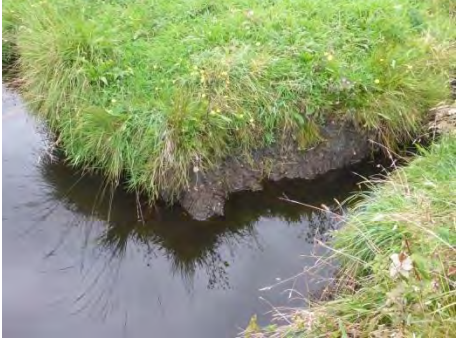
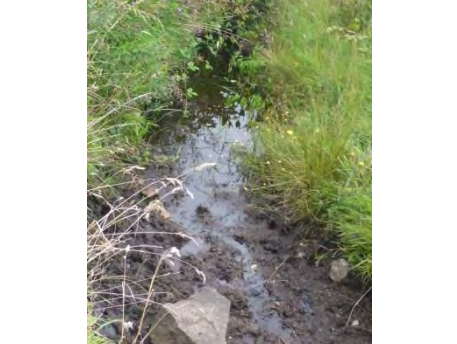
Muddy drain entering river	Muddy drain entering river

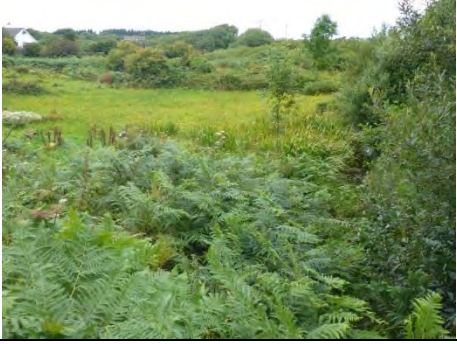
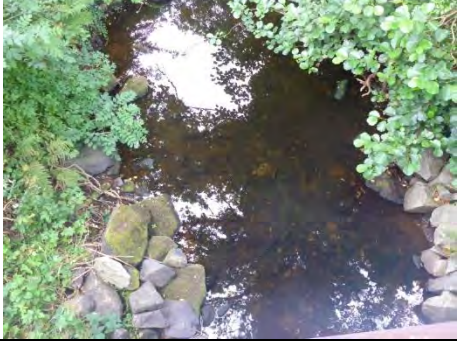
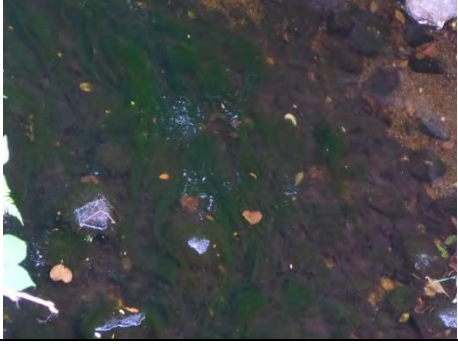
Site 2	Very shallow water with black cobble and gravel substrate, extensive covering of filamentous algae in places. Virtually no flow - water still beneath bridge.	
Lough Inch River		
M18890 23883 at bridge		
Surveyed 50m u/s and d/s bridge

Upstream of bridge	Downstream of bridge	Downstream of bridge - algae

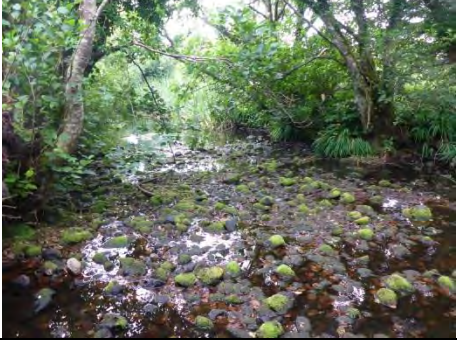
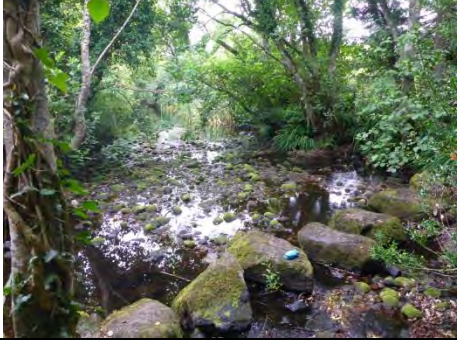
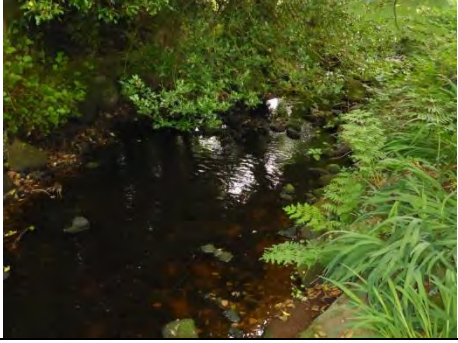
Site 6	Rocky boulder crossing, dry and widened (may be old ford). Dry mossy rocks and <i>Sparganium</i> stands downstream	
Lough Inch River		
M18874 23799		
Surveyed local area

View downstream	View downstream	View upstream

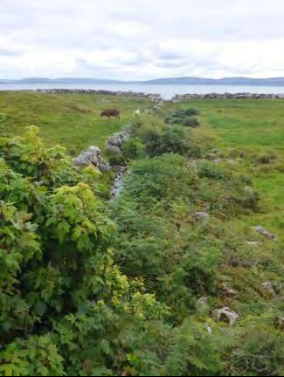
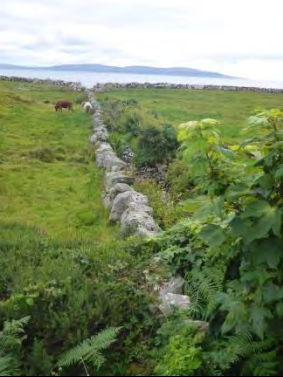
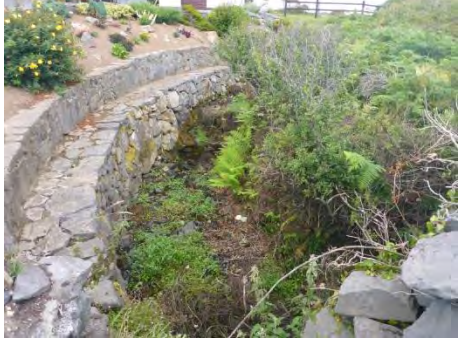
Site B	Temporary stream, runs dry, no <i>Margaritifera</i> habitat	
Small stream		
M20060 22752

View downstream	View downstream	View upstream

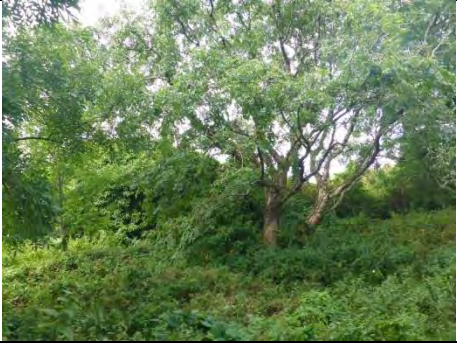
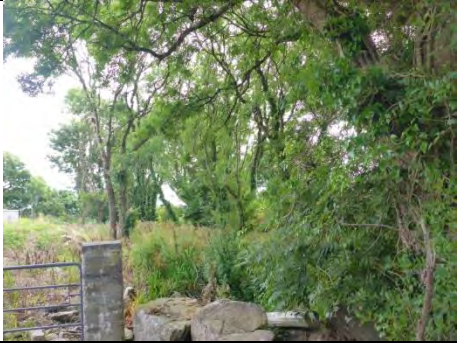
View upstream	View downstream

Site E	Old tree line marks where the stream was. It is now dry and absorbed into the surrounding land through drainage. No <i>Margaritifera</i> habitat	
Small stream		
M22088 23187

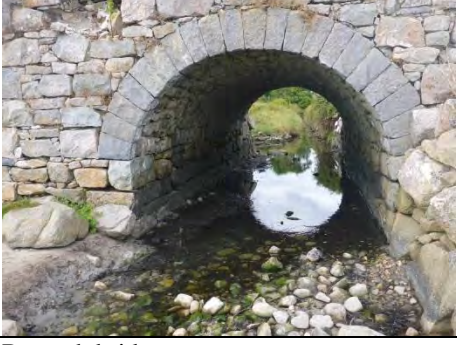
Beneath bridge

Site G	At the quay in Barna, tidal influence, no habitat	
Trusca Sstream		
M23265 22735

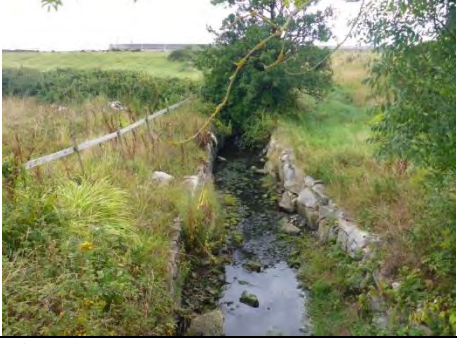
View downstream

Site H	Too small and shallow for <i>Margaritifera</i> , dense filamentous algae	
Trusca Stream		
M23243 22814

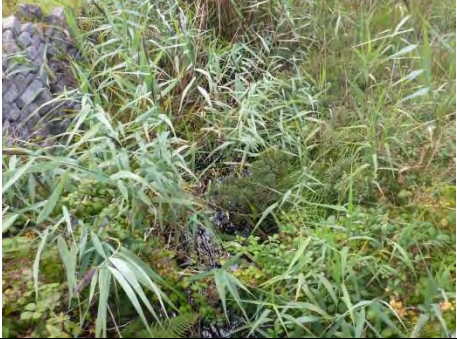
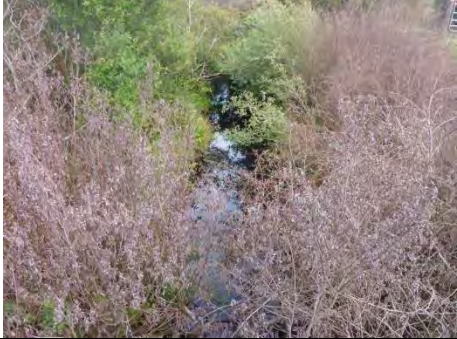
View downstream	View upstream

Site J		
An Sruthan Dubh	Very low flowing water in flat area in reed bed. No <i>Margaritifera</i> habitat	
M22459 27033

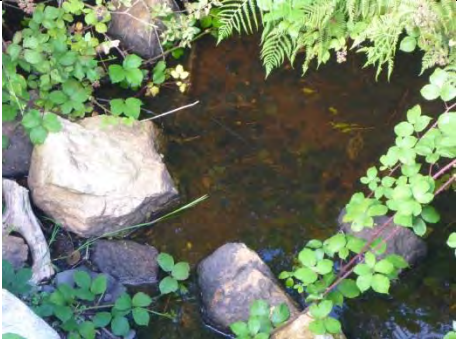
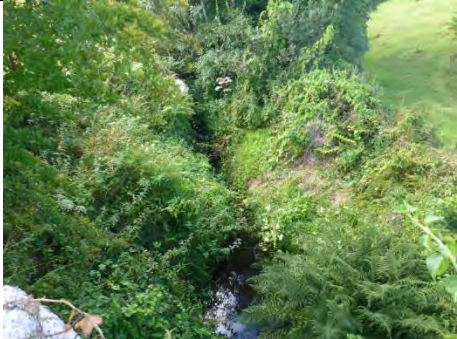
Site K		
An Sruthan Dubh	Good gravel substrate but no significant flow and very tunnelled. No <i>Margaritifera</i> habitat	
M23477 26284

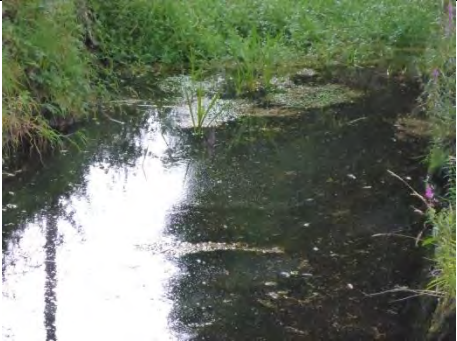
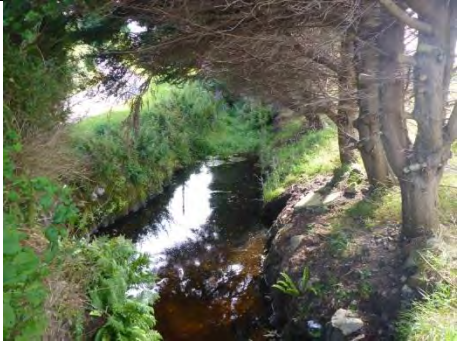
Site M	Larger water body but slow flowing and highly silted, narrow and tunnelled upstream. No <i>Margaritifera</i> habitat	
Barna stream upper branch		
M24369 26282

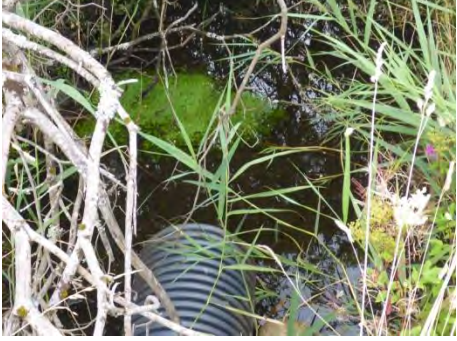
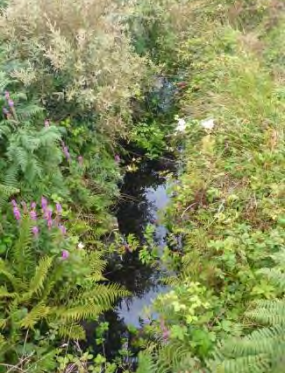
Site O	Tunnelled, overgrown, very little flow, <i>Callitiche</i> , sandbags, culverted pipe. Narrowed downstream, water with grey tinge	
Barna Stream main channel		
M25346 26206

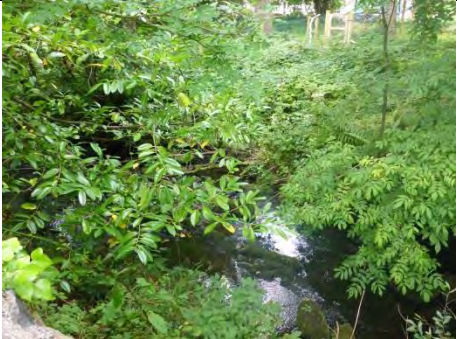
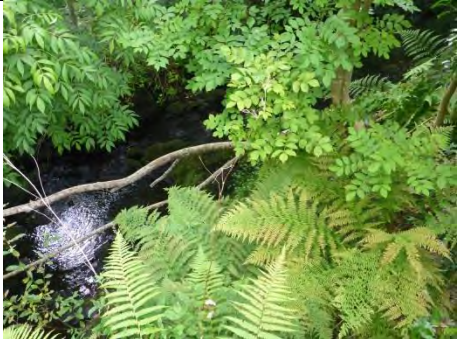
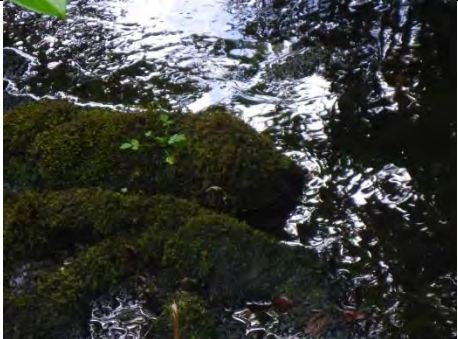
Site P	Good flow with mossy rocks in stream, good boulder and gravel mixed substrate. Tree-lined banks, but lots of new housing estates nearby. Rather shallow, mostly less than 20cm deep but with flow where gradient is good. Some potential but no mussels found.	
Barna Stream main channel		
M24644 23946
