Galway County Council
N6 Galway City Ring Road
Karst Survey Report

GCOB-4-03-0-6.2.8_010

Issue 3 | 26 July 2018

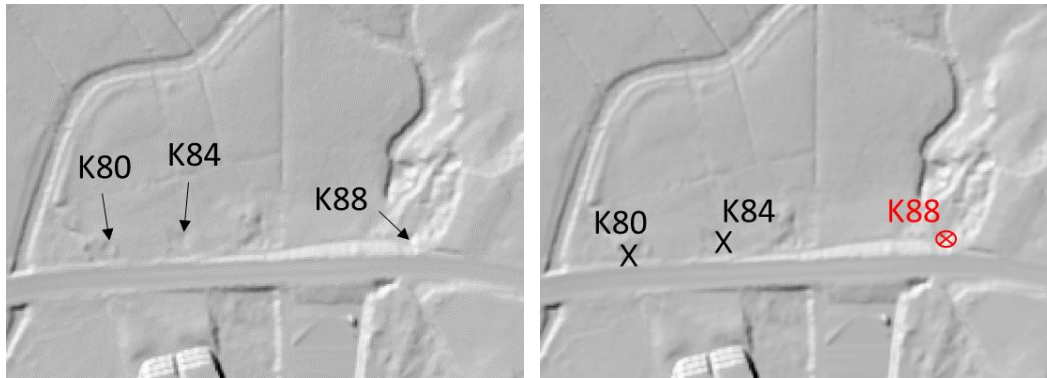
Figure 2a (left) lidar image showing three potential enclosed depressions identified from the desk study, **2b** (right) the field survey confirmed enclosed depression K88 (red circle) but also proved that K80 and K84 (black crosses) were not karst.

Figure 2a shows the lidar image of three potential enclosed depression identified from the desk study. During the site visit K88 was confirmed to be an enclosed depression, however, onsite inspection K80 and K84 were found to be mounds and therefore classified as not karst (**Figure 2b**).

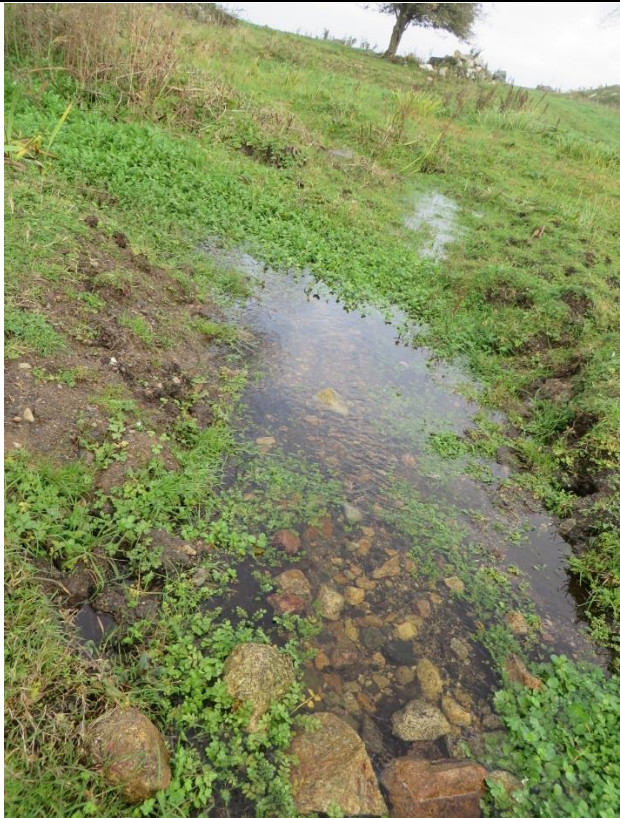
Feature ID	K9
Feature type	Spring
Coordinates	527285, 728284
Source	Field Survey
Field survey date	20/10/2014
Field survey status	Confirmed
Water present	Yes
Additional Information	
Site photo

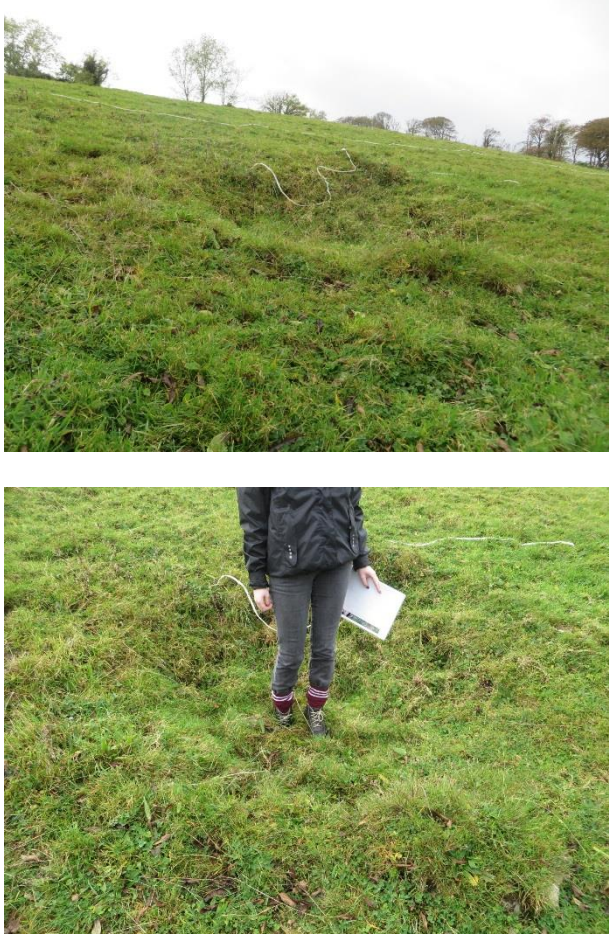
Feature ID	K10
Feature type	Enclosed depression
Coordinates	527301, 728143
Source	Field Survey
Field survey date	20/10/2014
Field survey status	Confirmed
Water present	No
Additional Information	1 m diameter small enclosed depression, base contains loose rocks
Site photos

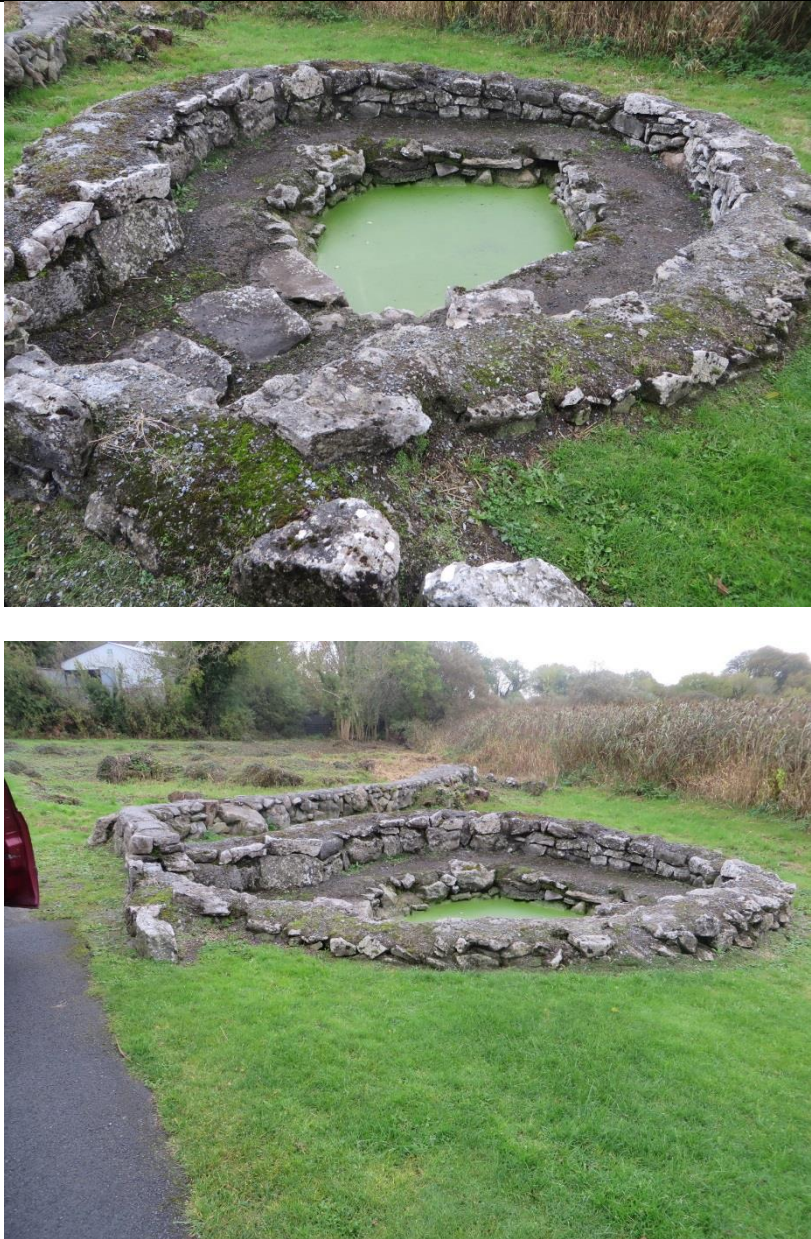
Feature ID	K17	
Feature type	Spring	
Coordinates	528345, 728630	
Source	Field Survey	
Field survey date	17/10/2014	11/11/2014
Field survey status	Confirmed	Confirmed
Water present	Yes Electrical conductivity: 520 uS/cm Temperature: 13.8 °C pH: 7.83	Yes Electrical conductivity: 622 uS/cm Temperature: 12 °C pH: 6.87
Water elevation	n/a	6.12 mAOD
Additional Information	Constructed pond (2 m diameter) covered in algae surrounded by constructed stone wall beside path.	
Site photos

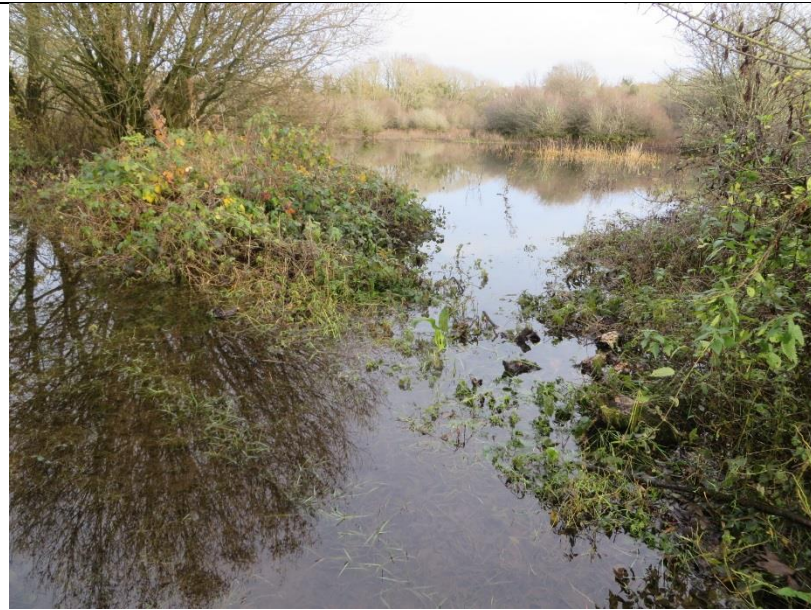
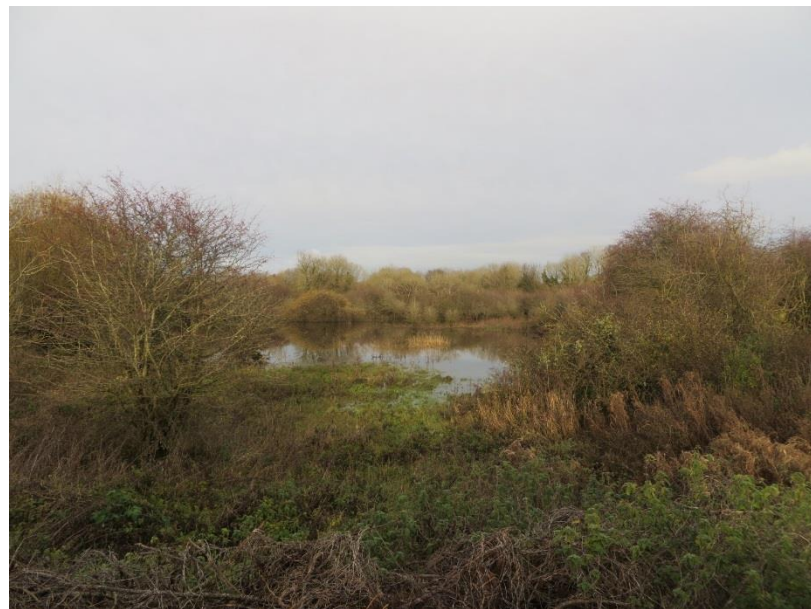
Other sources: aerial photography	
Field survey date	17/10/2014	11/11/2014
Field survey status	Confirmed	Confirmed
Water present	No	Yes Electrical conductivity: 481 uS/cm Temperature: 9.8 °C pH: 7.64

Water elevation		10.42 mAOD
Additional Information	A plug hole was not found	
Site photos 17/10/2014

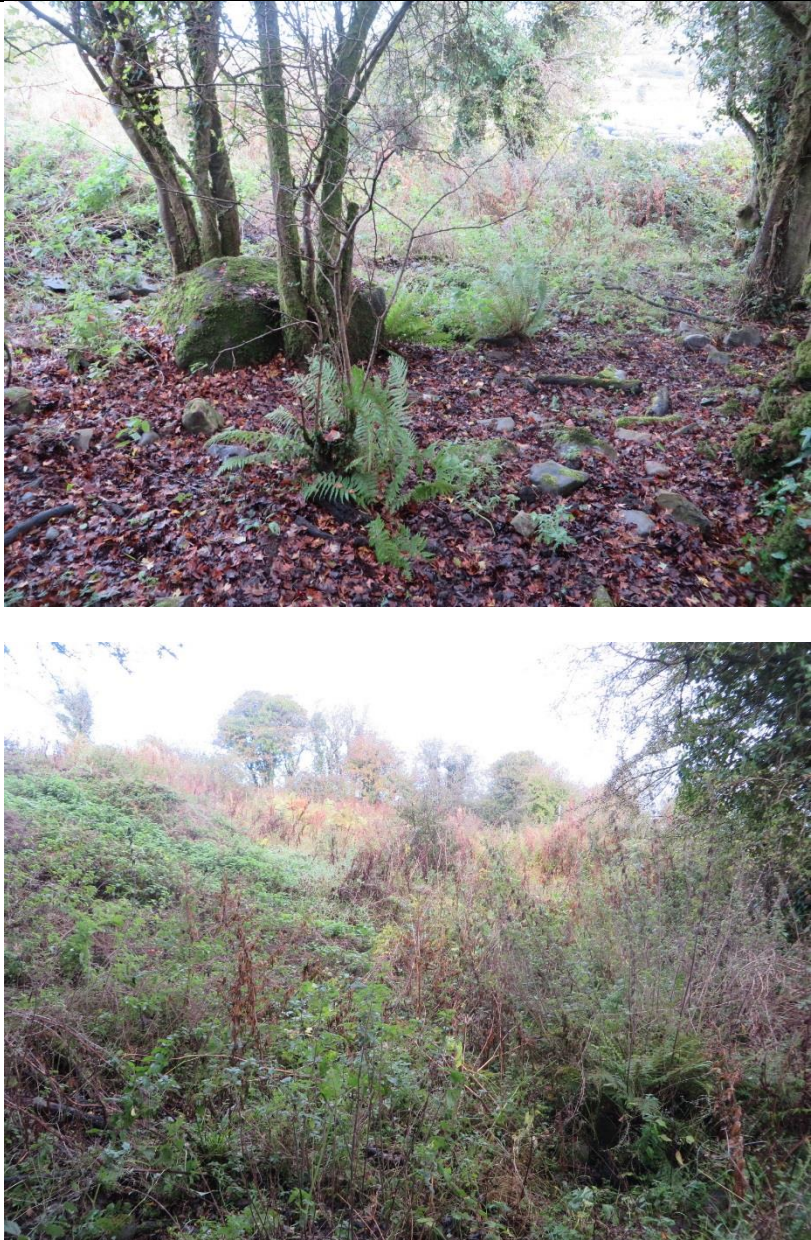
Feature ID	K70
Feature type	Enclosed depression
Coordinates	530671, 728317
Source	Field Survey
Field survey date	21/10/2014
Field survey status	Confirmed
Water present	No
Additional Information	15 x 3 m diameter enclosed depression Possibly filled in depression
Site photo

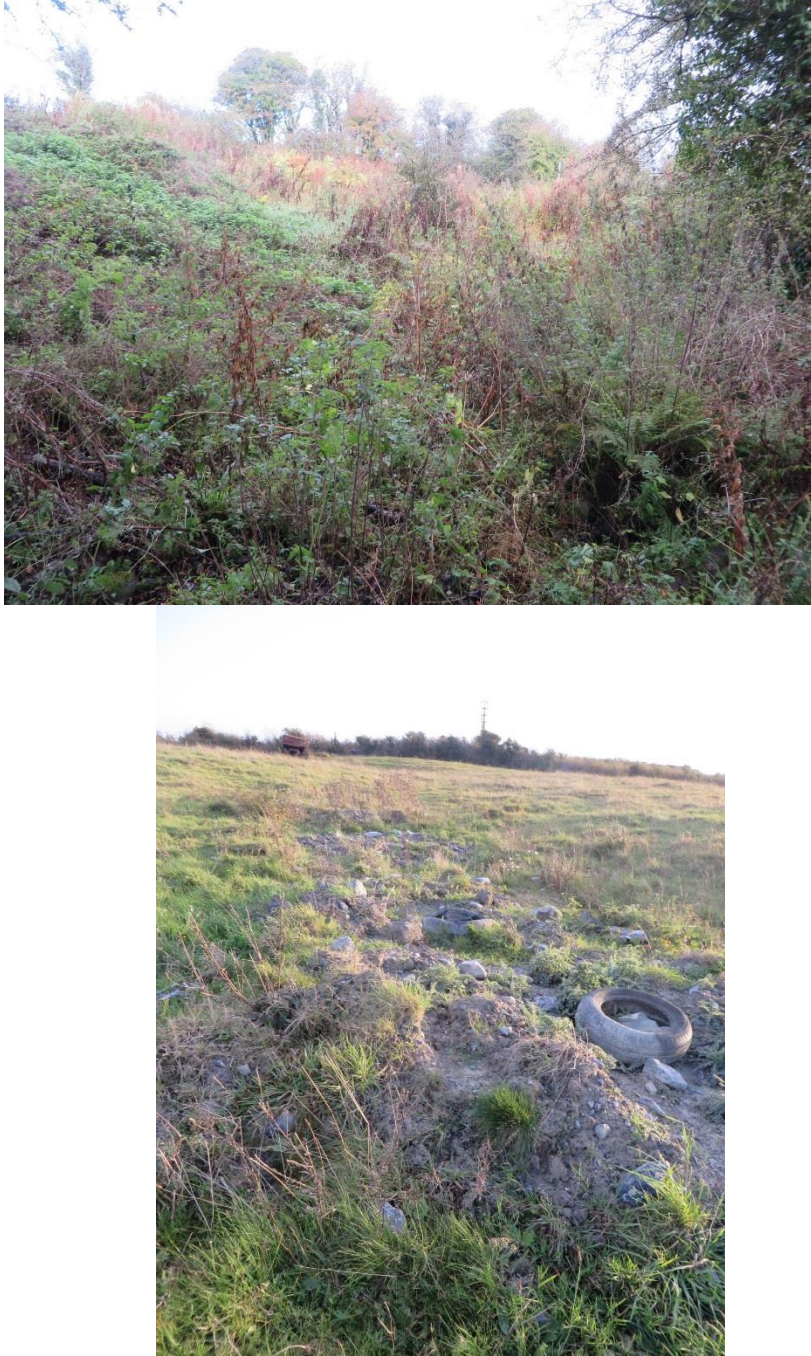
Feature ID	K71
Feature type	Enclosed depression
Coordinates	530694, 728662
Source	Field Survey
Field survey date	16/10/2014
Field survey status	Confirmed
Water present	No
Additional Information	2m by 4m along slope line Small depression near top of slope contains exposed rock
Site photo

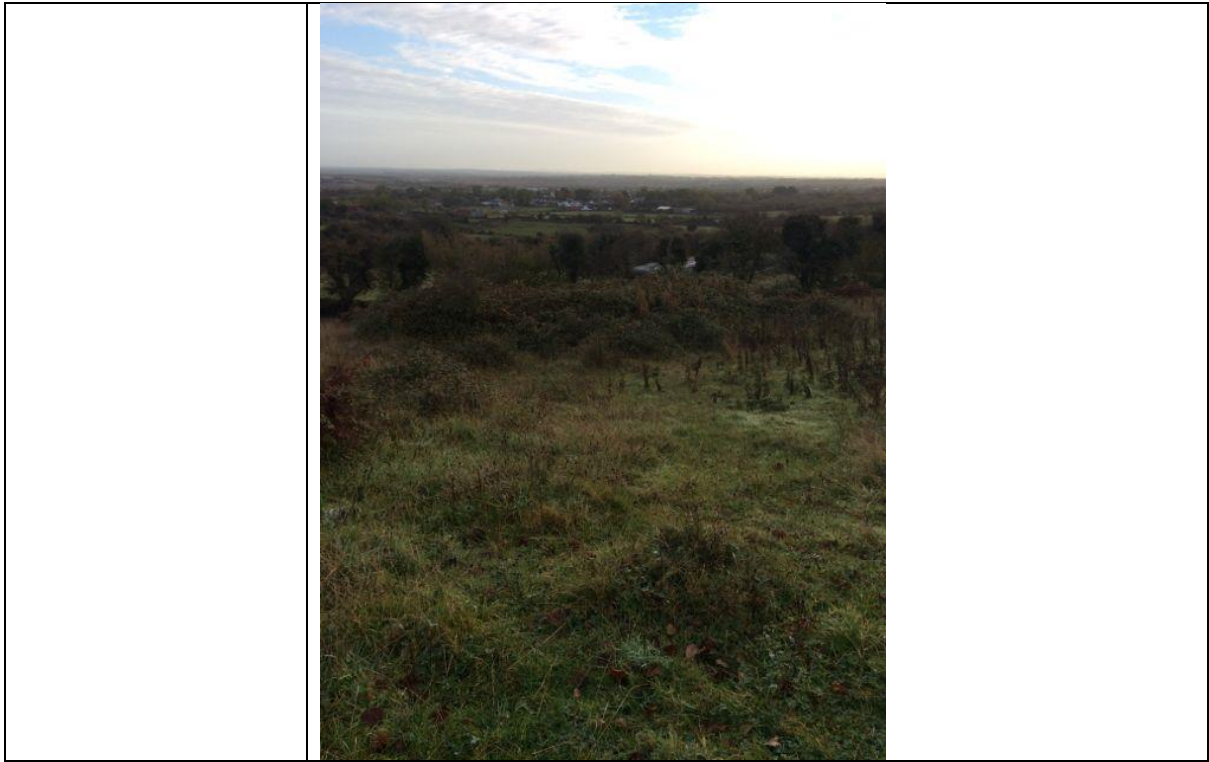
Feature ID	K85
Feature type	Enclosed depression
Coordinates	531456, 729194
Source	Field Survey
Field survey date	16/10/2014
Field survey status	Confirmed
Water present	No
Additional Information	10 m diameter semicircle intercepted by wall/road (N84). Possible enclosed depression slightly questionable as it could be as a result of excavation for N84 road construction
Site photo

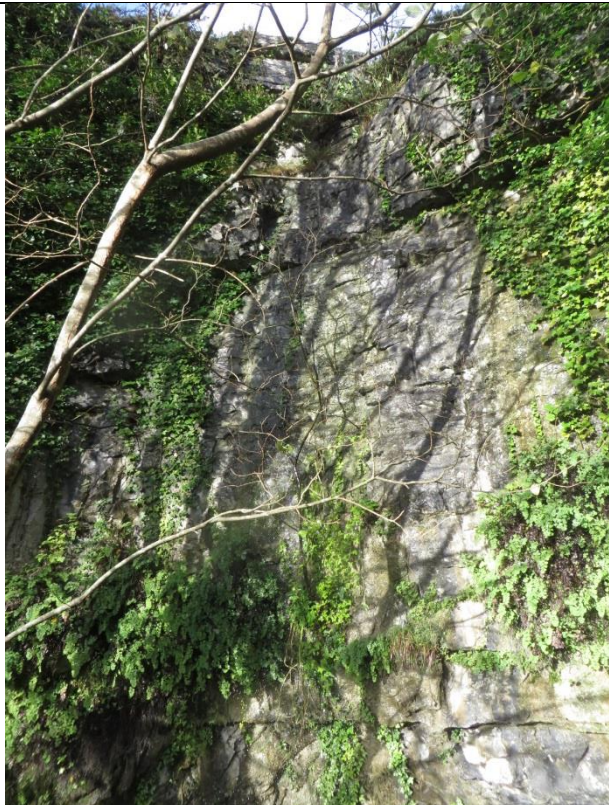
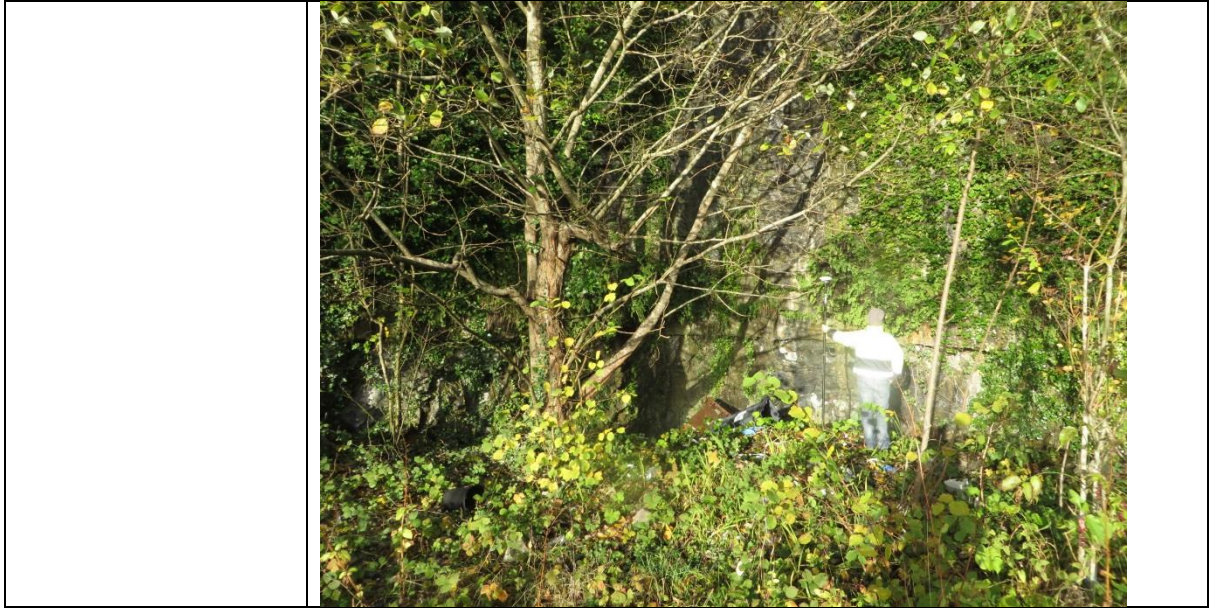
Field survey date	14/11/2014
Field survey status	Confirmed
Water present	Yes Electrical conductivity: 490 uS/cm Temperature: 12 °C pH: 8.23
Additional Information	Feature is located in old quarry. Water is discharging from fractures approx. 5m above ground level.
Site photos

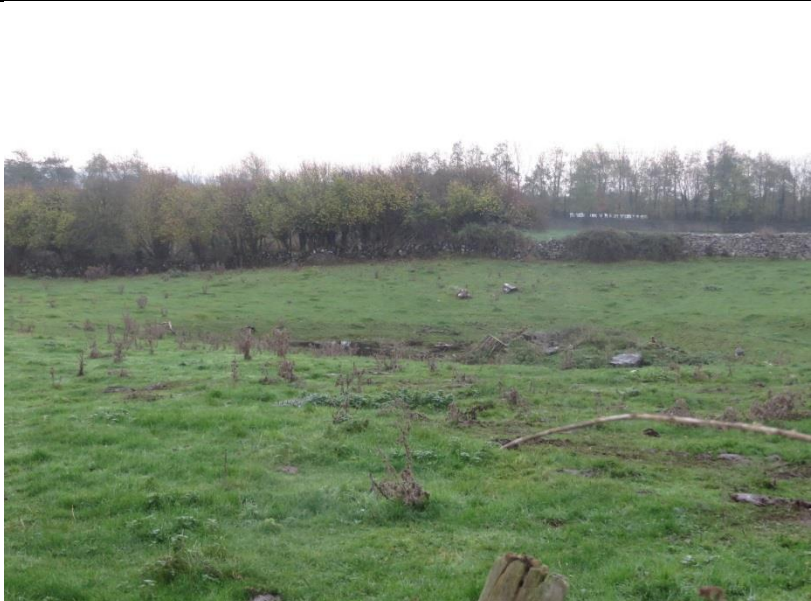
Field survey date	18/11/2014
Field survey status	Confirmed
Water present	Yes No water quality analysis recorded
Additional Information	Farmer noted that the depression fills with water
Site photos
