Galway City Transport Project –
Assessment of Annex I habitats
in the Ballygarraun survey area
(Perrin, 2014)

N6 Galway City Transport Project

ASSESSMENT OF ANNEX I HABITATS IN
THE BALLYGARRAUN AREA

OCTOBER 2014

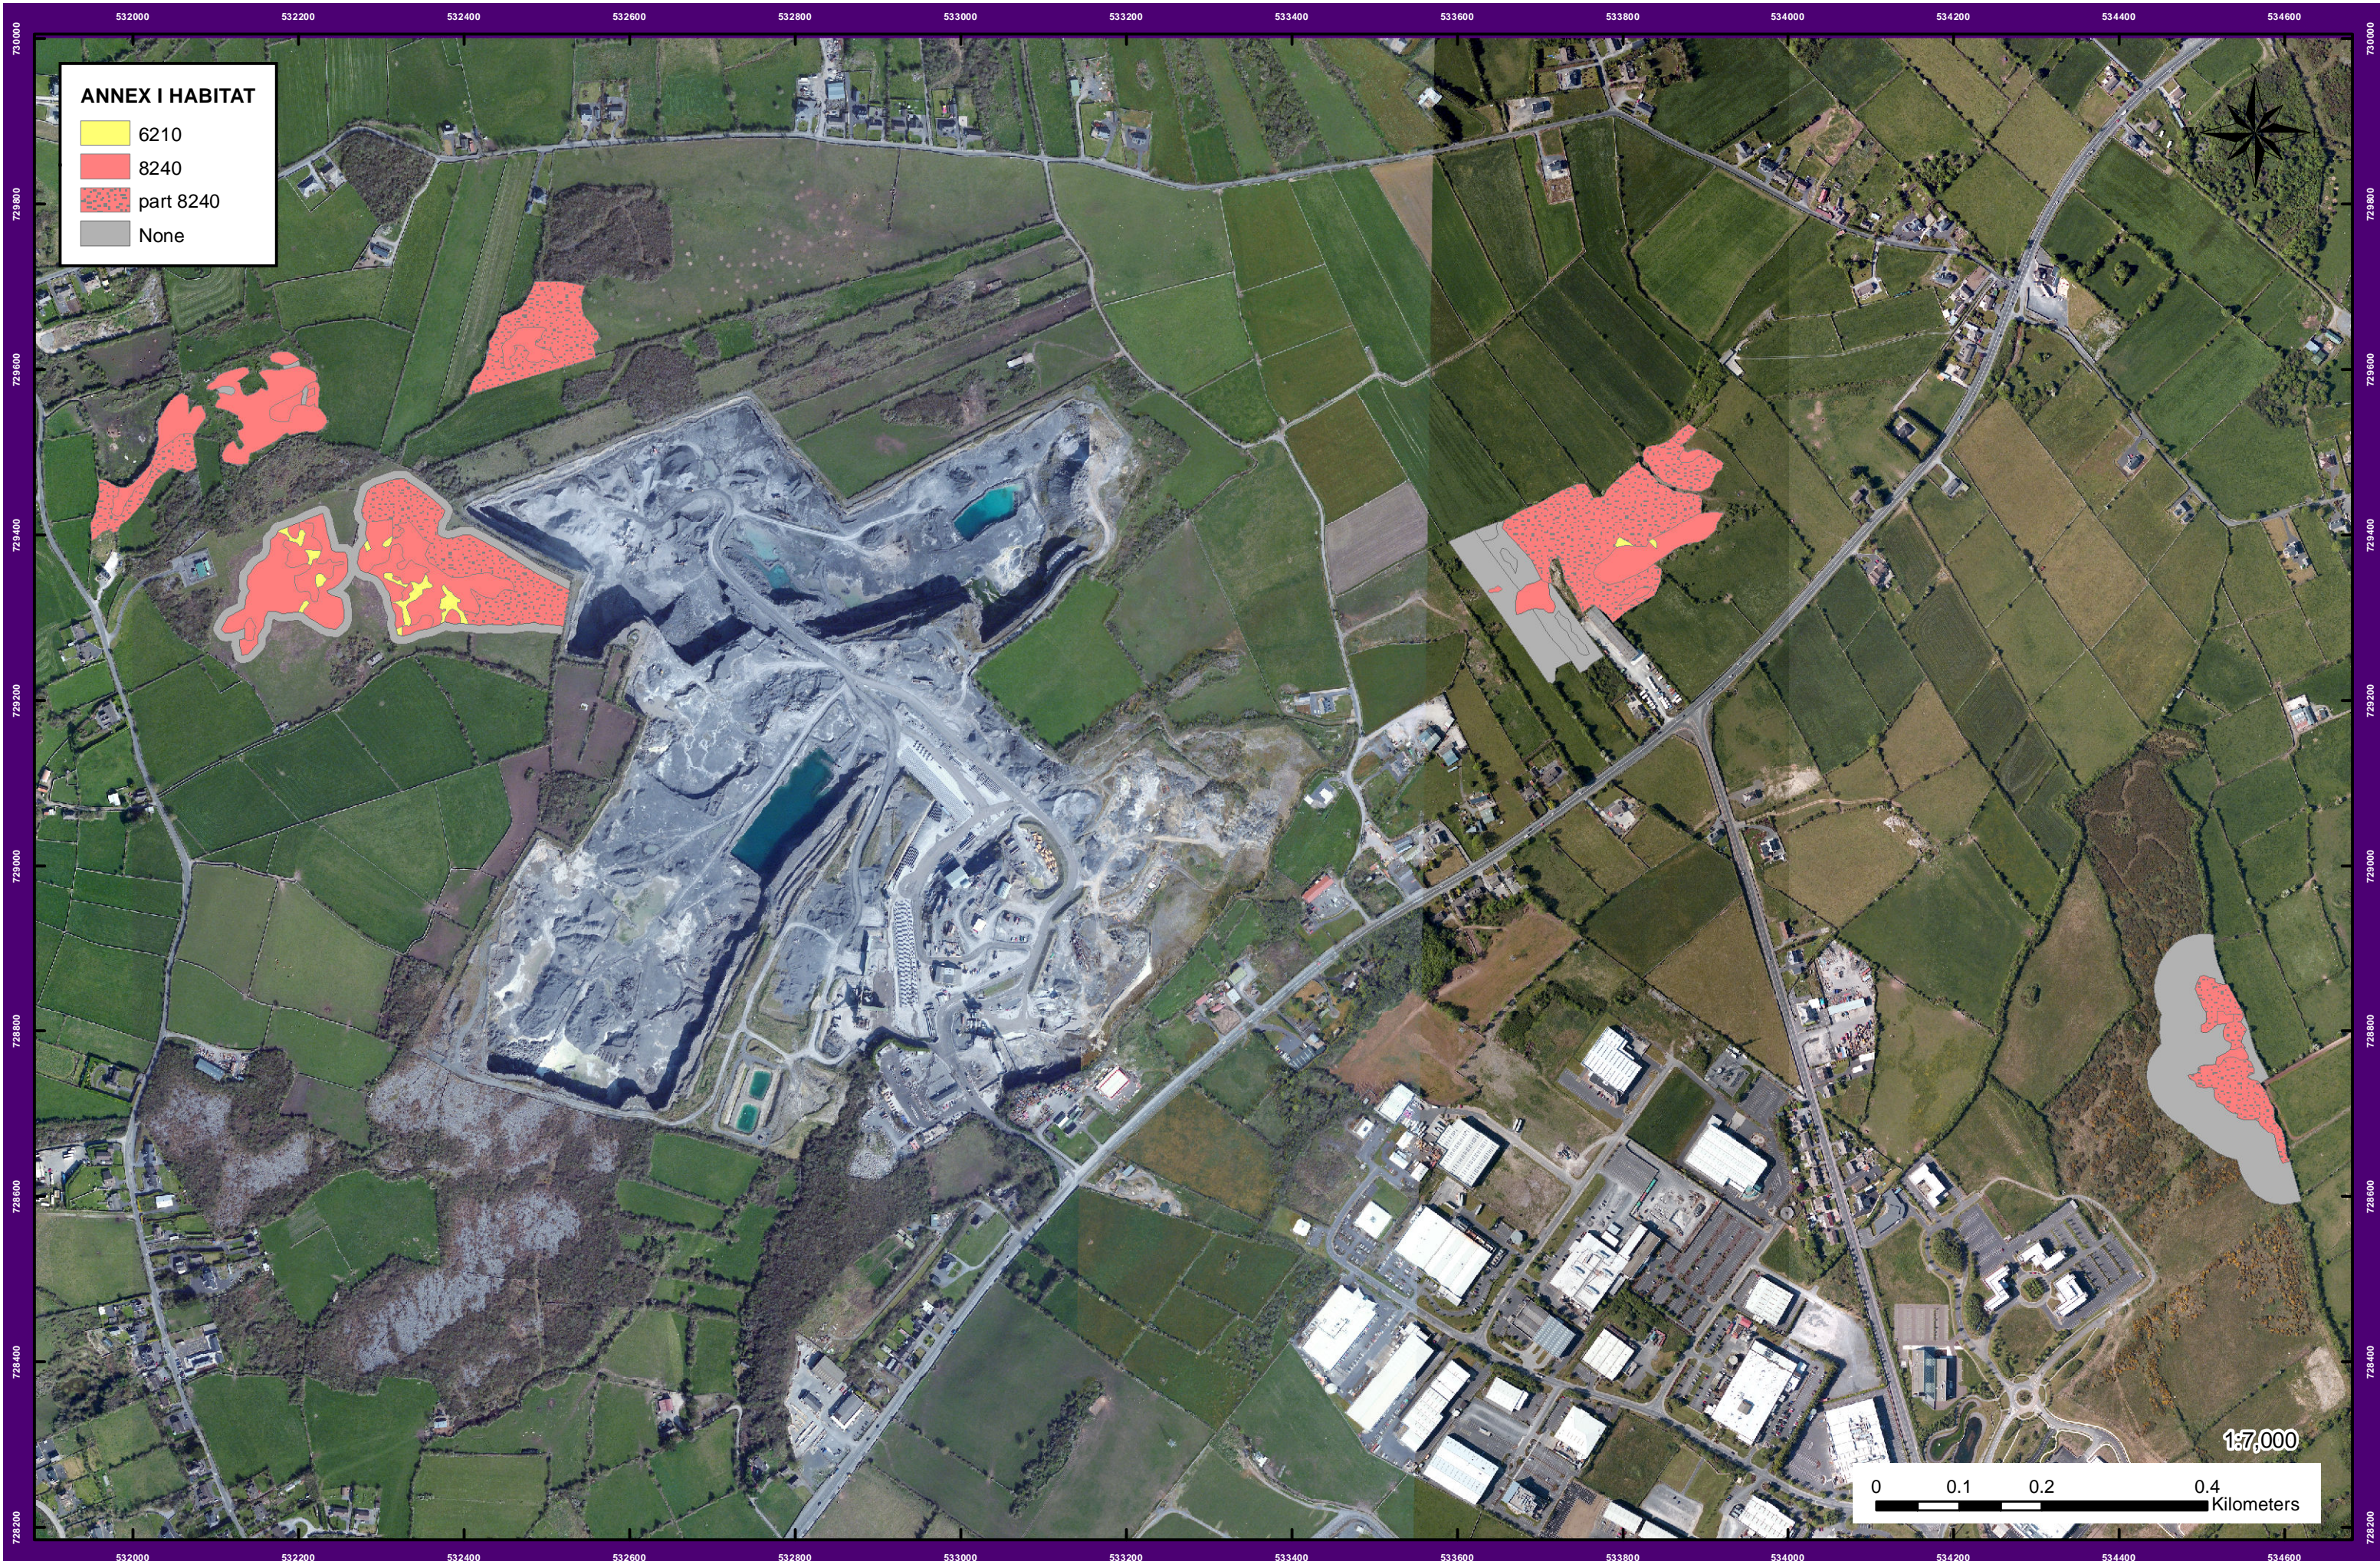
Figure 1. Ballygarraun area Annex I habitat map

Three Annex I habitats were recorded in the Ballygarraun area: 4060 Alpine and Boreal heaths, 6210 Semi-natural dry grasslands and scrubland facies on calcareous substrates (Festuco-Brometalia), and *8240 Limestone pavement (Table 1). These habitats are shown in Figure 1. Habitat 4060, which was represented by the lowland *Dryas octopetala* community, covered only a few square metres and was not assessed.

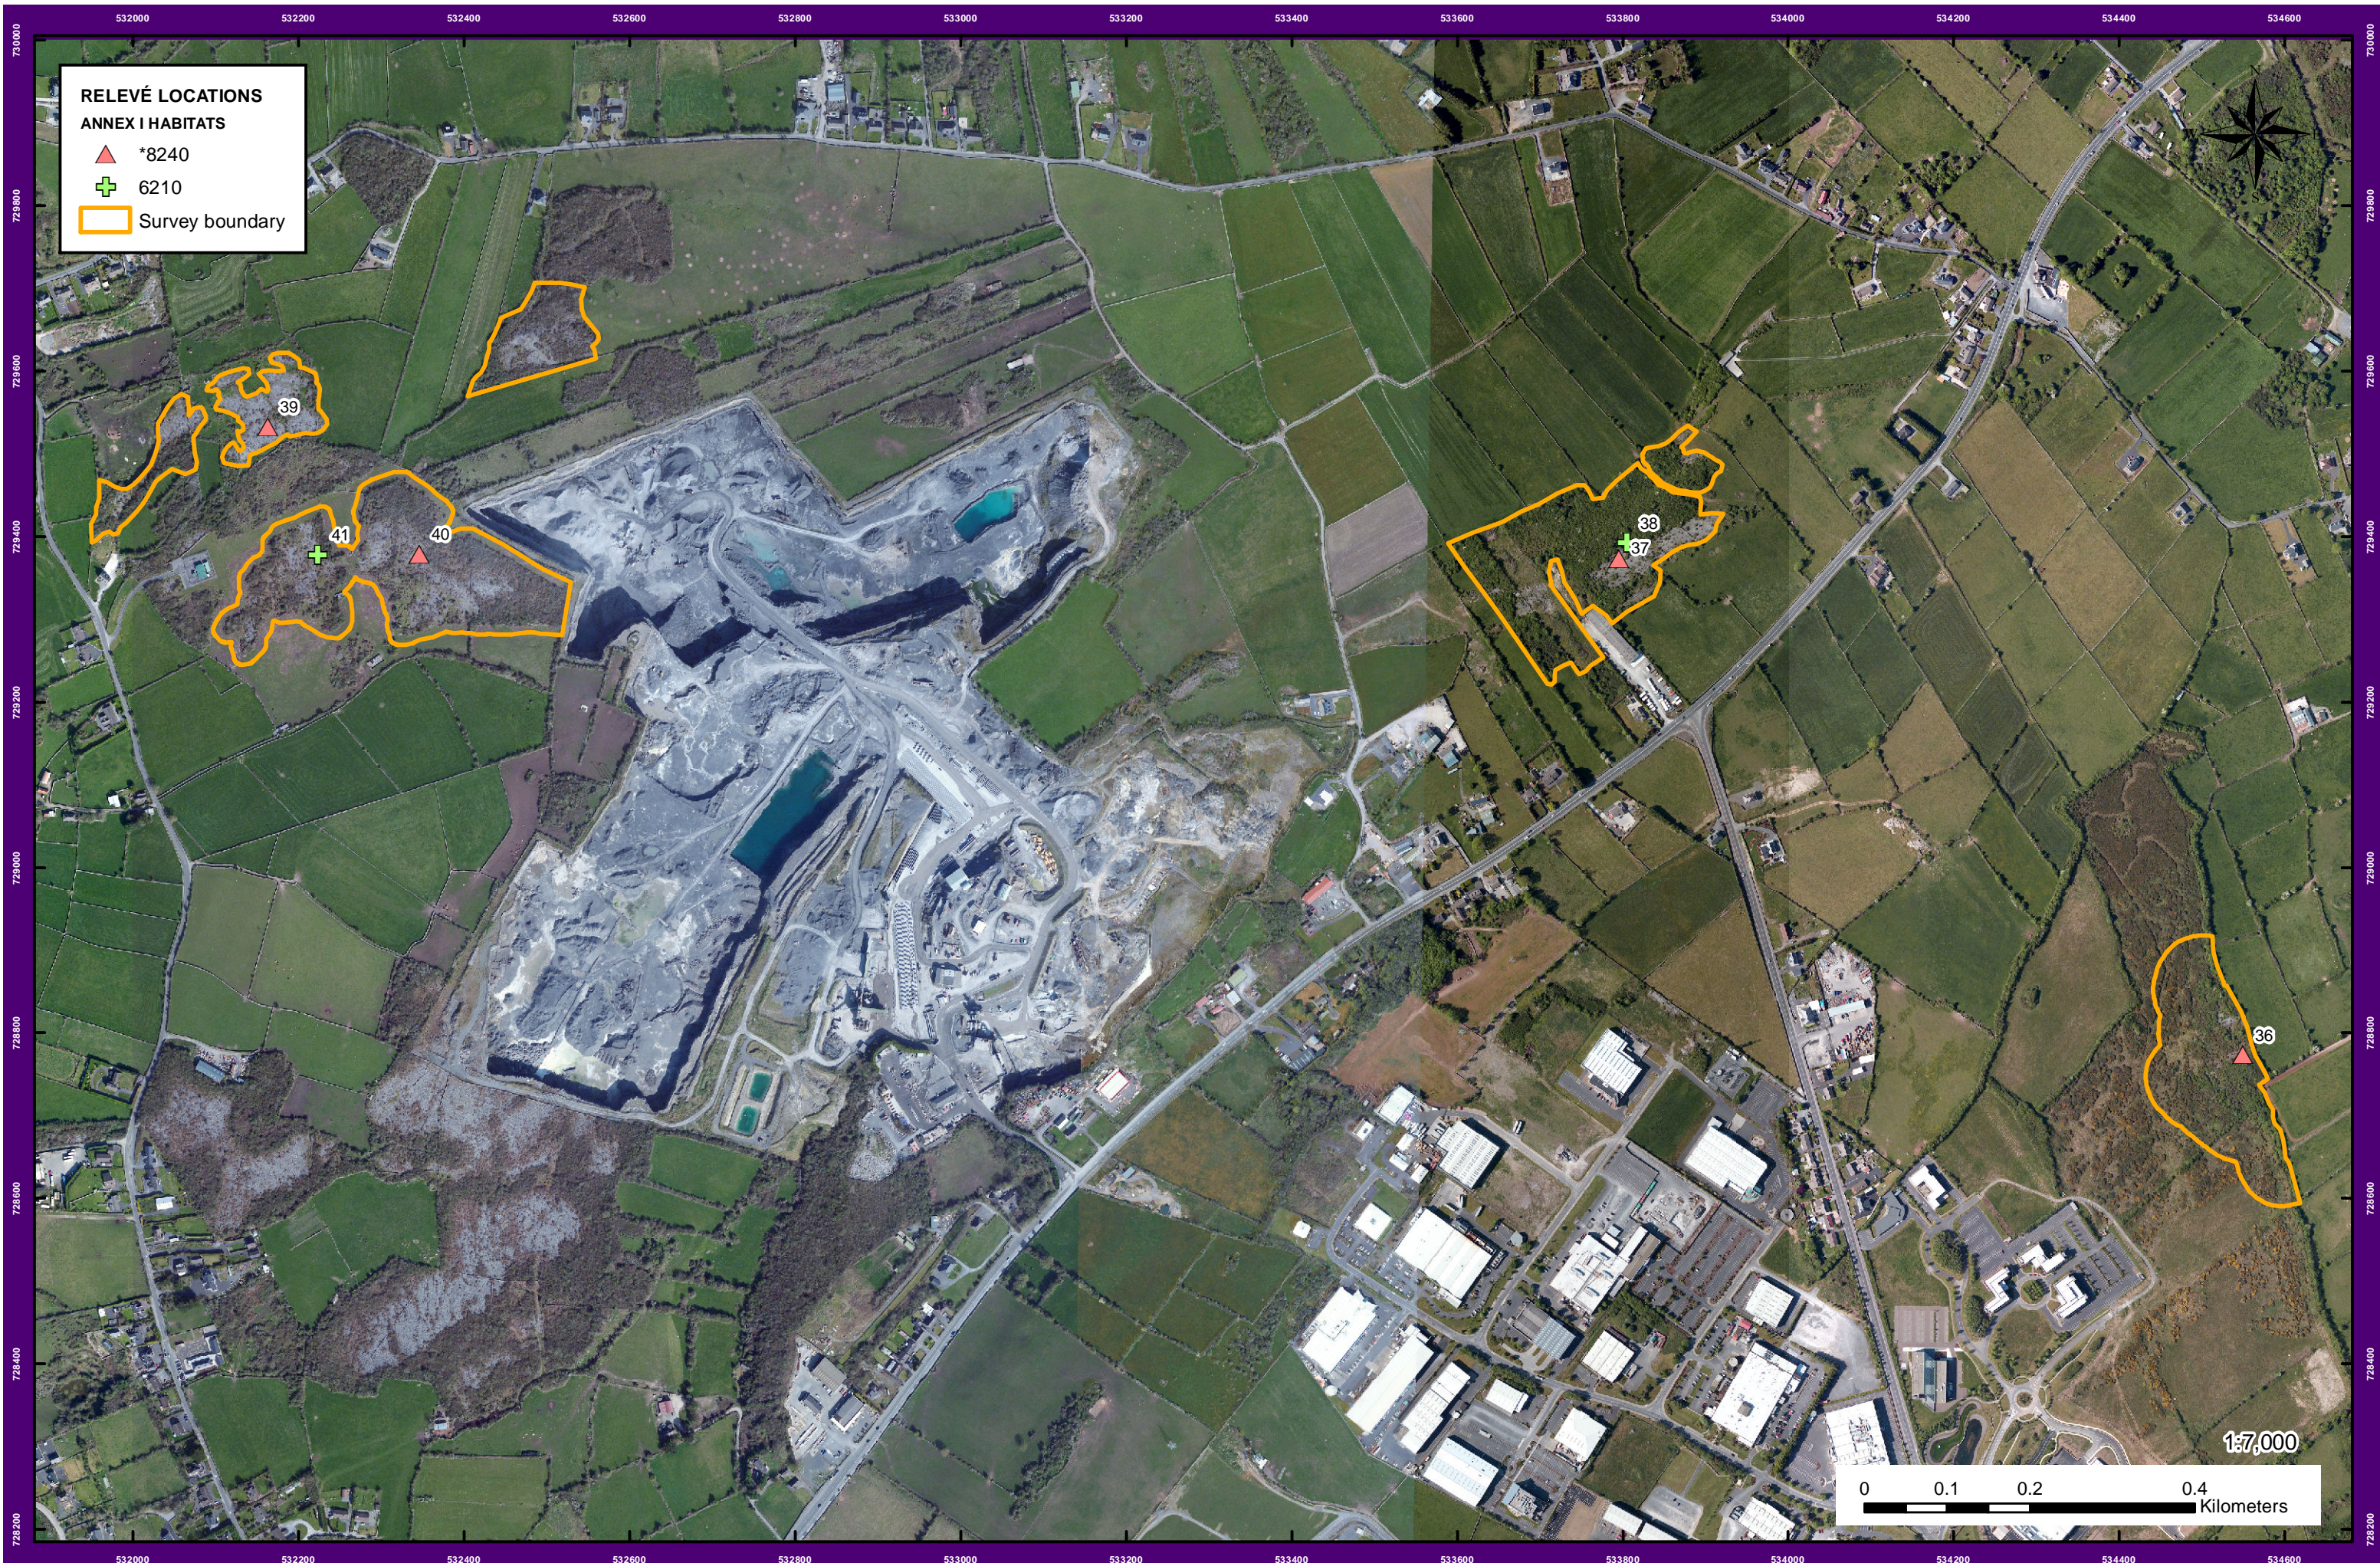
Figure 2. Ballygarraun area relevé locations.
(Relevé numbers shown correspond to those used in Appendix 1.)

This parameter assesses the condition of the habitats. Six relevés were recorded, two in habitat 6210 and four in habitat *8240. The locations of these relevés are shown in Figure 2. Full details of these relevés are included in Appendix 1. Habitat 6210 was assessed using the criteria of O'Neill *et al.* (2013). Habitat *8240 was assessed using the criteria of Wilson & Fernández (2013); all *8240 relevés were recorded on exposed limestone pavement. Relevés passed or failed depending on whether they achieved the relevant target for each criterion (e.g., number of indicator species, sward height). One of the 6210 relevés and two of the *8240 relevés passed the assessment (Table 2), both thus only achieving a 50% pass rate, which gives an assessment of *Unfavourable – Bad*. Scrub encroachment appears to be an issue in areas of *8240 habitat.
