N6 Galway City Ring Road

**Lackagh Tunnel: Geotechnical and
Hydrogeological Appraisal**

GCOB-4.03-4.16

Issue 3 | 26 July 2018

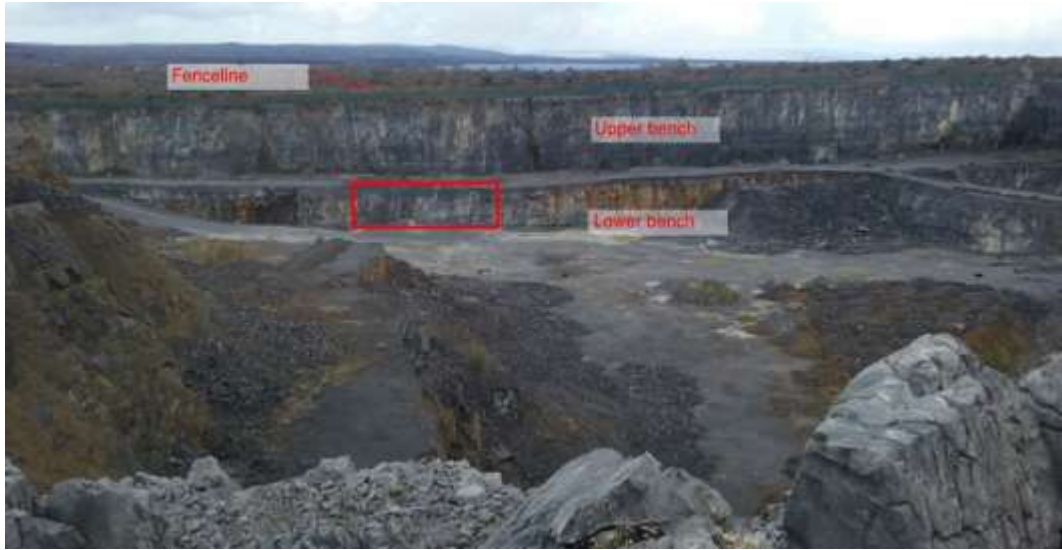
Figure 3.4: Features of the eastern tunnel portal area, with extent of tunnel portal marked within red rectangle

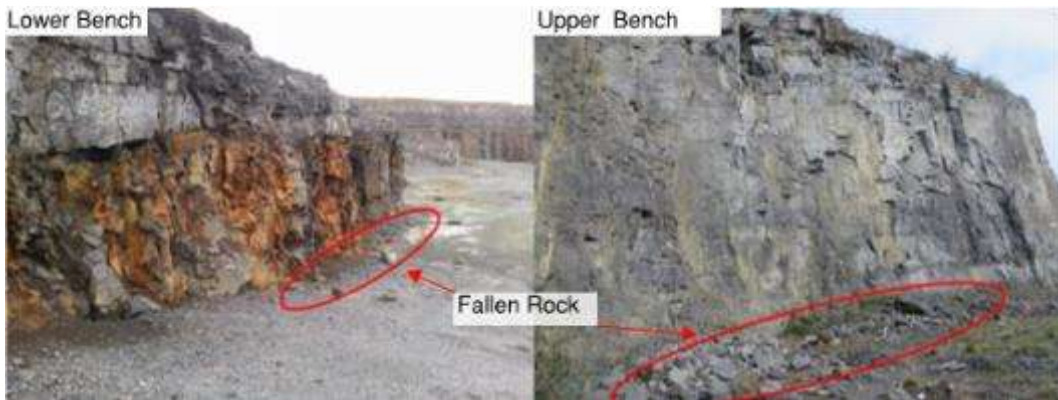
Some instability in the rock face is evident predominantly from blast damage during the operation of the quarry, with open discontinuities (joints and fractures), loose rock and the accumulation of debris resulting from spalling and failures present at the base of the lower and upper benches, see **Figure 3.5** below.

Figure 3.5: Face instability on the lower and upper bench

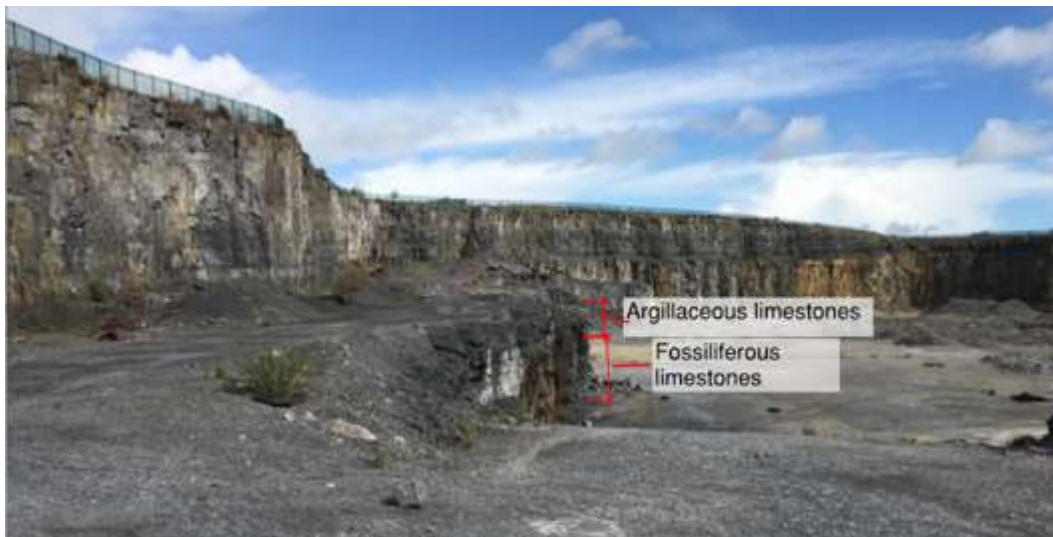
Ground conditions at the western face of Lackagh Quarry comprise a cyclical sequence of carboniferous limestones (see **Figure 3.14**). Each cycle is between 10m and 15m thick and is characterised by thinly bedded, dark mud-rich (argillaceous) limestones which pass upward into thicker bedded, paler non-argillaceous limestones. The darker limestone marks the beginning of the upper bench at the western face, and is generally considered to be stronger than the paler limestones.

Figure 3.14: Cyclical sequence of Limestones at Lackagh Quarry

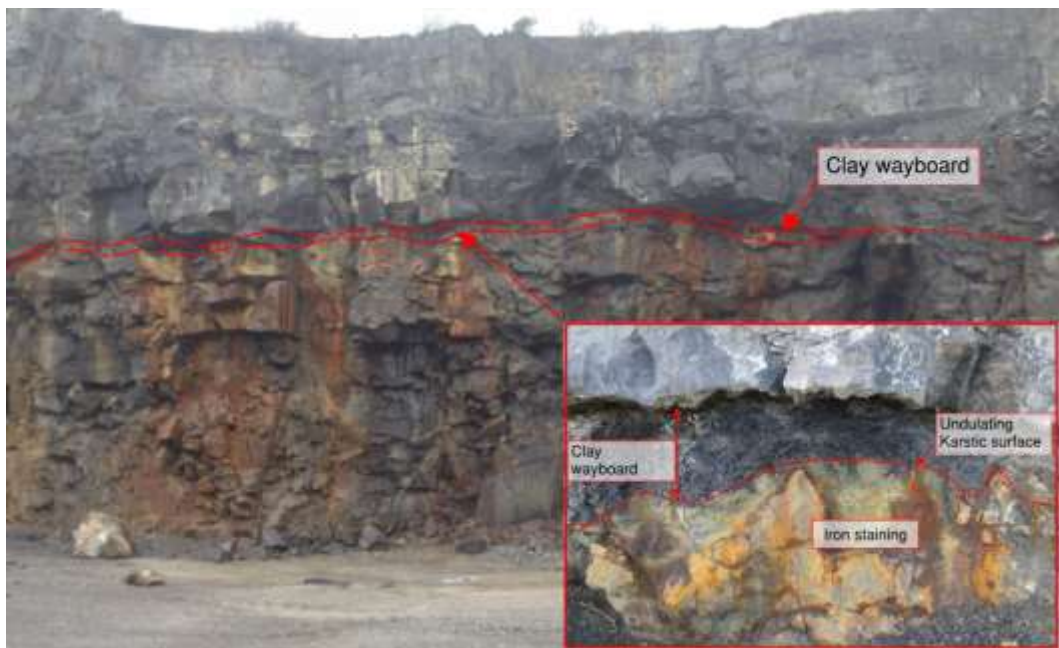
A clay wayboard of varying thicknesses from ~30cm to absent is evident on all faces of Lackagh Quarry, refer to **Figure 3.15**. A thin 20cm band of laminated mudstone, which compares favourably with the material observed on the quarry face, was encountered in BH04, however it is unknown whether this is a continuous layer or a cavity infill. BH04 and BH05 encountered several cavities, some not filled, and some infilled with clay.

Figure 3.15: Clay wayboard on the quarry face at Lackagh Quarry

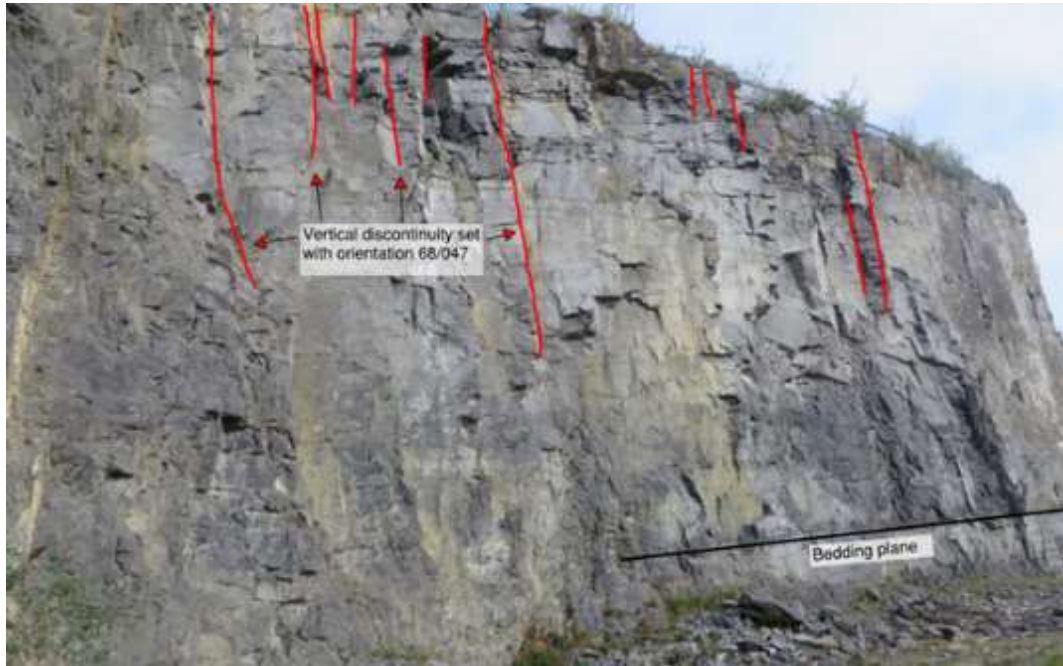
Figure 3.16: Exposed discontinuities on the upper bench

The vertical and horizontal discontinuities are visible on the exposed quarry face and are more evident in the upper bench wall, as the lower bench wall has been heavily affected by blast induced fractures.

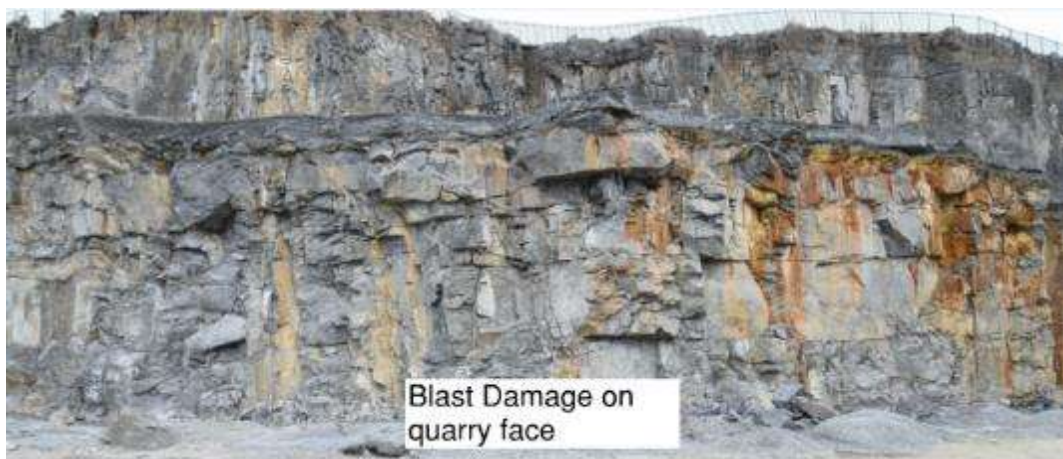
The western face has been left unprotected since the closure of the quarry in 2010 and has gradually deteriorated over time. Previous quarry workings have resulted in a heavily fractured rock face, both natural and blast induced (**Figure 3.17**), and unsafe overhangs and loose rock are present in the area of the proposed tunnel portal.

Figure 3.17: Blast damage on quarry face

Given the nature of the fracturing and the evidence of failures, the angle at which the current rock face stands is too steep in parts, suggesting that this unprotected face, if left in its present state will continue to erode and may potentially impact the overlying Limestone pavement if a deep seated slope failure was to occur.

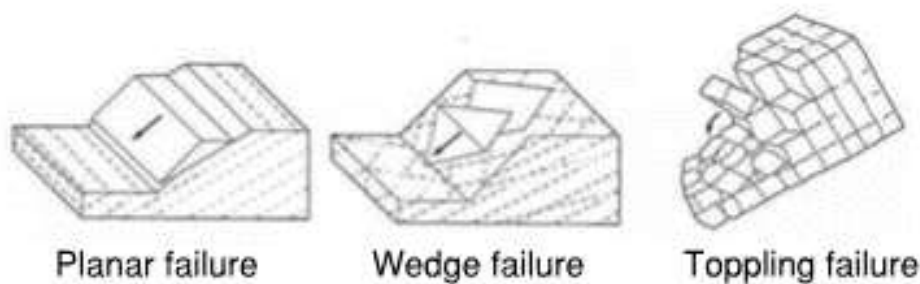
The three principal failure mechanisms which occur in a rock mass are discussed below and illustrated as schematics in **Figure 5.1**. The principal rock mass failure mechanisms are:

- Planar Failure
 - In order for a rock mass to undergo planar failure, the dip of the rock face must exceed the dip of the potential slip plane
 - The potential slip plane must be visible on the rock face
- Wedge Failure
 - Occurs when the dip of the rock face exceeds the dip of the line of intersection between two discontinuity planes
 - The line of intersection of the two discontinuity planes must daylight on the rock face
- Toppling Failure (Direct toppling)
 - Two sets of discontinuity planes whose intersections must dip into the rock face
 - Another set of discontinuity planes which daylight on the rock face and dip at a shallow angle

Figure 5.1: Schematic of potential failure mechanisms, Planar, Wedge and Toppling⁵

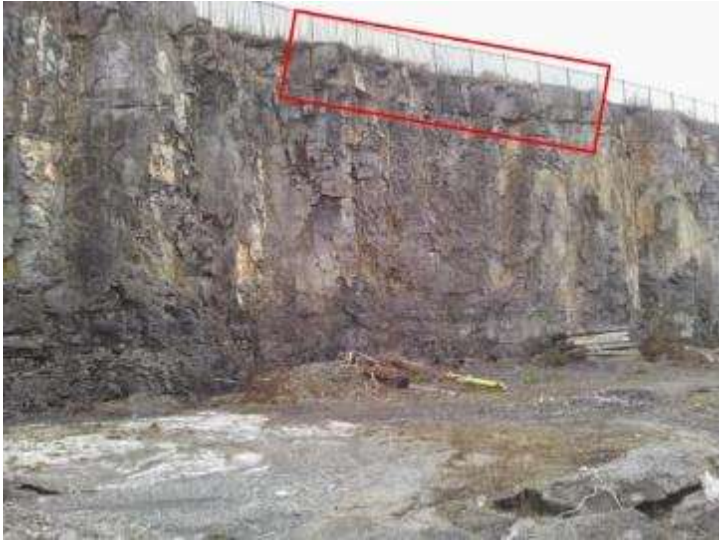
Following analysis of the site specific ground information and the discontinuity data, presented in **Table 3.4** in **Chapter 3**, it was determined that the failure most likely to occur within the rock mass and impact upon the structural integrity of the Limestone pavement is wedge failure and toppling. Wedge failures are seen in the upper section of the upper bench illustrated in **Figure 5.2** below.

Figure 5.2: Wedge failure in the upper bench
