### **Road Safety Audit Stage 1**

Transport Infrastructure Ireland  
**Galway City Transport Plan**  
Road Safety Audit – Stage 1

REP/001

Issue 1 | 14 August 2017

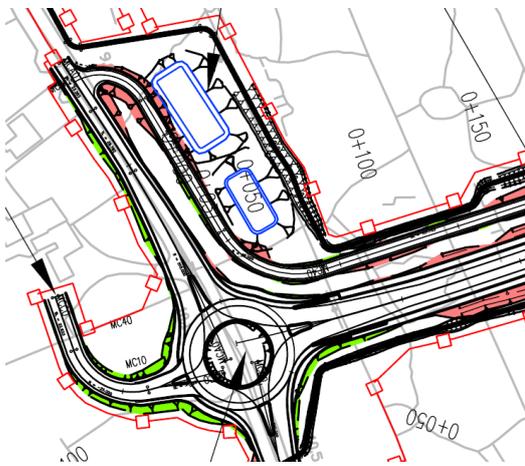
Figure 2: Earthworks overlap – Bearna West Roundabout

**Problem:** The earthworks design at various locations throughout the scheme appears to overlap (see figures 2 and 3). This could lead to an inability to construct the scheme as currently presented which could potentially result in a scheme which may be unsafe in parts for all users.

**Recommendation:** The Designer should reassess the earthworks design to ensure that the scheme can be constructed within the proposed scheme footprint without any adverse impact of all user's safety.

3.1	✓		✓		Areas of earthworks overlap have been re-examined to ensure that the scheme can be constructed. The scheme footprint takes account of construction requirements.	✓

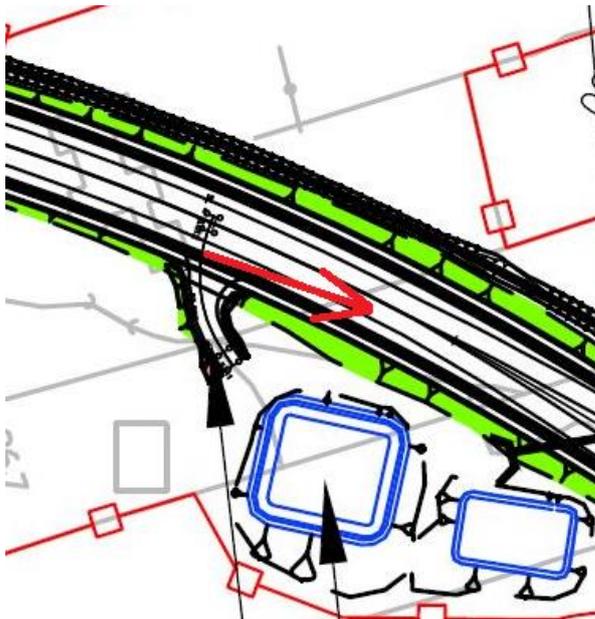
Figure 4: Visibility to oncoming traffic

**Problem:** The Audit Team is concerned that there may be issues with appropriate sightlines at junctions being achieved as a result of proposed adjacent infrastructure. It is also noted that the level of detail provided to the Audit Team at this stage does not allow for an analysis of verge widening to ensure that visibility is achieved. Substandard visibility at junctions could increase the potential for collisions at these locations.

**Recommendation:** The Designer should ensure that they have allowed sufficient land take to provide the required visibility at all road junctions. The Designer should also demonstrate that sufficient visibility is provided by the preparation of the appropriate drawings.

3.2	✓		✓		Forward visibility has been provided in accordance with TII Publications. All junctions have been assessed to ensure visibility in accordance with TII Publications is provided.	✓

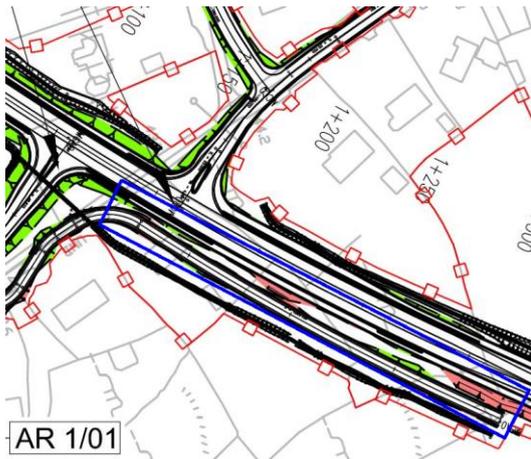
Figure 5: Possible headlight glare location

**Problem:** A number of parallel access roads are proposed in close proximity to the mainline. The Auditors are concerned that there could be a headlight glare issue between road users travelling in opposite directions on these roads. This could cause temporary blindness or dazzle and road user confusion ultimately leading to sudden braking which could result in rear end shunt type collisions.

**Recommendation:** The Designer should assess the potential for headlight glare between opposing road users on the parallel access roads and the mainline. If it is found that headlight glare could be an issue appropriate mitigation measures should be introduced.

3.3	✓		✓		The scheme has been assessed from the perspective of headlight glare. Where the potential arises, appropriate timber screening fencing and landscaping (bunds, shrubs) is provided within the scheme footprint.	✓

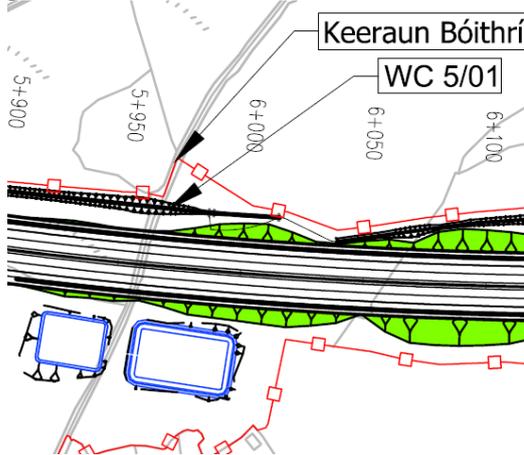
Figure 6: Attenuation pond with no access provided

**Problem:** A number of attenuation ponds do not appear to have been provided with access roads or links to the adjacent road network (see figures 5 and 6). This could have an impact on the overall scheme design if the lands made available for the scheme are not extensive enough to cater for all design elements.

**Recommendation:** The Designer should ensure that all attenuation ponds are provided with an access either from the proposed scheme or the existing adjacent road network.

3.4	✓		✓		Access to all attenuation ponds has been designed within the lands made available for the scheme.	✓	
3.5	✓		✓		The clearance of Lackagh Tunnel and the Galway Racecourse tunnel have been increased to accord with TII Publications. Consequently, the exits now serve as	✓

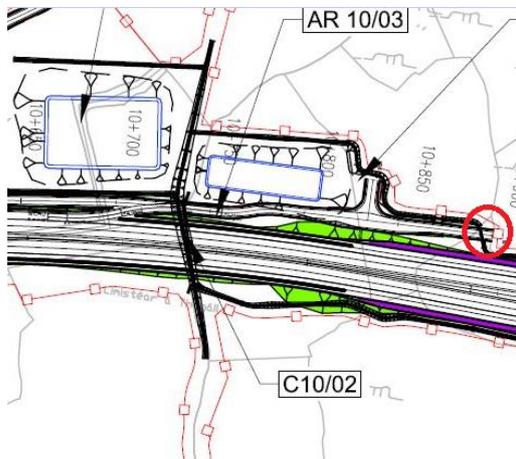
Figure 8: Exit road at Lackagh Tunnel (eastbound)

**Problem:** It is the Auditors' understanding that the exit roads on the mainline approaches to both tunnels are proposed in order to divert over height vehicles to the local road network to continue their journey. The Auditors are concerned that an over height vehicle that exits the mainline on the eastbound approach to Lackagh Tunnel (see figure 7) may have difficulty joining the local road network as there does not appear to be a turning area to enable the vehicle driver to do so. The Auditors are also concerned that an over height vehicle may need to reverse along the access road in order to join the local road network which could increase the potential for rear end shunt type collisions at this location.

**Recommendation:** The Designer should assess how an over height vehicle will reach the local road network having been directed from the mainline at this location. Measures should be put in place to make the required movements as simple as possible.

To be completed by the Designer				To be completed by Audit Team Leader	
Problem / Comment	Problem / Comment Accepted		Recommended Measure Accepted		Describe Alternative Measure	Alternative Measures Accepted	
	Yes	No	Yes	No		Yes	No
					<p>emergency exit routes. These emergency exit routes accommodate egress from the mainline during tunnel incidents. The operation of these emergency exits will be controlled by an intelligent transportation system.</p> <p>The emergency routes via which redirected vehicles will join the local road networks has been examined and simplified by eliminating the need to complete a turnaround.</p>

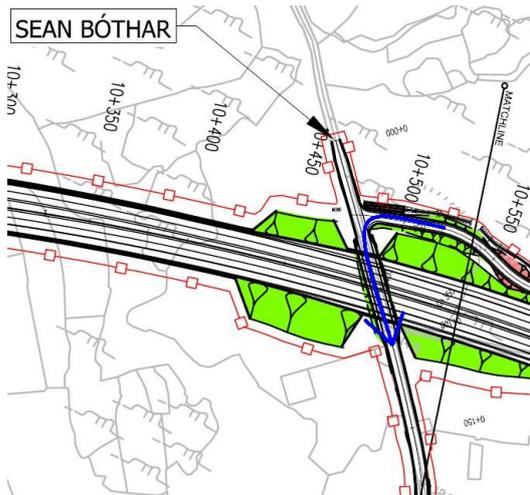
Figure 9: Sean Bothar diversion route

**Problem:** Exit roads are provided in advance of both tunnels in order to offer an alternative route to over height vehicles. The Auditors are concerned that some of the local road network may not be suitable for such vehicles (see figure 9) which could lead to blockages potentially resulting in various collision types.

**Recommendation:** Diversion routes should be developed from each exit road at the tunnels. These routes should indicate the maximum height available to such vehicles in order to minimise disruption to other road users.

3.6	✓		✓		<p>The clearance of Lackagh Tunnel and the Galway Racecourse tunnel have been increased to accord with TII Publications. Consequently, the exits now serve as emergency exit routes. These emergency exit routes accommodate egress from the mainline during tunnel incidents. The operation of these emergency exits will be controlled by an intelligent transportation system.</p> <p>The need for exiting vehicles to perform u-turn movements have been removed.</p> <p>The routes that overheight vehicles will utilise following departure from the mainline has been examined and where required are proposed for upgrade as part of the scheme so as to enhance safety and operational performance. Refer to drawings GCOB-100-DP-210 and GCOB-100-DP-217.</p>	✓

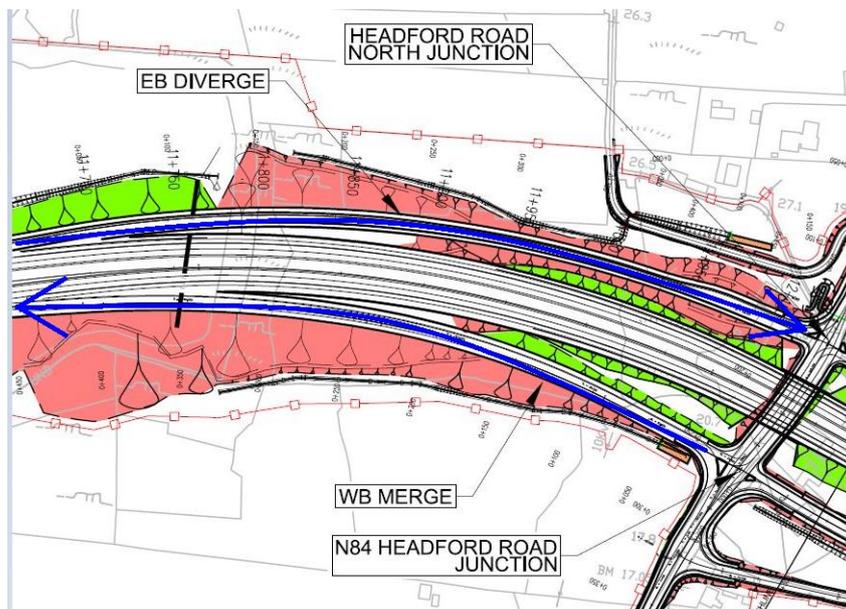
Figure 10: Lack of verge widening (Headford Road Junction)

**Problem:** The Auditors are concerned that forward visibility on the eastbound diverges and westbound merges for these junctions may be insufficient as there does not appear to be verge widening proposed at this stage. Sub-standard forward visibility could lead to road users being unaware of a hazard within the carriageway ahead. This could lead to late braking or erratic manoeuvres potentially increasing the risk of collision at these locations.

**Recommendation:** The Designer should make an assessment of the requirements for verge widening and alter the design if necessary.

3.7	✓		✓		<p>Visibility for the Headford Road and N17 junction have been re-assessed. Visibility in accordance with TII Publications has been provided.</p>	✓

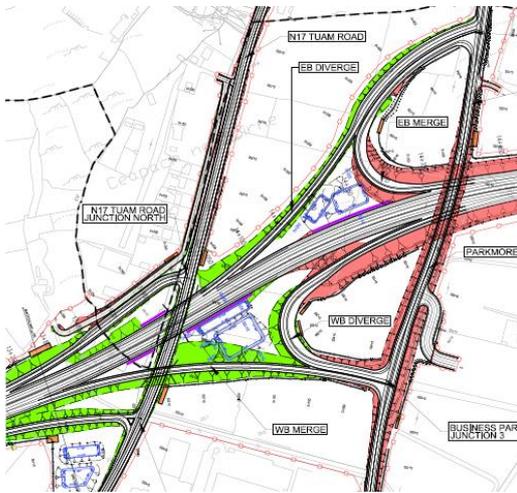
Figure 11: Successive merges and diverges

**Problem:** The design presented for audit includes successive eastbound merges at chainages 13+580 and 13+850 and successive westbound diverges at chainages 13+550 and 13+350. The Auditors are concerned that road users may become confused or distracted by these layouts which could result in sudden braking, weaving or erratic manoeuvres which could increase the risk of injury to all users. This issue could also be complicated by the proposed N84 Headford Road junction which will be situated ~1,100m west of the N17 Tuam Road junction, including auxiliary lanes between both.

**Recommendation:** The Designers should assess whether the diverge for the N17 and merge for the mainline from Parkmore Link Road are required as there appears to be an alternative route within the proposed design for each of these movements. If a merge and diverge was removed from the design these issues would not arise. Please also refer to comment 3.5.

3.8	✓		✓		The layout of the N17 junction has been examined. Following further traffic analysis and junction optioneering the eastbound diverge to the Parkmore Link Road has been removed and the westbound merge from the Parkmore Link Road has been removed.	✓

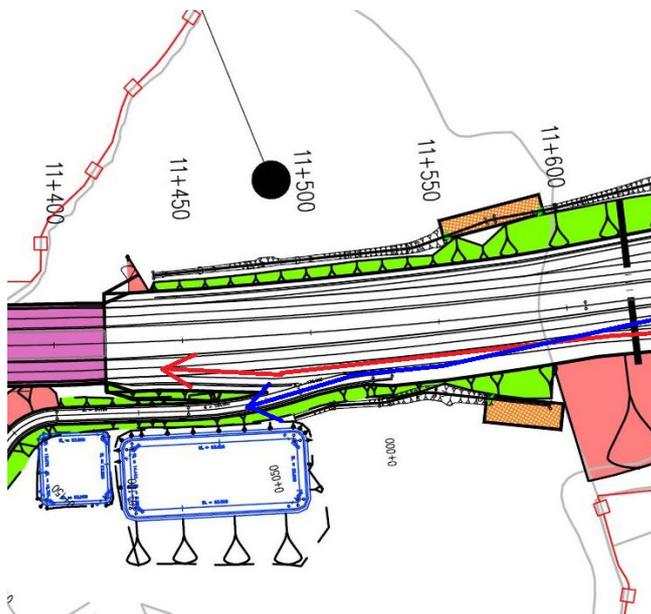
Figure 12: Lackagh Tunnel / N84 Headford Junction

**Problem:** The Auditors are concerned about the proximity of this tunnel to the junction to the east. The diverge for the N84 begins almost immediately east of the tunnel and the merge from the N84 to the N6 terminates just east of the tunnel entrance.

Travelling eastbound there is little or no opportunity for the provision of the required advanced directional signage and the diverge commences immediately upon egress from the tunnel. This may lead to driver confusion potentially resulting in stopping or reversing on the mainline.

Travelling westbound the merge lane terminates at the tunnel entrance, where there is no hard shoulder. This could lead to slow moving vehicles attempting to merge into fast moving traffic which could potentially result in side swipe or rear end type collisions as well as increasing the risk of hard braking or skidding. The crossover between the over-height vehicle escape lane with the westbound merge lane exacerbates this situation by placing merging vehicles in direct conflict with egressing over-height vehicles. This additional conflict may result in additional issues for merging vehicles, particularly considering the potential restricted visibility afforded due to over-height vehicles exiting the carriageway.

**Recommendation:** The Designer should investigate widening the tunnel to include a hardshoulder or to extend the merge/diverge lanes through it. This would simplify the provision of signage on the eastbound direction and will reduce the potential for the collision types outlined.

Alternatively, the interchange could be relocated further east or the merge / diverge lane configurations adjusted to relocate their interaction points further east and away from the tunnel entrance / exit.

In relation to the emergency over height vehicle egress, egressing vehicles should not be in direct conflict with merging vehicles. The Designer should take this into account in the redesign of the egress for these vehicles.

3.9	✓			✓	<p>The interaction of the N84 and Lackagh Tunnel portal has been examined and the following measures are proposed to enhance safety and operational performance.</p> <p>Travelling eastbound the length of the auxiliary lane of the parallel diverge has been reduced to 100m to provide a travel distance between the Lackagh portal and the start of the diverge taper thereby allowing diverging traffic to identify the diverge. Hourly diverging traffic flows for the 2039 design year, with high growth, are low (169) thereby minimising the interaction between diverging and mainline traffic. A departure from standard has been obtained from TII for the reduced auxiliary lane length. The area will be lit to enhance the safety of the scheme and ensure the layout is clearly visible to road users. The diverge will be appropriately sign posted via fixed signage (posts and gantries) allowing motorists to anticipate the diverge.</p> <p>Travelling westbound the hourly merging traffic flows for the 2039 design year, with high growth, are low (242) thereby minimising the interaction between merging and mainline traffic. The area will be lit to enhance the safety of the scheme</p>	✓

To be completed by the Designer				To be completed by Audit Team Leader	
Problem / Comment	Problem / Comment Accepted		Recommended Measure Accepted		Describe Alternative Measure	Alternative Measures Accepted	
	Yes	No	Yes	No		Yes	No
					<p>and ensure the layout is clearly visible to road users. The merge will be appropriately sign posted via fixed signage (posts and gantries) allowing motorists to anticipate the diverge.</p> <p>Regarding the emergency route which is in proximity to the Lackagh tunnel portal and the N84 westbound diverge. The clearance of Lackagh Tunnel and the Galway Racecourse tunnel have been increased to accord with TII Publications. Consequently, the exits now serve as emergency exit routes. These emergency exit routes accommodate egress from the mainline during tunnel incidents. The operation of these emergency exits will be controlled by an intelligent transportation system. Thus vehicular traffic interactions at this location will be limited to tunnel incidents and not everyday usage.</p> <p>Refer to drawing GCOB-100-DP-108.</p>
