Galway County Council
N6 Galway City Ring Road
Karst Survey Report

GCOB-4-03-0-6.2.8_010

Issue 3 | 26 July 2018

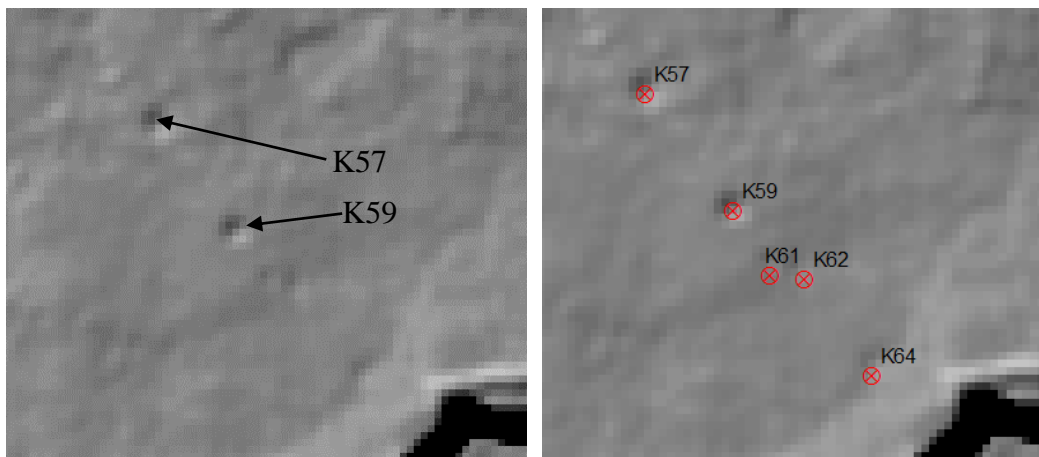
Figure 1a (left) lidar image showing two potential enclosed depressions identified from the desk study, **2b** (right) karst features confirmed during field survey

Potential features were identified during the desk study and then investigated in the field. As an example, **Figure 1a** presents the lidar image showing two clear circular shapes interpreted as likely karst landforms but also shows multiple surrounding features that are less clear. The potential features (K57 and K59) were visited and confirmed as enclosed depressions during the field survey. Survey of the surrounding features also confirmed three further enclosed depressions (K61, K62 and K64) as shown in **Figure 1b**.

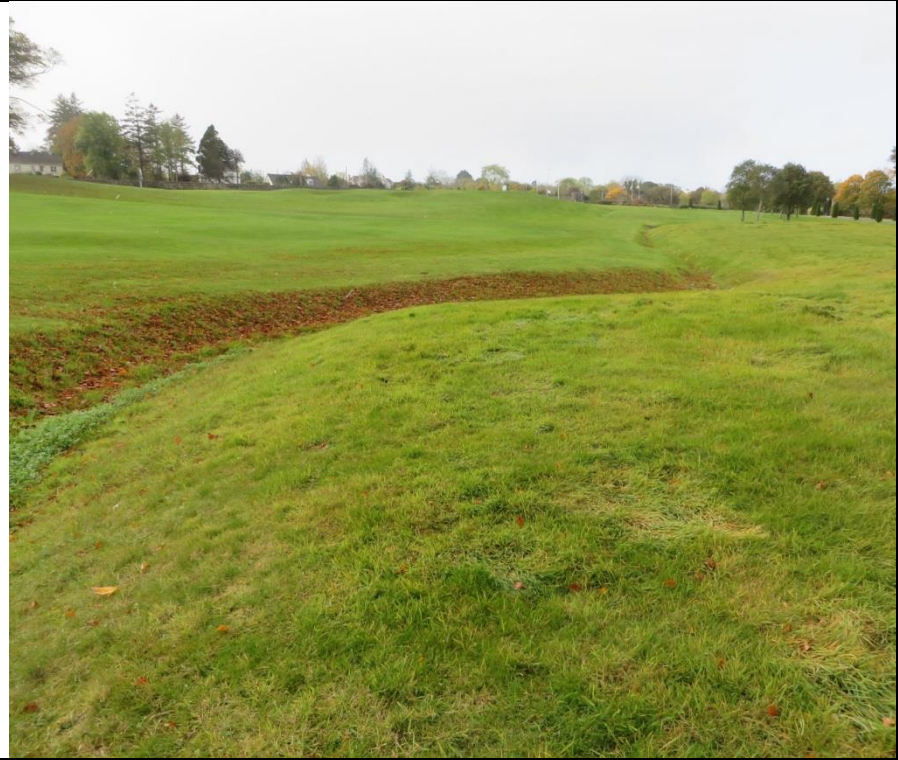
Feature ID	K2
Feature Type	Spring
Coordinates	526837, 728183
Source	<p>Lidar and OSI water line:</p>  
	<p>Bing Maps:</p>  
	Other sources: aerial photography
Field survey date	21/10/2014
Field survey status	Confirmed
Water present	Yes
Additional Information	Spring discharging into large pond. Drain also discharges into the pond. The drain may be modified and contains little water on day of visit.

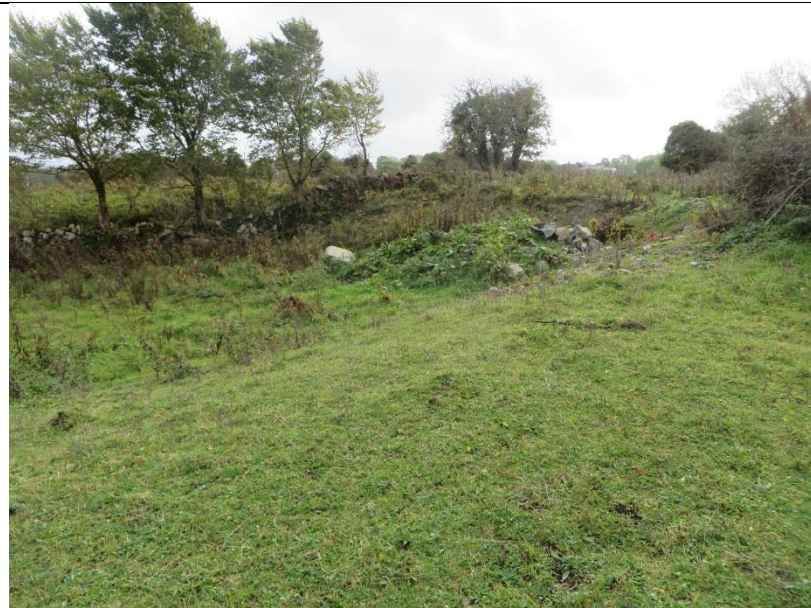
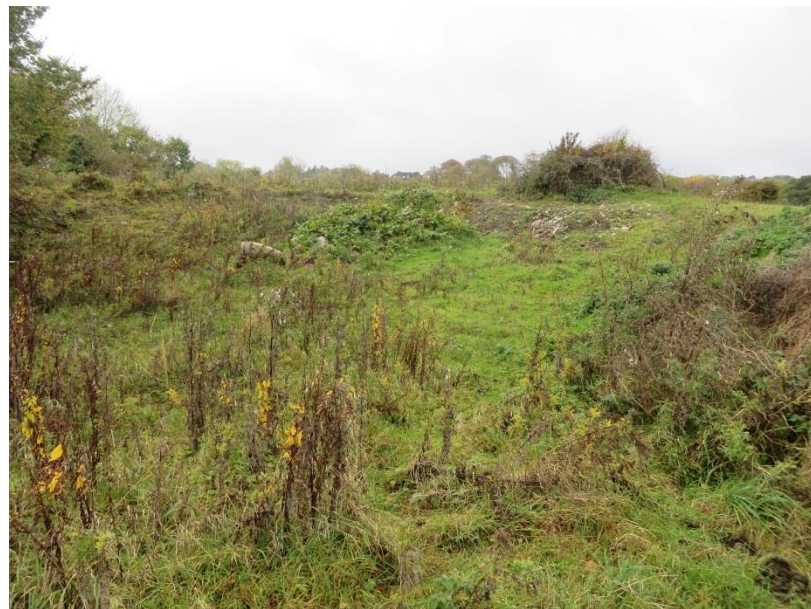
Other sources: aerial photography
Field survey date	20/10/2014
Field survey status	Confirmed
Water present	No
Additional Information	15m diameter enclosed depression.

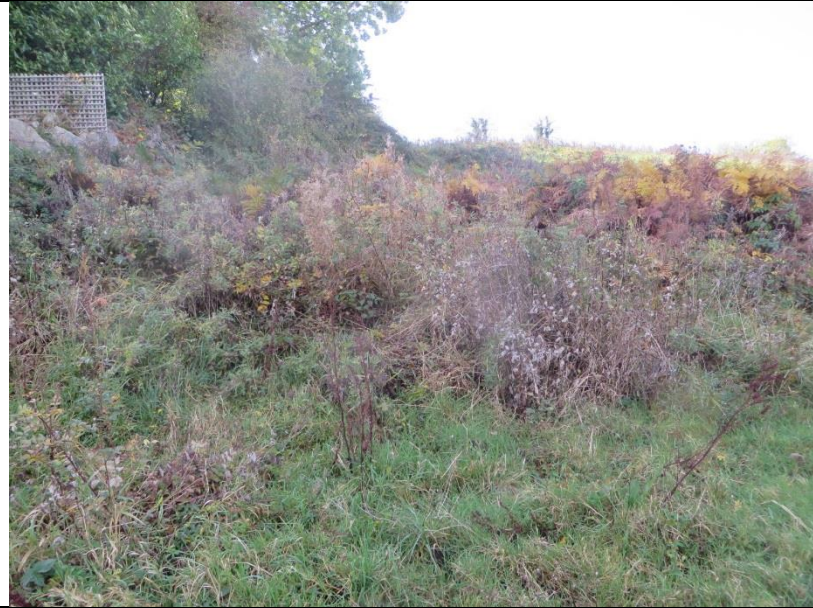
Feature ID	K12
Feature type	Enclosed depression
Coordinates	527555, 728068
Source	<p>Lidar:</p>   <p>Bing Maps:</p>   <p>Other sources: aerial photography</p>
Field survey date	21/10/2014
Field survey status	Confirmed
Water present	No
Additional Information	20m diameter enclosed depression with gently sloped sides.

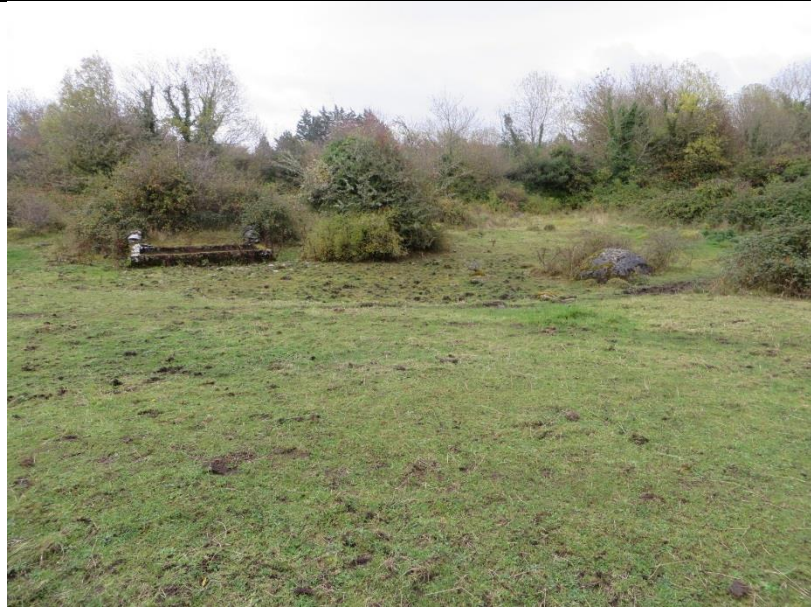
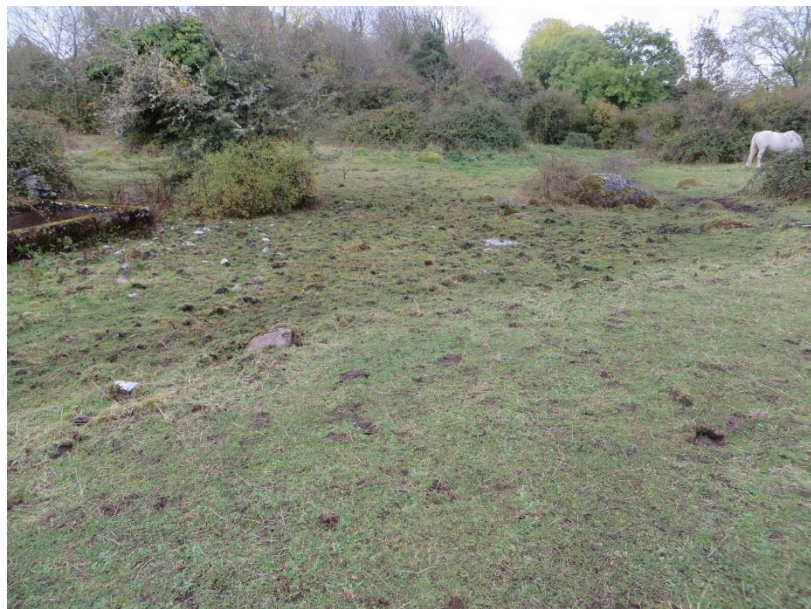
<p>Other sources: aerial photography</p>
Field survey date	17/10/2014
Field survey status	Confirmed
Water present	<p>Yes</p> <p>Electrical conductivity: 350 uS/cm</p> <p>Temperature: 14.2 °C</p> <p>pH: 8.72</p>
Additional Information	Water logged depression in field.

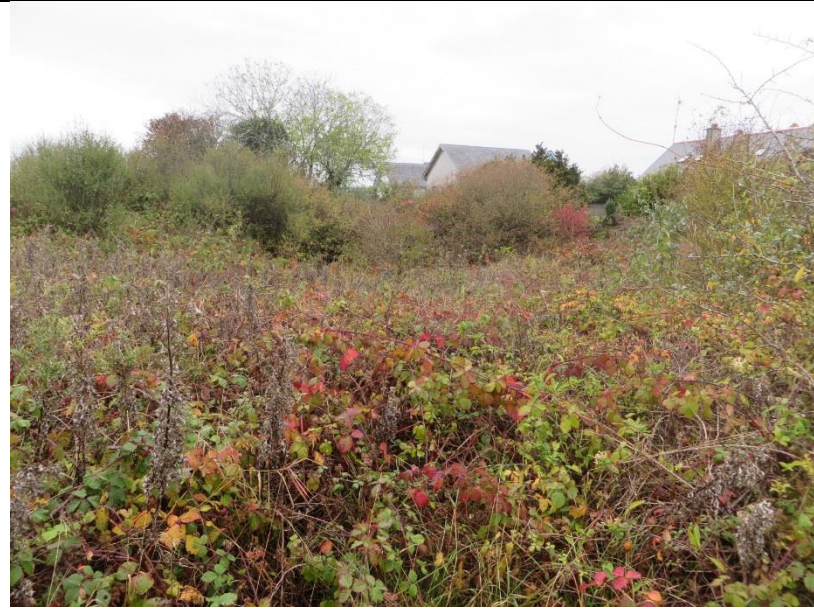
<p>Other sources: aerial photography</p>
Field survey date	17/10/2014
Field survey status	Confirmation/identification problem
Water present	No
Additional Information	Area covered in briars and vegetation preventing access.

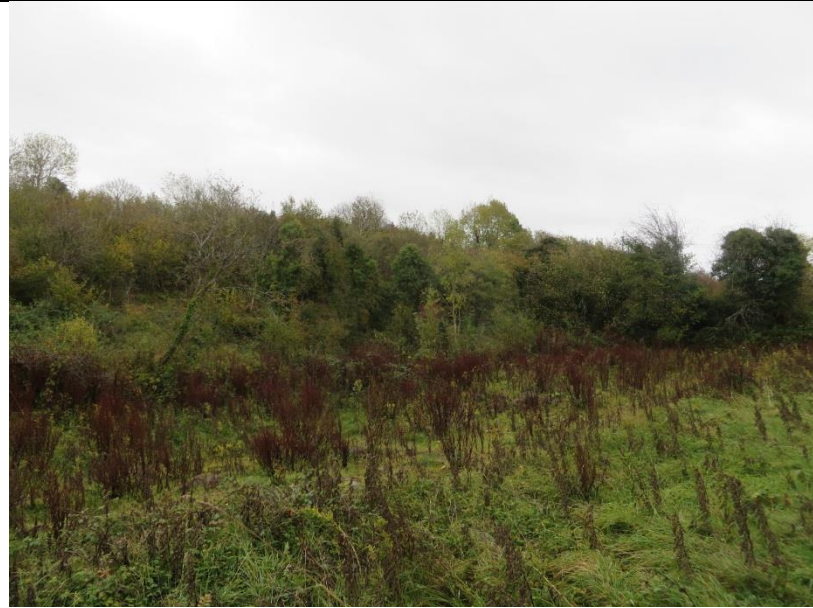
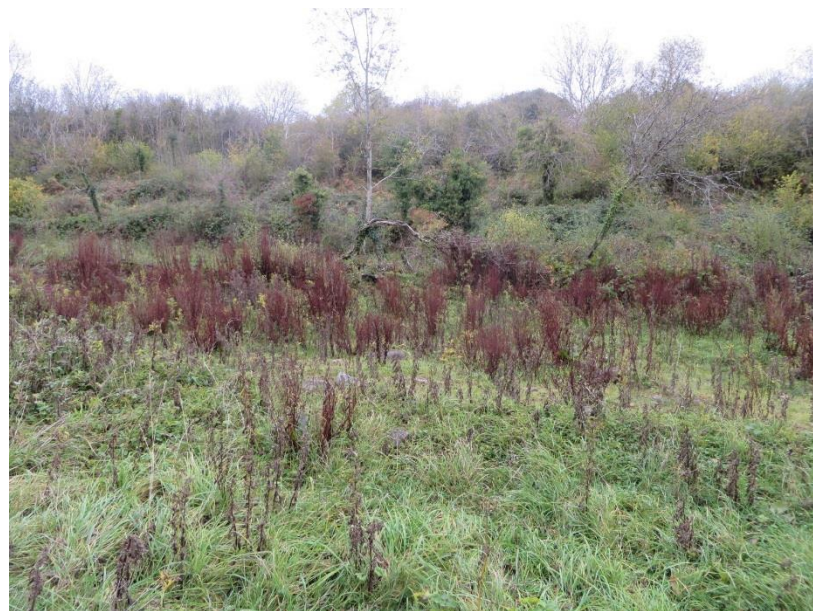
Field survey date	17/10/2014
Field survey status	Confirmed
Water present	No
Additional Information	Turlough is divided in two parallel sections with relatively well defined edges. The elevation of the eastern section is lower than the western section. A potential plug hole evident in the upper western section

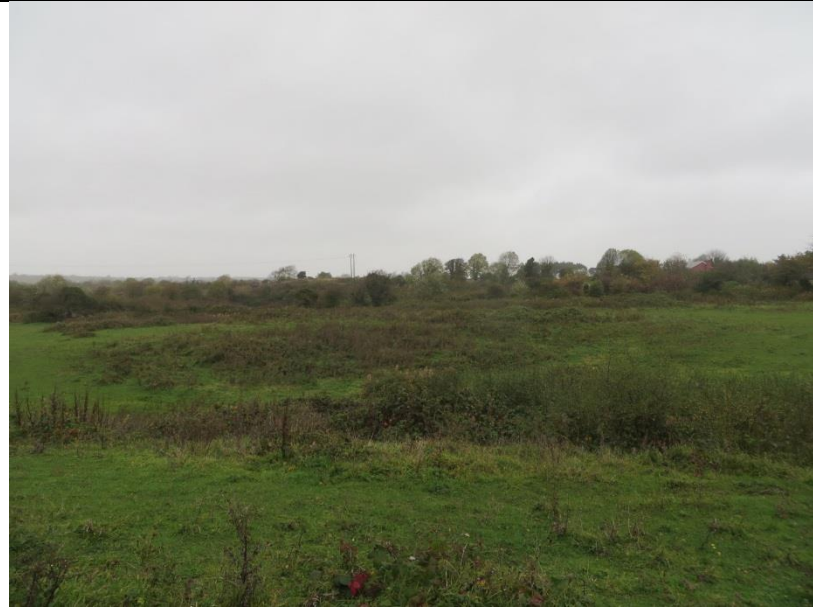
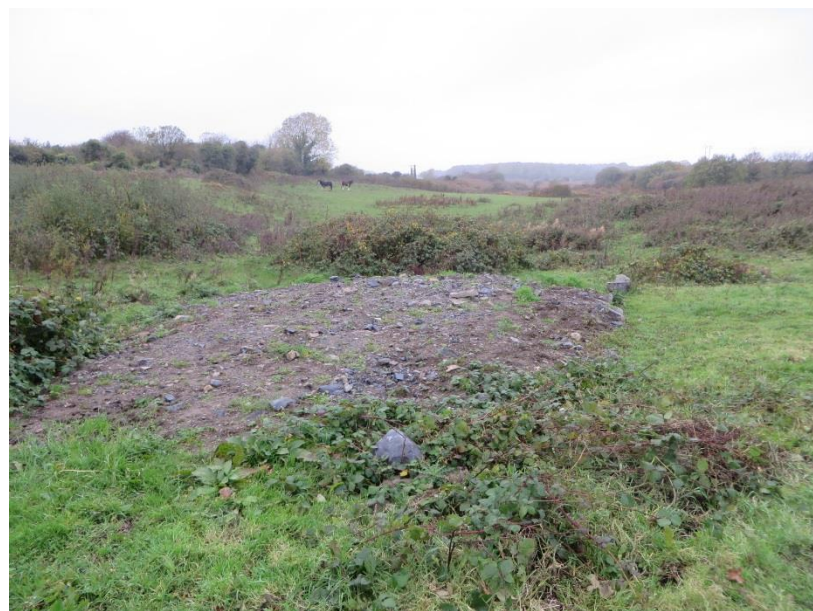
Site photos

Field survey date	20/10/2014
Field survey status	Confirmed
Water present	No
Additional Information	30 m diameter enclosed depression. However this feature is questionable as there may be disposal of material to the east of the depression.

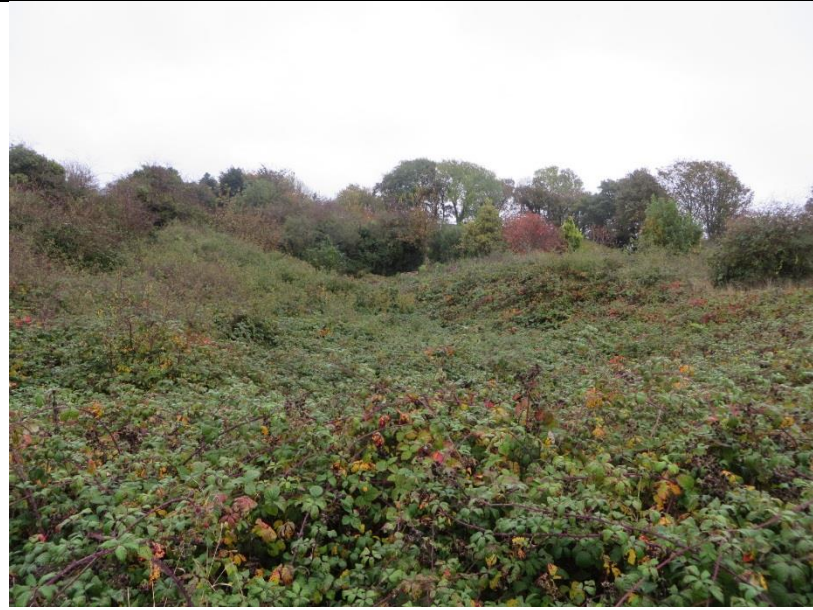
Site photos

Field survey date	20/10/2014
Field survey status	Confirmation/identification problem
Water present	Unknown
Additional Information	May be enclosed depression but access inhibited by dense vegetation

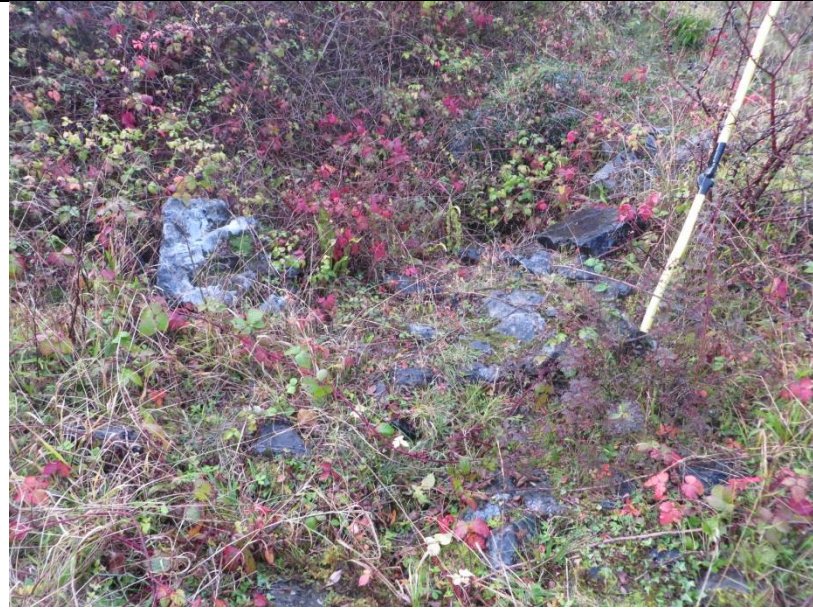
Site photo

Field survey date	16/10/2014
Field survey status	Confirmed
Water present	No
Additional Information	Small depression with rock exposed Approx. 2 m diameter and 1 m depth

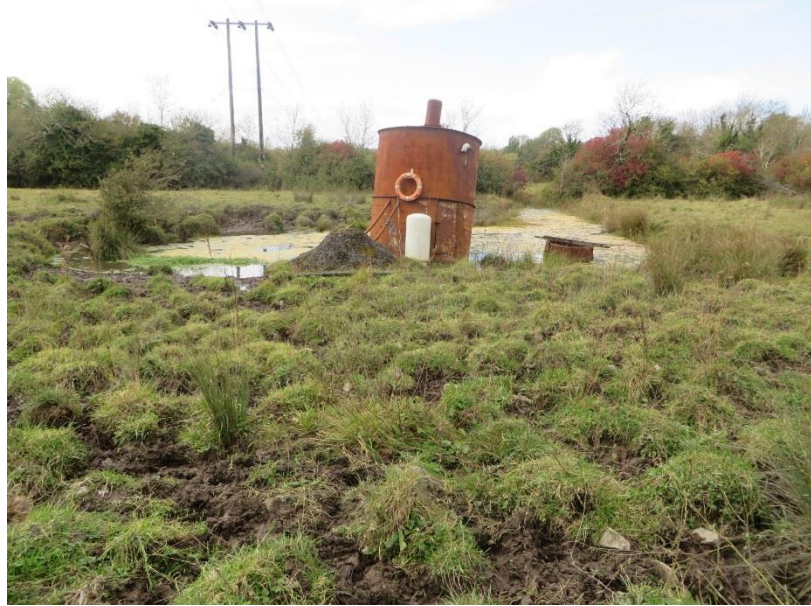
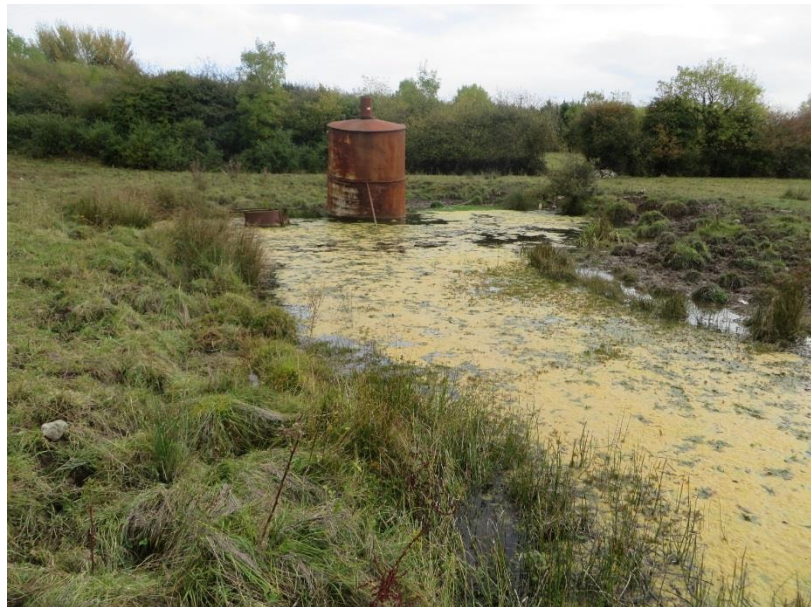
Site photo

Field survey date	16/10/2014
Field survey status	Confirmed
Water present	Yes Electrical conductivity: 680 uS/cm Temperature: 15.1 °C pH: 7.28
Additional Information

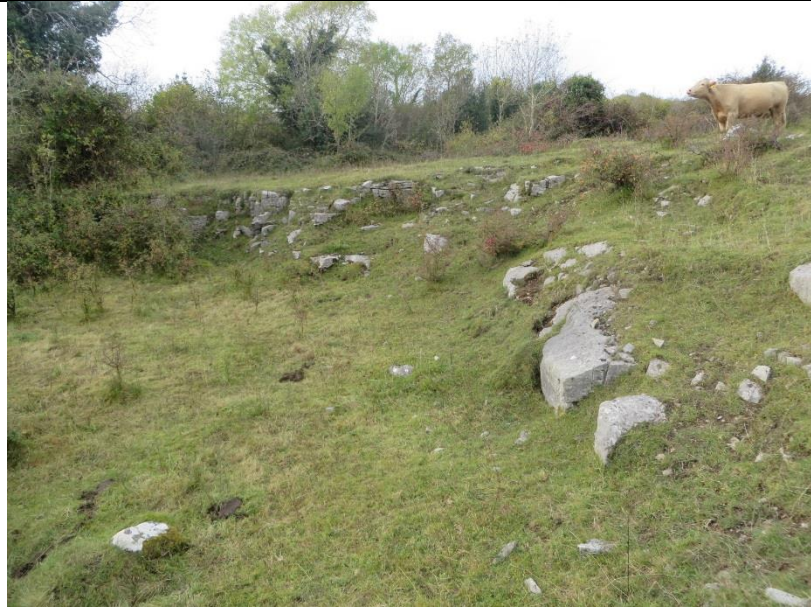
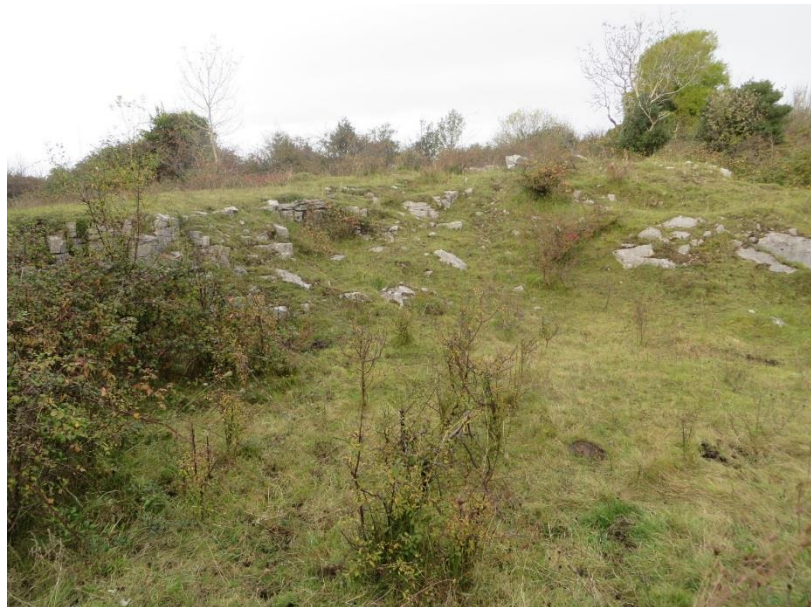
Site photos

Field survey date	16/10/2014
Field survey status	Confirmed
Water present	No
Additional Information	Exposed rock at northern side and gentle slope on Southern side Approx. 20 m diameter 2 m depth

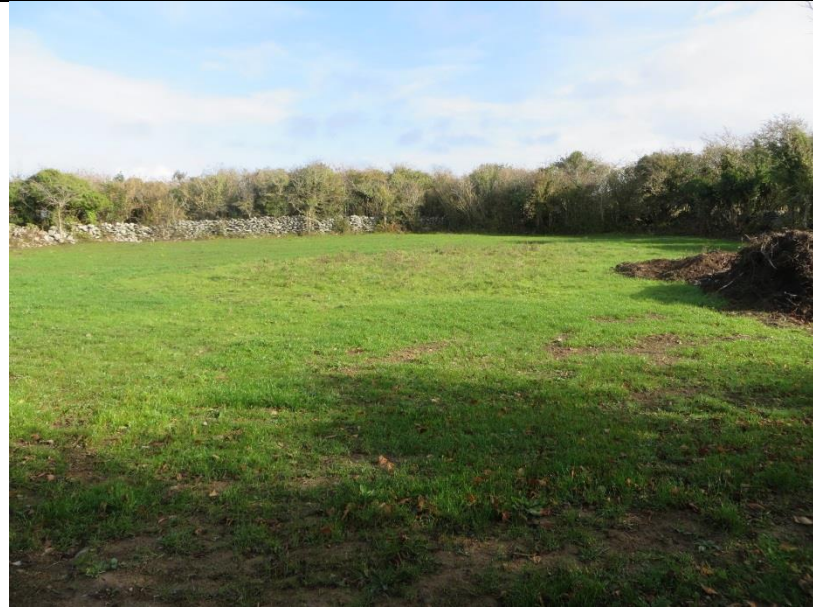
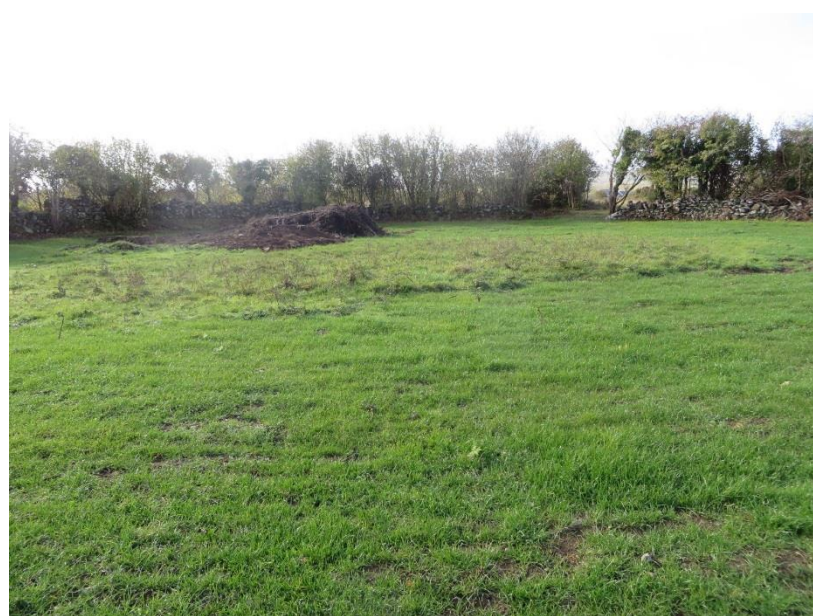
Site photos

Field survey date	16/10/2014
Field survey status	Confirmed
Water present	No
Additional Information	Slight enclosed depression which may be filled in

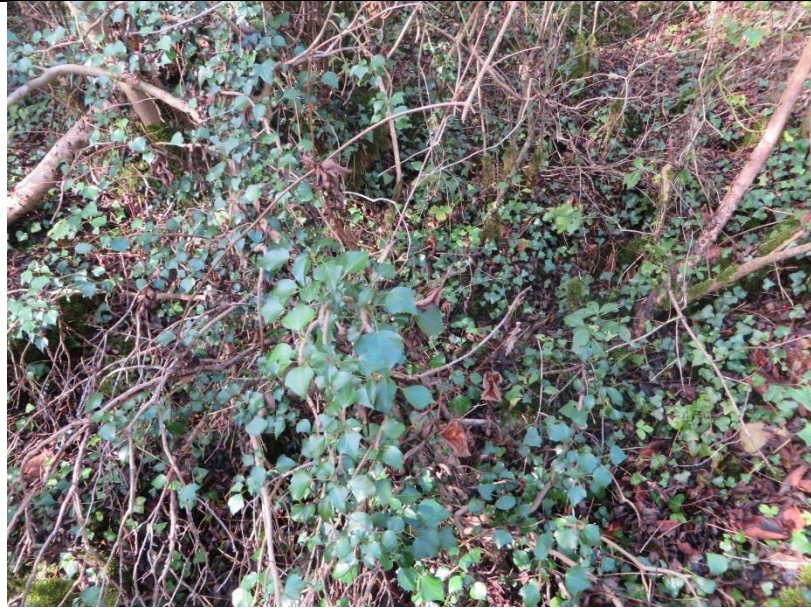
Site photos

Field survey date	16/10/2014
Field survey status	Confirmed
Water present	No
Additional Information	Very small enclosed depression plug hole not obvious but probably due to covering of moss

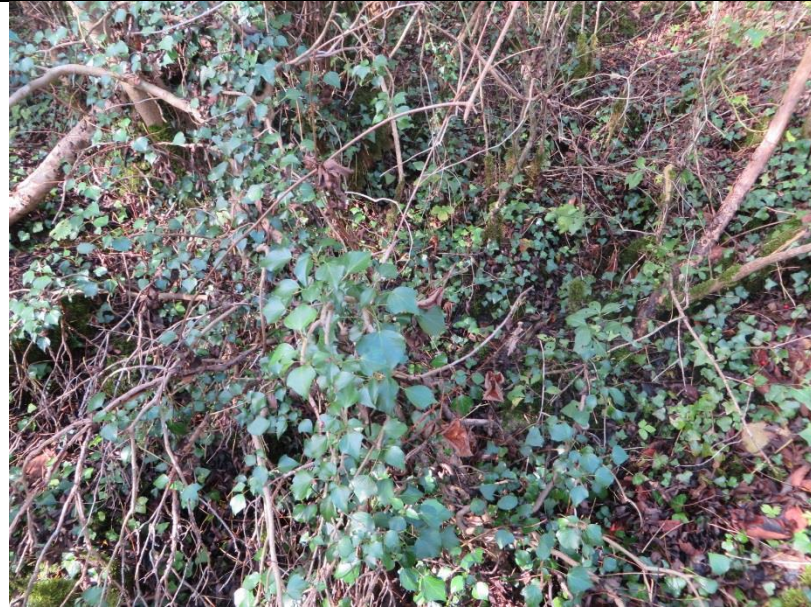
Site photos

Field survey date	16/10/2014
Field survey status	Confirmation/identification problem
Water present	No
Additional Information	Could not locate. Unpredictable Livestock in field and appears very overgrown where the feature is located.

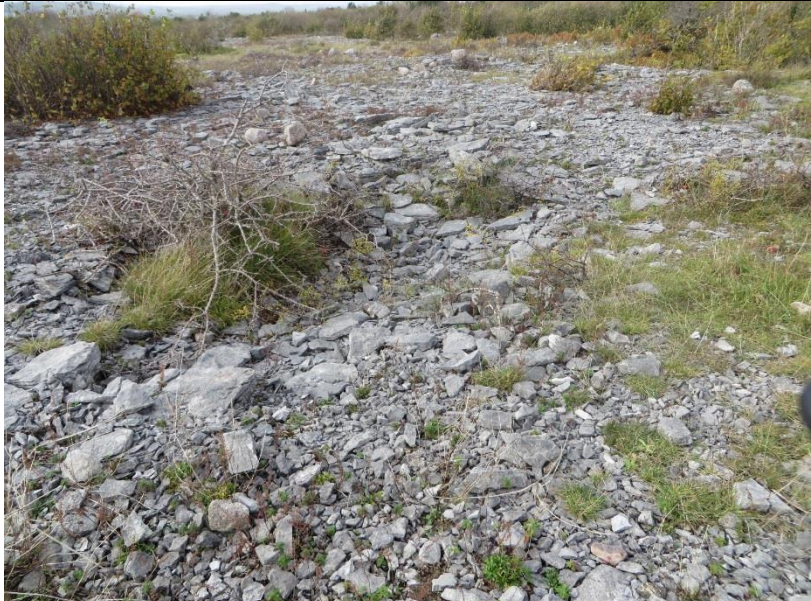
Feature ID	K61
Feature type	Enclosed Depression
Coordinates	530360, 728644
Source	Field Survey
Field survey date	16/10/2014
Field survey status	Confirmed
Water present	No
Additional Information	Approx. 1m diameter Enclosed depression is in line of depressions running EW
Site photo

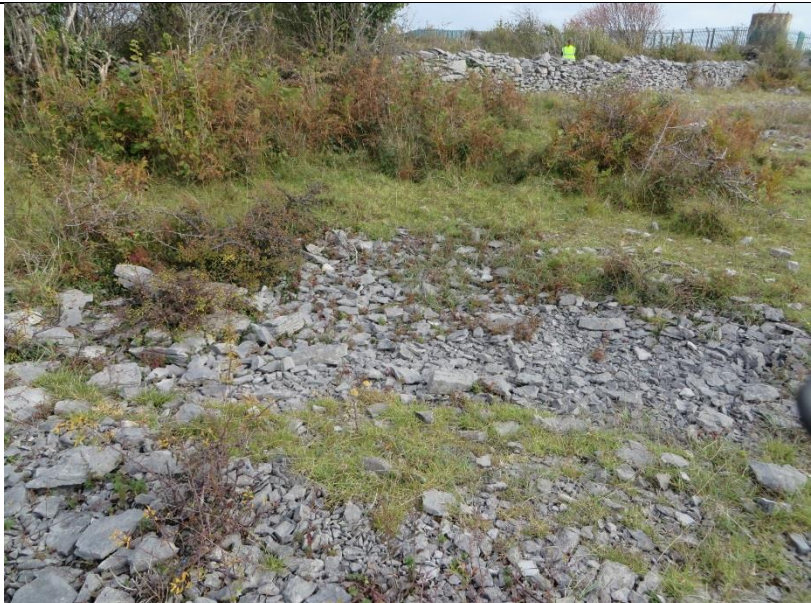
Feature ID	K62
Feature type	Enclosed Depression
Coordinates	530369, 728642
Source	Field Survey
Field survey date	16/10/2014
Field survey status	Confirmed
Water present	No
Additional Information	Approx. 2m diameter and less than 0.5 m in depth. Enclosed depression is in line of depressions running EW
Site photo

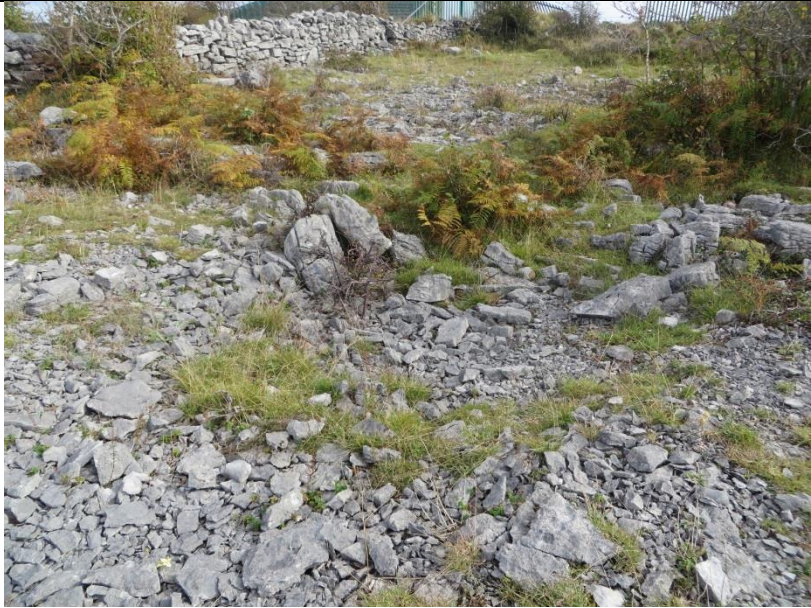
Feature ID	K64
Feature type	Enclosed Depression
Coordinates	530386, 728617
Source	Field Survey
Field survey date	16/10/2014
Field survey status	Confirmed
Water present	No
Additional Information	Approx. 2m diameter and less than 0.5 m in depth. Enclosed depression is in line of depressions running EW
Site photo

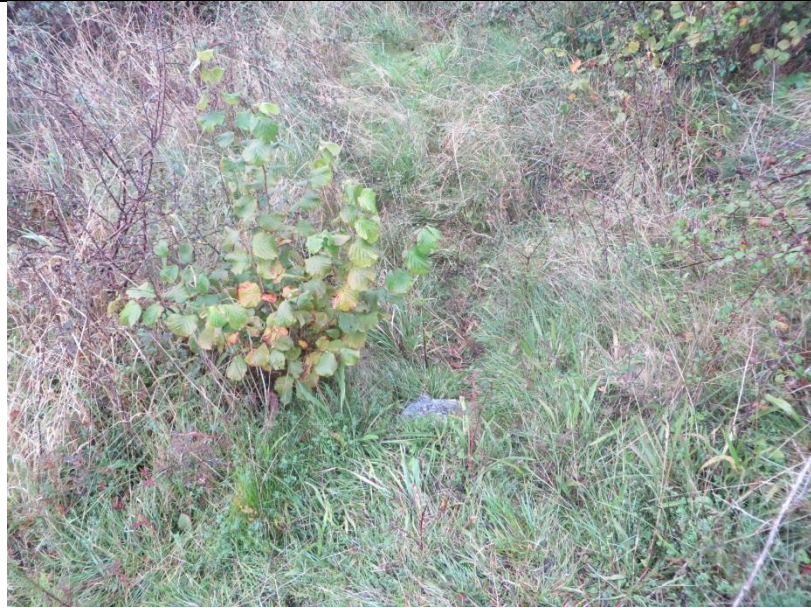
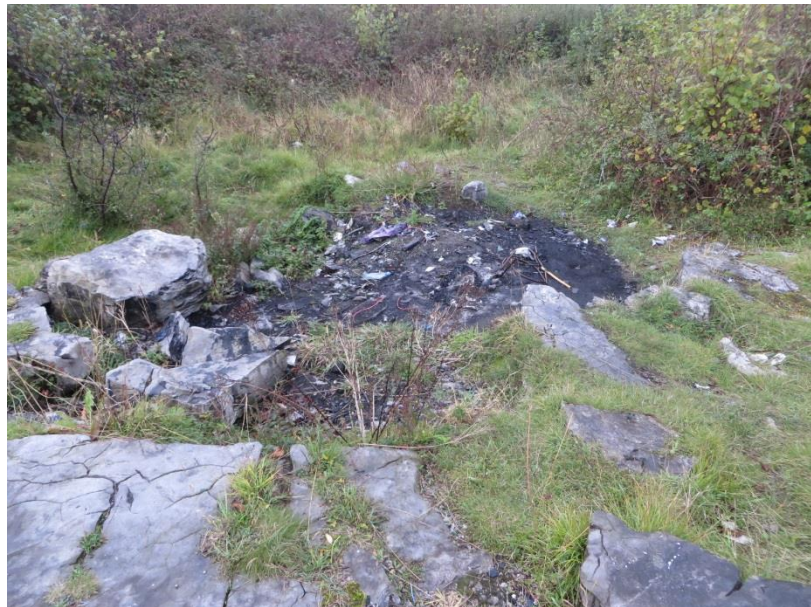
Site photo

Field survey date	16/10/2014
Field survey status	Confirmed
Water present	No
Additional Information	2 depressions 3 m diameter and 1 m diameter less than 0.5 m depth. Larger depression is filled with a fire pit

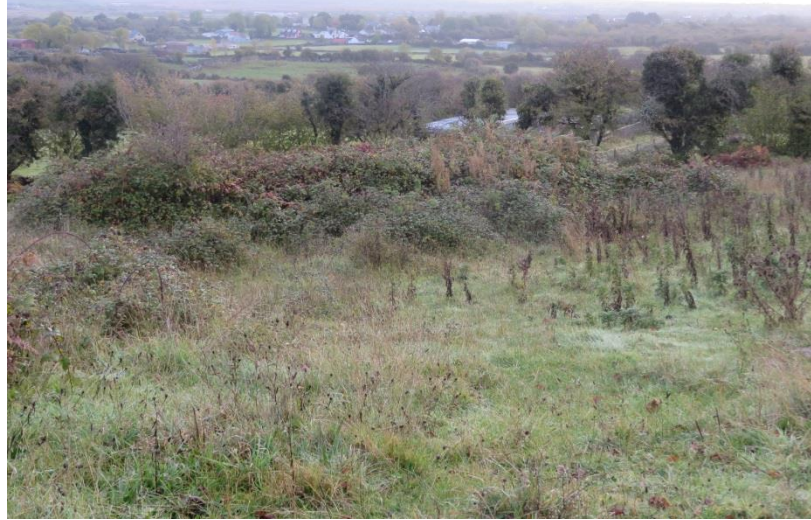
Site photo

Field survey date	17/10/2014
Field survey status	Confirmation/identification problem
Water present	Unknown
Additional Information	Circle of brambles. Looks like a dip in the middle but covered in brambles preventing access.

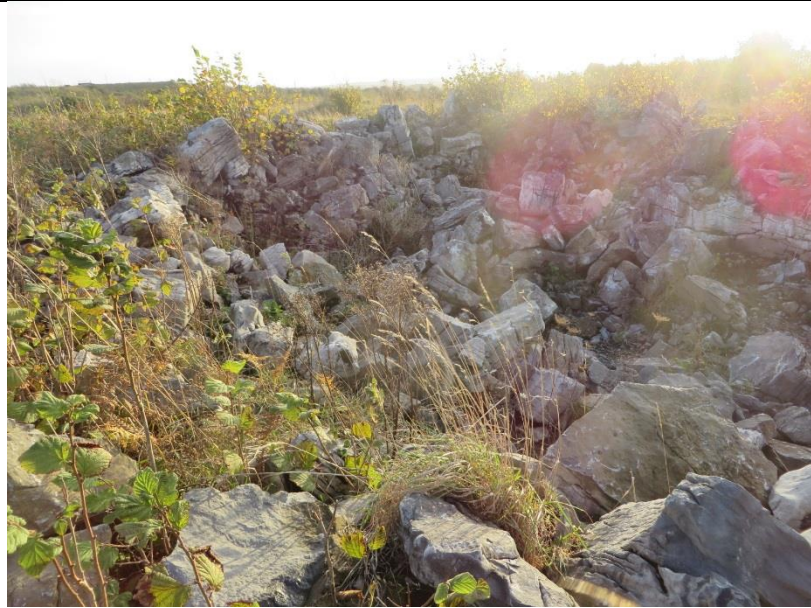
Field survey date	21/10/2014
Field survey status	Confirmed
Water present	No
Additional Information	Numerous boulders in depression Approx. 20 x 10m diameter and depth of 2m

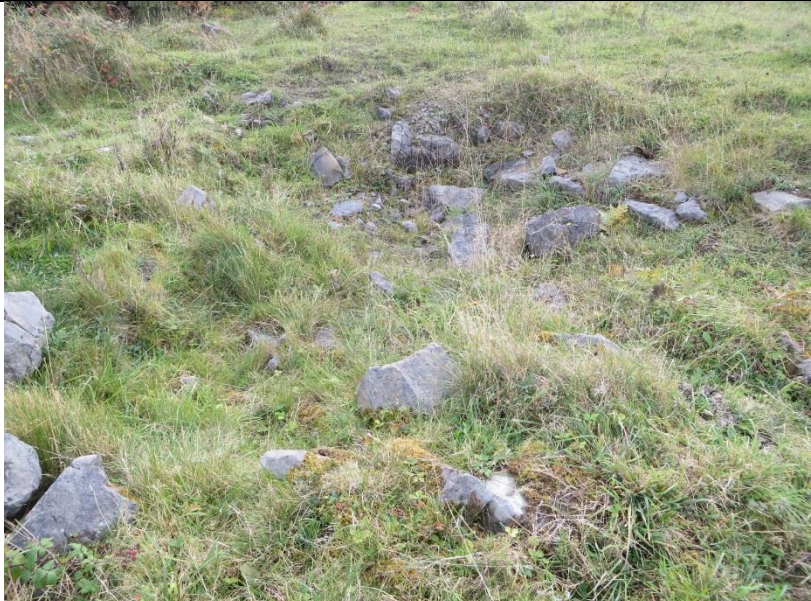
Feature ID	K71
Feature type	Enclosed depression
Coordinates	530694, 728662
Source	Field Survey
Field survey date	16/10/2014
Field survey status	Confirmed
Water present	No
Additional Information	2m by 4m along slope line Small depression near top of slope contains exposed rock
Site photo

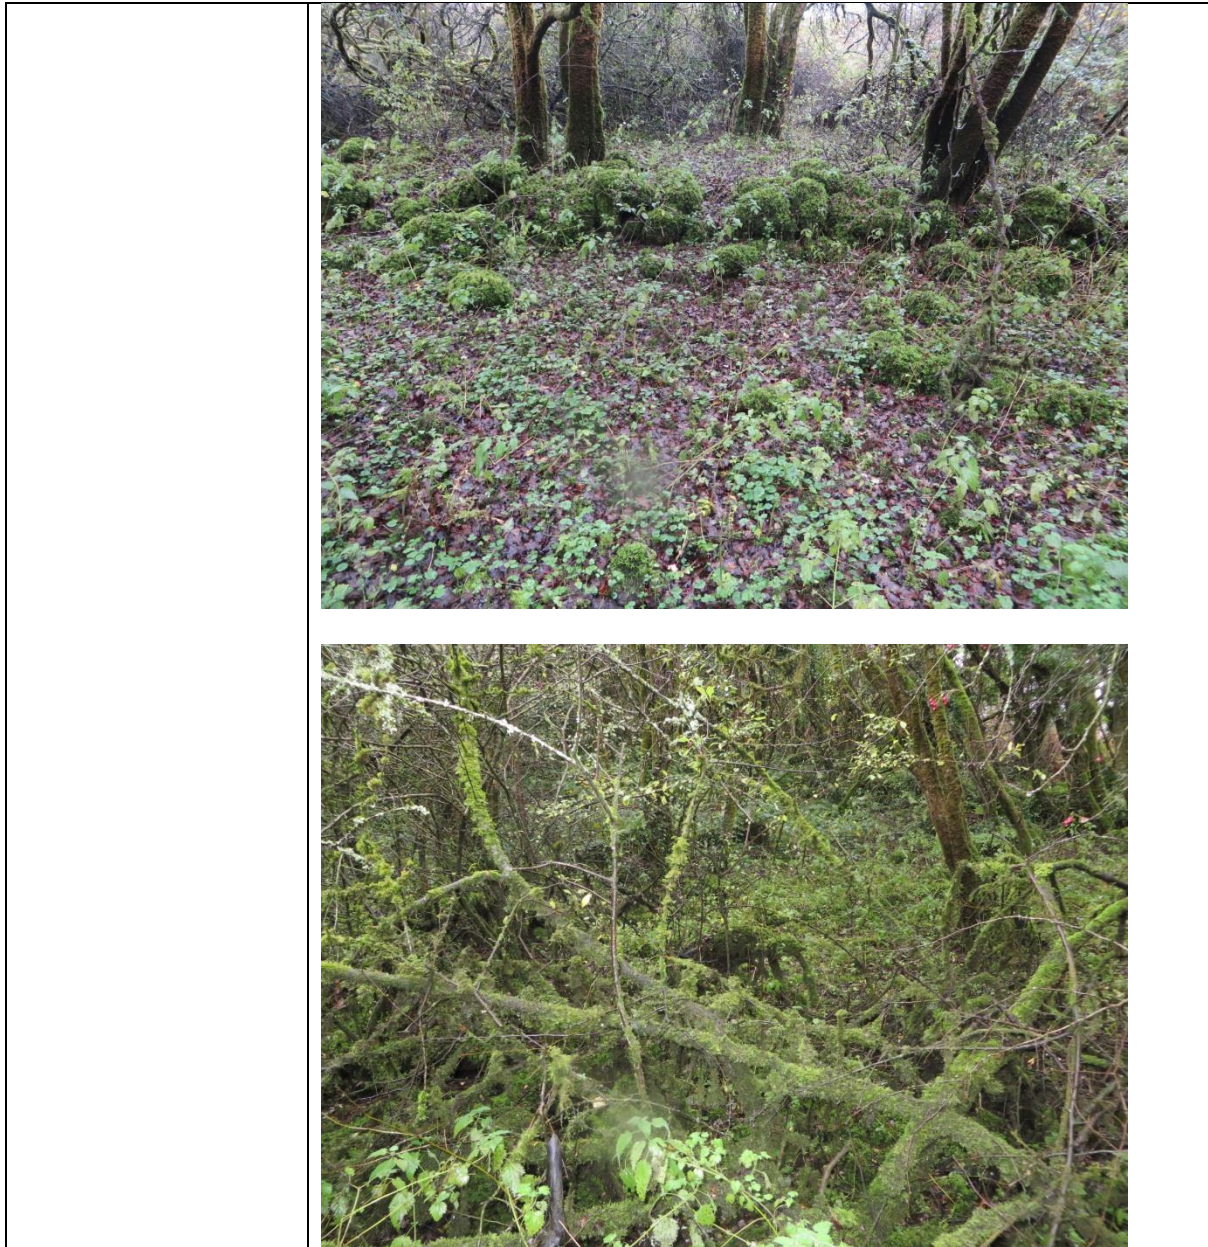
Field survey date	12/11/2014
Field survey status	Confirmed
Water present	No
Ground level elevation	15.46 mAOD, Estimated elevation. Elevation not recorded within feature due to tree coverage. Elevation reading taken 20 m south and approx.. 1m higher elevation (actual recorded elevation was 16.456)
Additional Information	Area mossy and covered with trees
Site photo

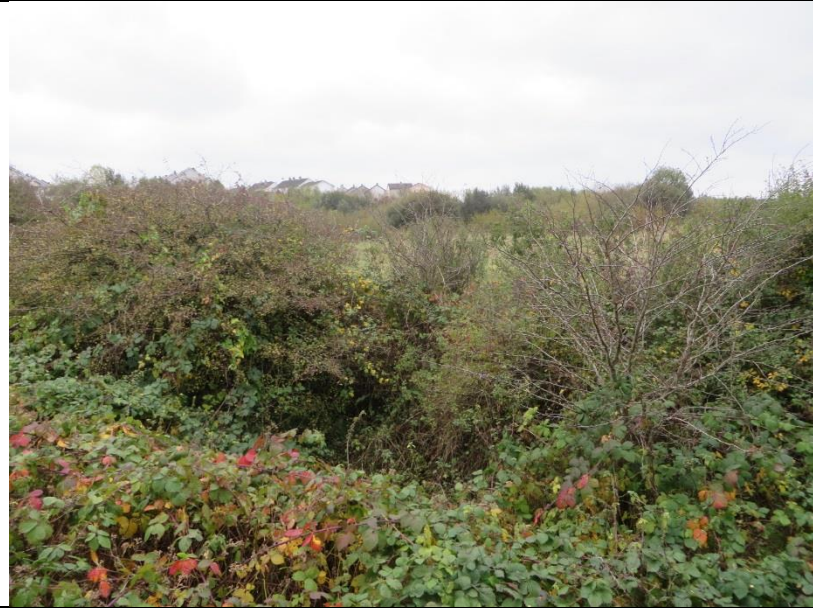
Feature ID	K75
Feature type	Enclosed Depression
Coordinates	531193, 727242
Source	Lidar:  
	Bing Maps:  
Field survey date	22/10/2014
Field survey status	Confirmation/identification problem
Water present	Unknown
Additional Information	Cannot access depression. Access hindered due to dense vegetation.

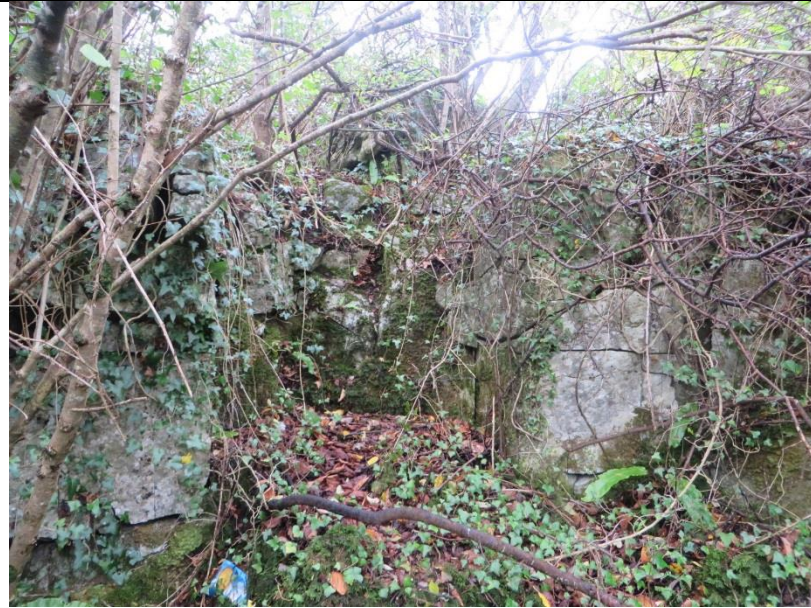
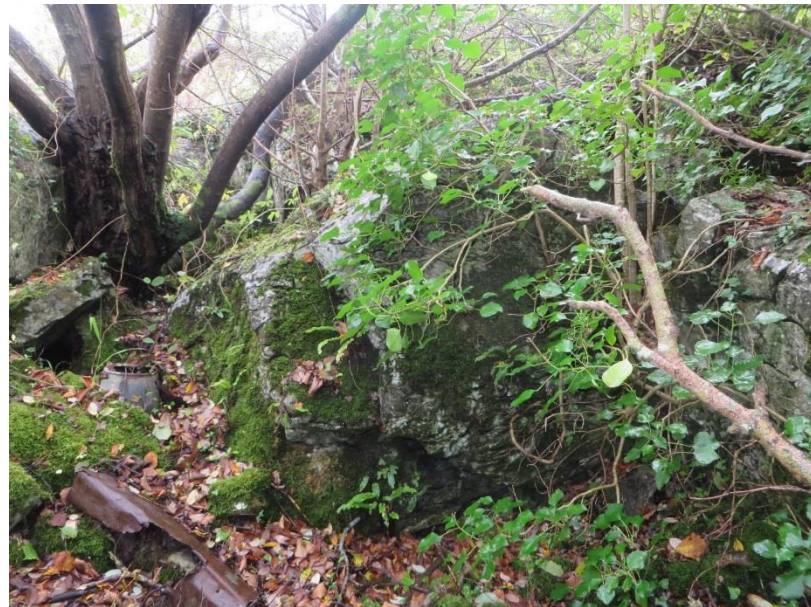
Field survey date	20/10/2014
Field survey status	Confirmed
Water present	No
Additional Information	10m diameter 4m depth. Steep sides with exposed rock May also be as result of rock excavation

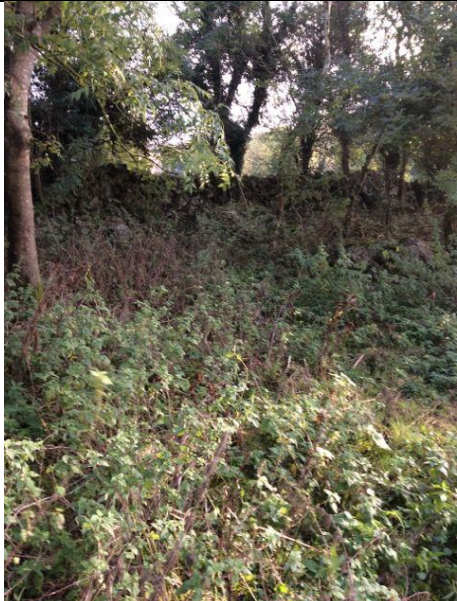
Feature ID	K82
Feature type	Enclosed depression
Coordinates	531437, 729244
Source	Field Survey
Field survey date	16/10/2014
Field survey status	Confirmed
Water present	No
Additional Information	10 m diameter. Possible enclosed depression slightly questionable
Site photo

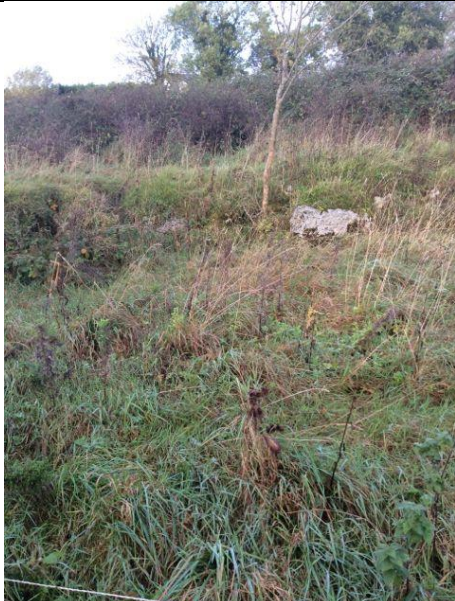
Feature ID	K85
Feature type	Enclosed depression
Coordinates	531456, 729194
Source	Field Survey
Field survey date	16/10/2014
Field survey status	Confirmed
Water present	No
Additional Information	10 m diameter semicircle intercepted by wall/road (N84). Possible enclosed depression slightly questionable as it could be as a result of excavation for N84 road construction
Site photo

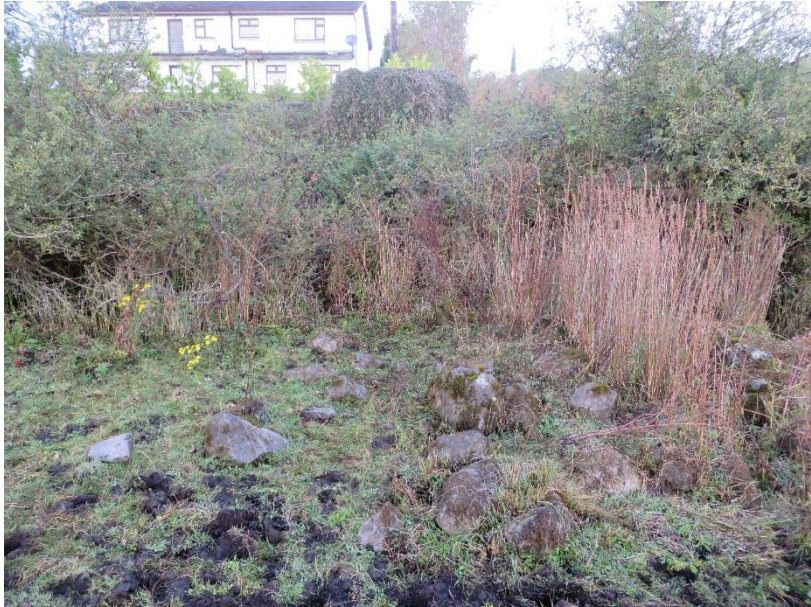
Feature ID	K86	
Feature type	Estavelle	
Coordinates	531476, 729108	
Source	EIS N6 Galway City Outer Bypass Vol 2 2006	
Field survey date	16/10/2014	11/11/2014
Field survey status	Confirmed	Confirmed
Water present	No	Yes Electrical conductivity: 590 uS/cm Temperature: 9 °C pH: 7.52 No flow to permit flow measurement
Water elevation	n/a	8.927
Additional Information	Drain runs from estavelle location near break in slope towards Ballindooley lough	
Site photo	<p>Estavelle location</p>

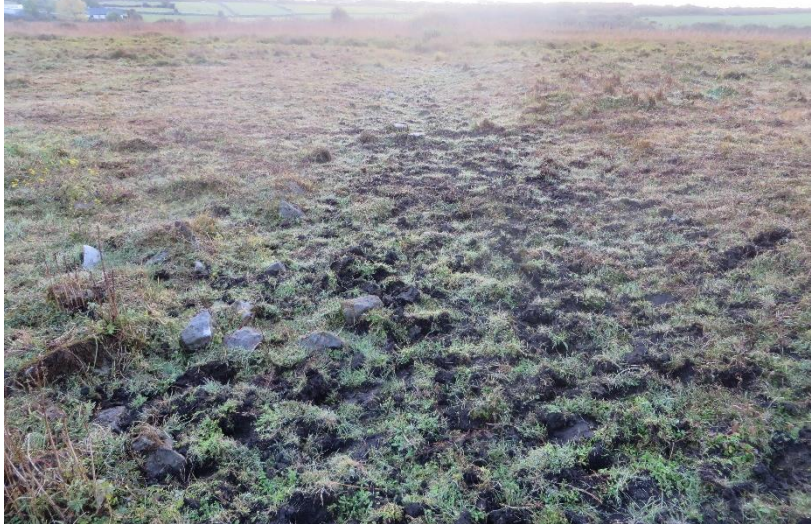
<p>Shallow ditch running between the estavelle and Ballindooley Lough:</p>

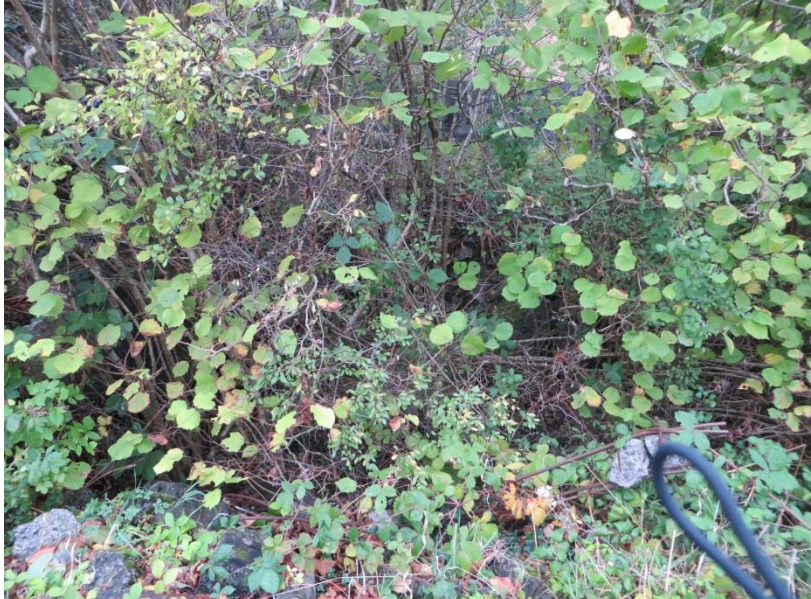
Figure 2a shows the lidar image of three potential enclosed depression identified from the desk study. During the site visit K88 was confirmed to be an enclosed depression, however, onsite inspection K80 and K84 were found to be mounds and therefore classified as not karst (**Figure 2b**).

Feature ID	K88
Feature type	Enclosed depression
Coordinates	531671, 727351
Source	Field Survey
Field survey date	22/10/2014
Field survey status	Confirmed
Water present	No
Additional Information	Approximate dimensions: 30m x 5m Elongated depression in an ESE WNW direction. The ESE wall is approx. 4m high. The depression contains numerous trees.
Site photo

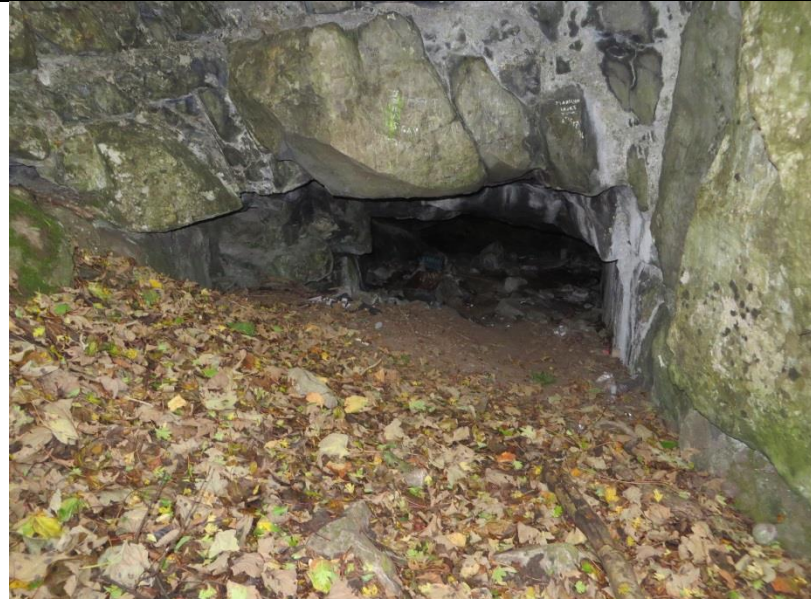
Field survey date	22/10/2014
Field survey status	Confirmed
Water present	No
Additional Information	Approx. 3m wide x 1 m high opening to cave
Site photo
