Galway County Council
N6 Galway City Ring Road
Karst Survey Report

GCOB-4-03-0-6.2.8_010

Issue 3 | 26 July 2018

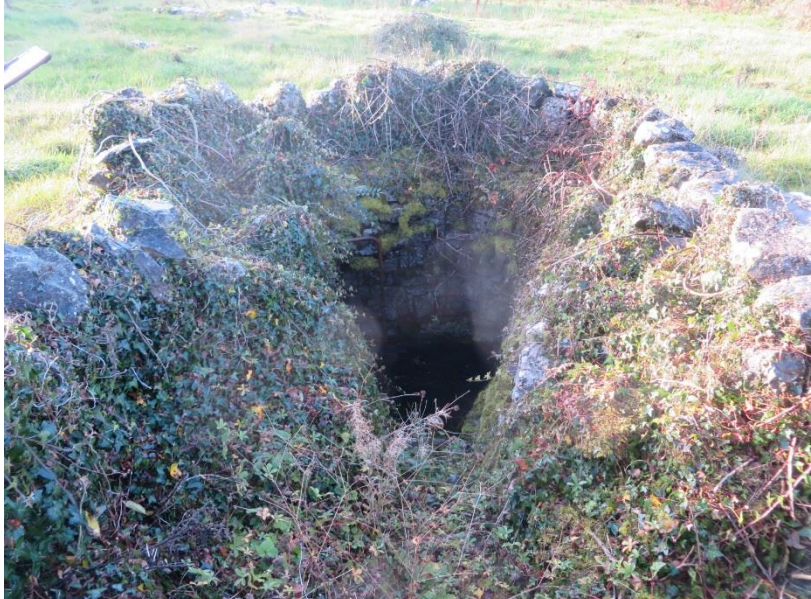
Feature ID	K92
Feature type	Well/ spring
Coordinates	531781, 729453
Source	Field Survey
Field survey date	21/10/2014
Field survey status	Confirmed
Water present	Yes Electrical conductivity: 370 uS/cm Temperature: 11.1 °C pH: 7.61
Additional Information	Approximate dimension: 2m diameter Old well surrounded by stone wall
Site photo

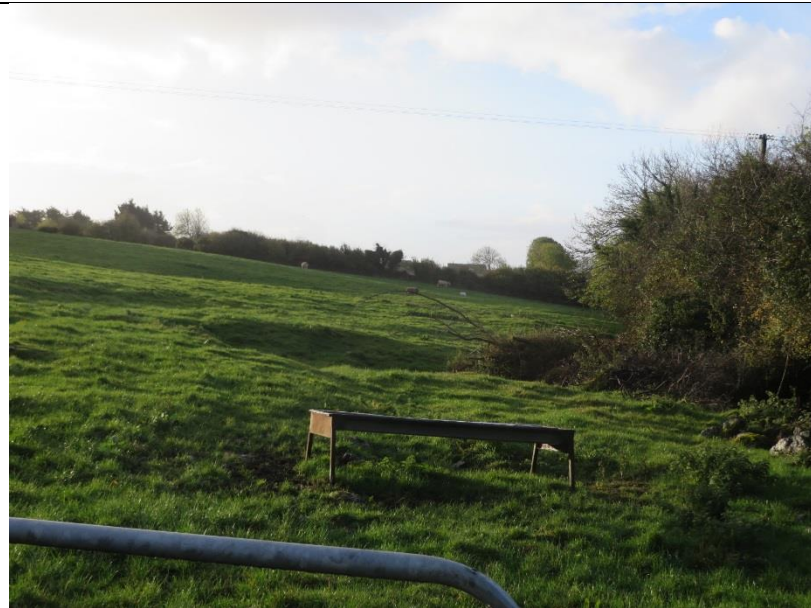
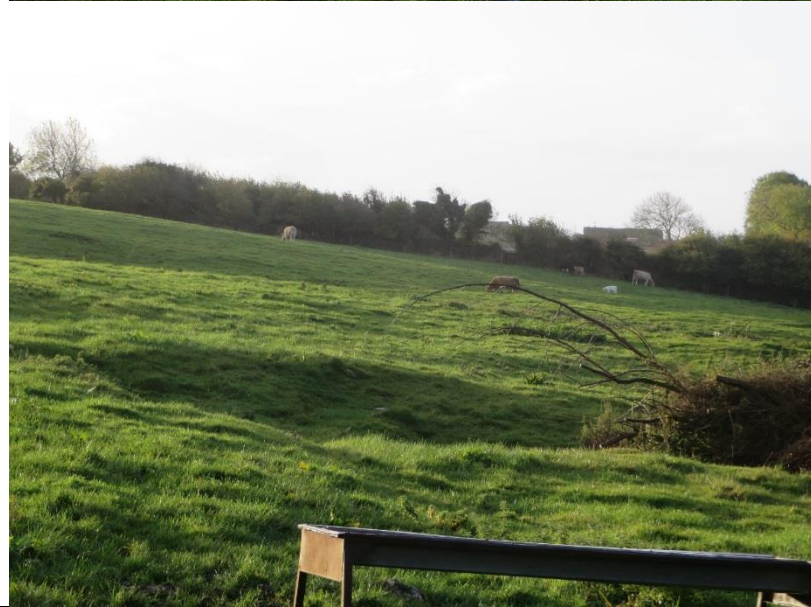
Field survey date	21/10/2014
Field survey status	Confirmed
Water present	No
Additional Information	Approx. 15m diameter Access inhibited due to cattle in field

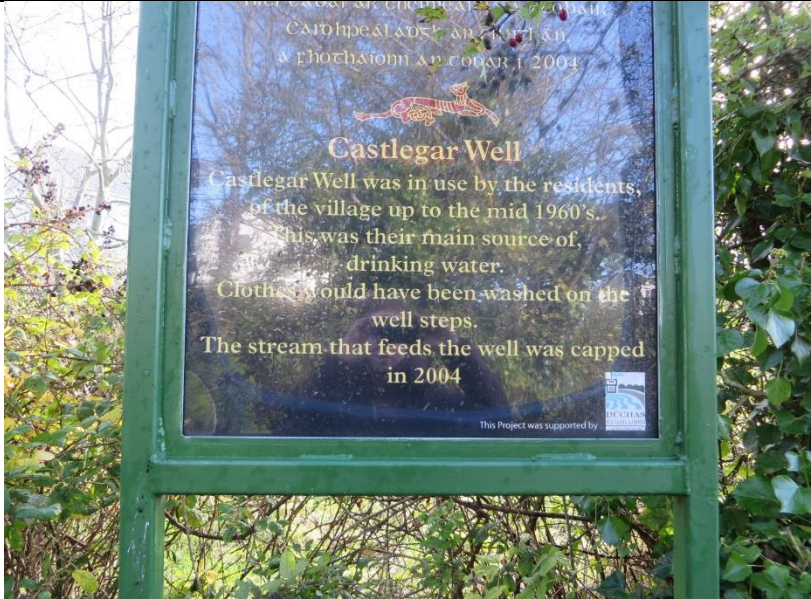
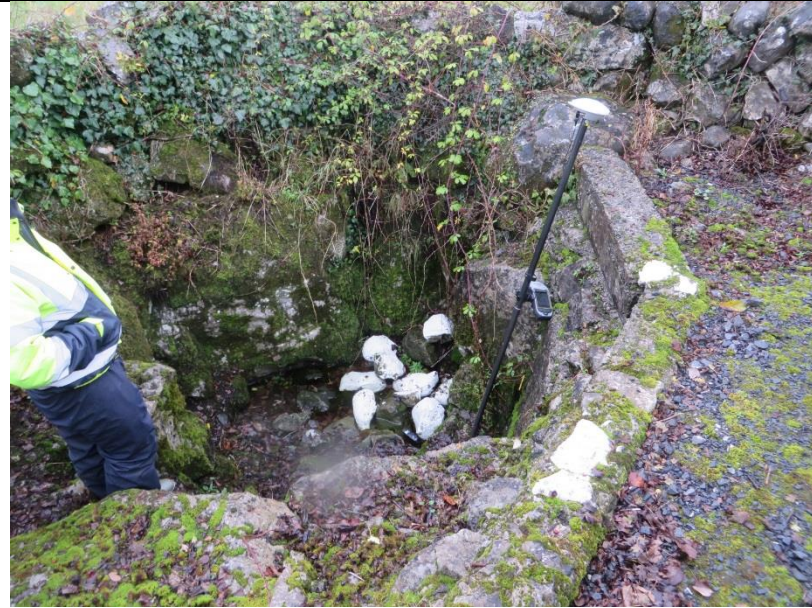
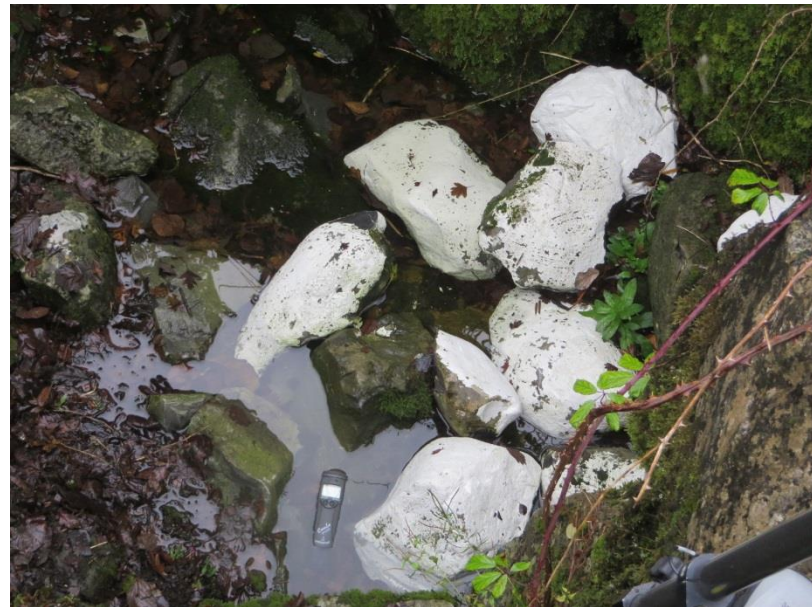
Field survey date	12/10/2014	12/11/2014
Field survey status	Confirmed	Confirmed
Water present	No	Yes Electrical conductivity: 728 uS/cm Temperature: 10.9 °C pH: 7.06
Water level elevation	n/a	3.73 mAOD
Additional Information	Approx. 2 m diameter Notice beside spring states that the feature is known as Castlegar well. It also notes that the stream that feeds the well was capped in 2004.	
Site photo

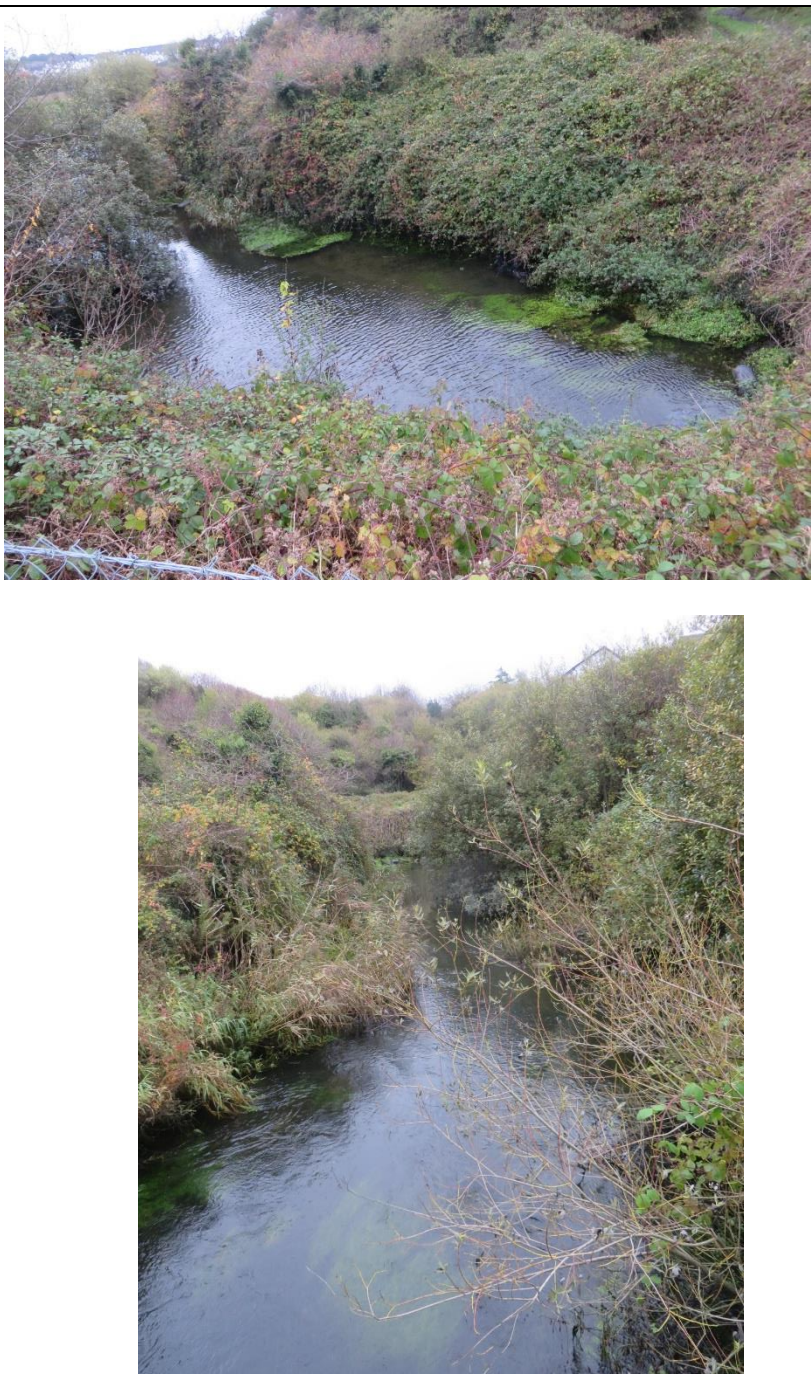
Field survey date	22/10/2014	12/11/2014
Field survey status	Confirmed	Confirmed
Water present	Yes Electrical conductivity: 370 uS/cm Temperature: 11.3 °C pH: 7.76 Flow direction into swallow hole No flow measurement taken	Yes Electrical conductivity: 576 uS/cm Temperature: 10.6 °C pH: 7.52 Flow direction into swallow hole Flow: 765 l/s
Water level elevation	n/a	1.77 mAOD
Additional Information	Terryland River discharges into or can be fed by this spring / swallow hole.	
Site photo

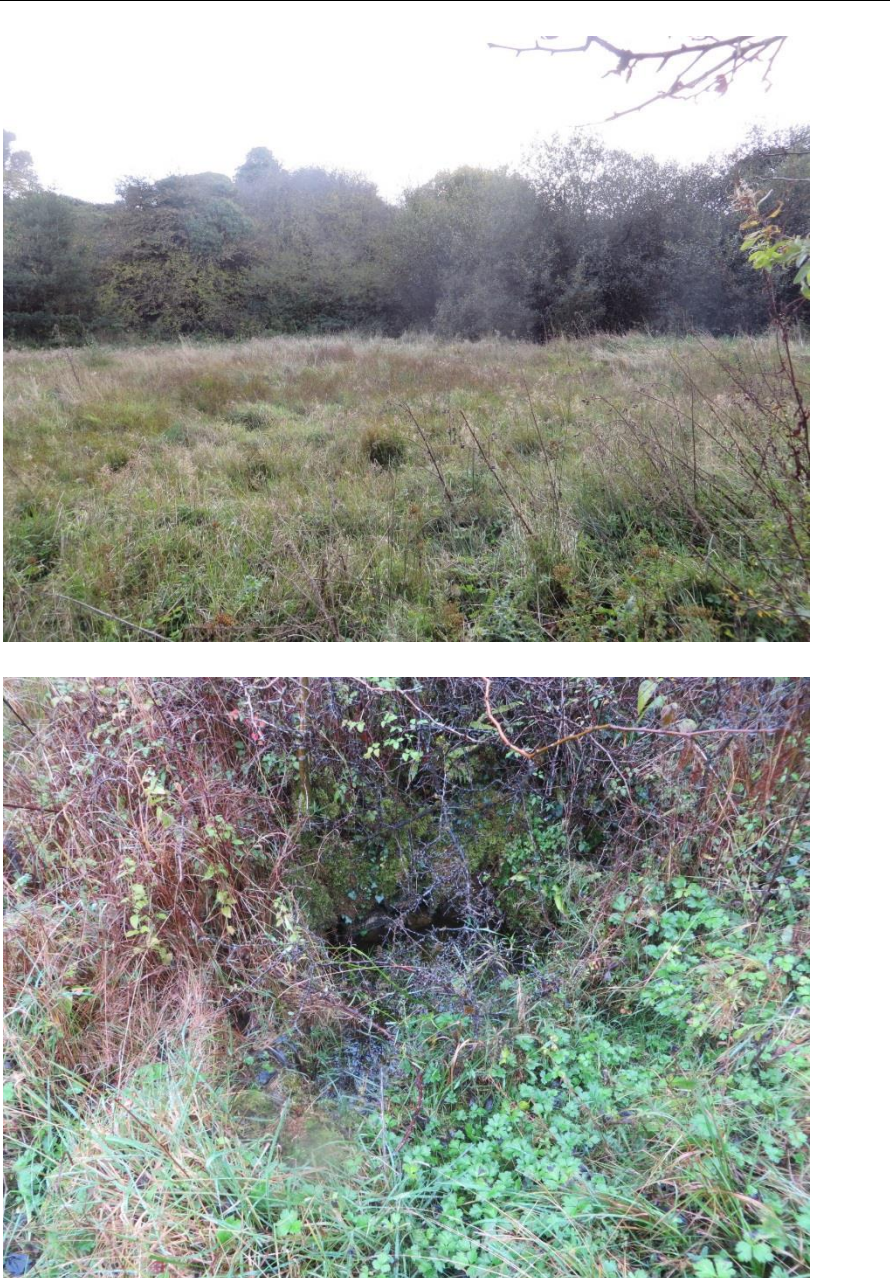
Field survey date	21/10/2014	12/11/2014
Field survey status	Confirmed	Confirmed
Water present	No	Yes Electrical conductivity: 219 uS/cm Temperature: 8.1 °C pH: 6.4
Elevation measurements	n/a	Ground level in centre: 12.11 mAOD Standing water: 12.17 mAOD (531947, 728372) & 12.22 mAOD (531934, 728379)
Additional Information	Approx 40 m diameter flat bottom depression. Soft muddy base. Sides and base composed of subsoil. No seepages.

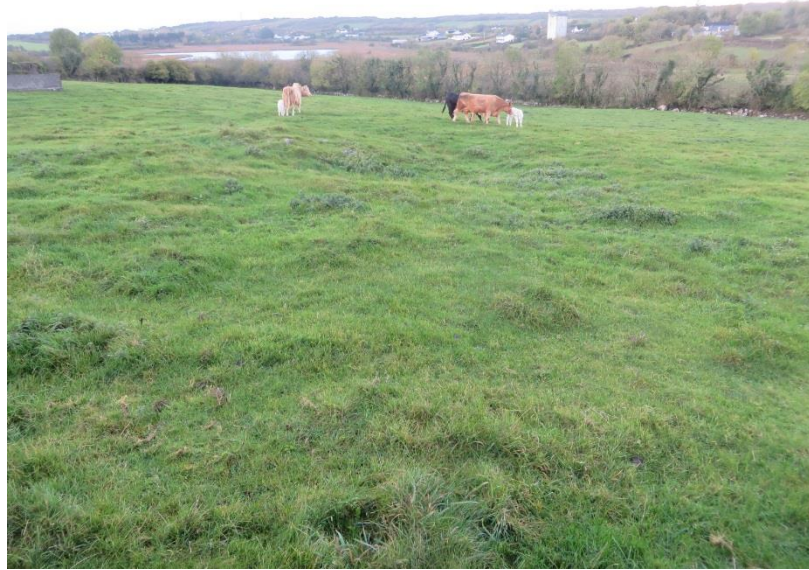
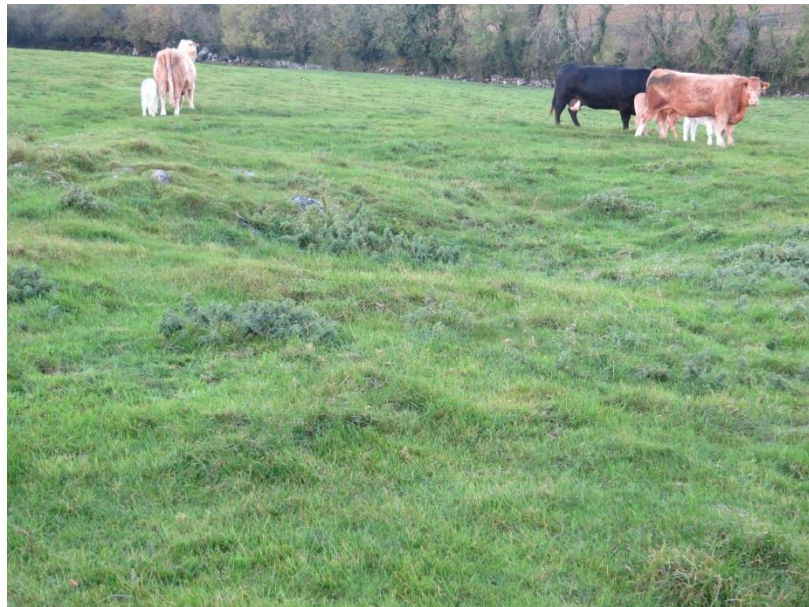
Feature ID	K98
Feature type	Enclosed Depression
Coordinates	531924, 729321
Source	Lidar:  
	Bing Maps:  
Field survey date	21/10/2014
Field survey status	Confirmed
Water present	No
Additional Information	Approx. 3m diameter depression

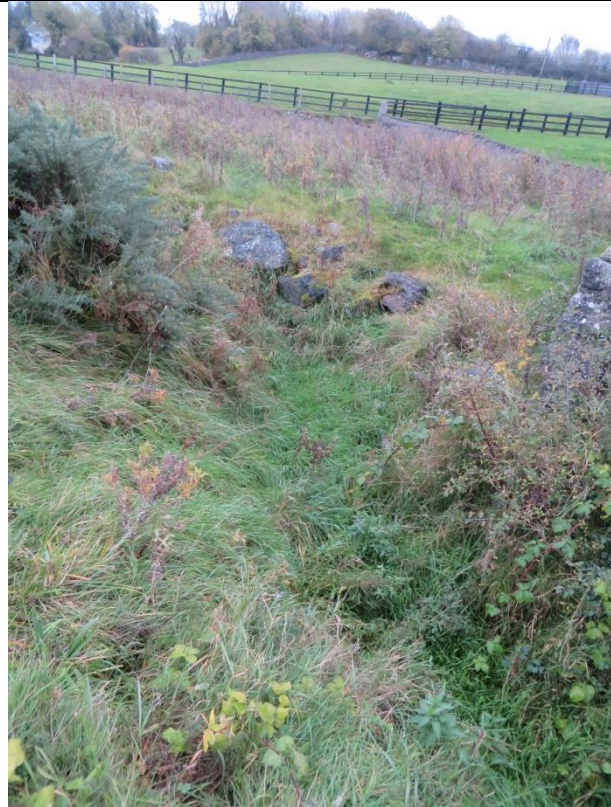
Field survey date	21/10/2014	12/11/2014
Field survey status	Confirmed	Confirmed
Water present	No	Yes Electrical conductivity: 995 uS/cm Temperature: 12 °C pH: 7.06 Flow not great enough for flow measurement
Additional Information	Drain leading from spring towards Terryland River

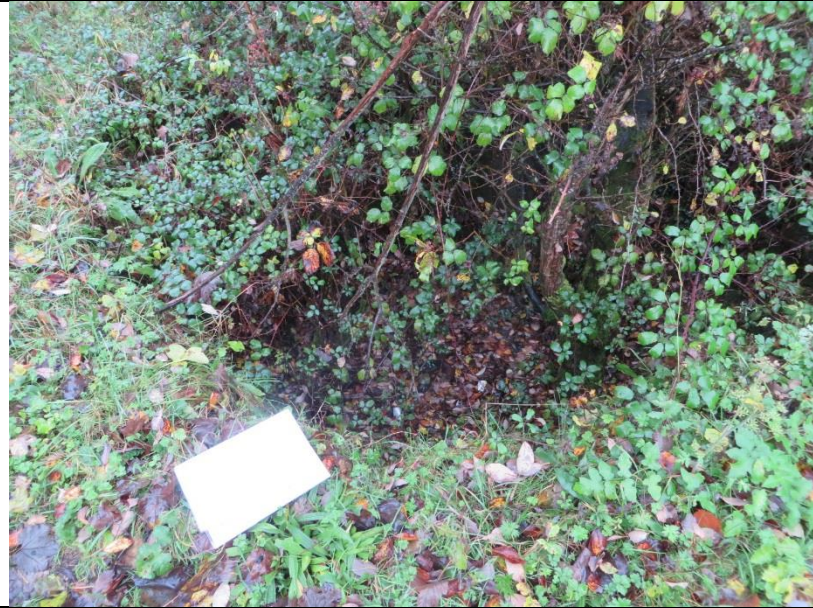
Field survey date	12/11/2014
Field survey status	Confirmed
Water present	No
Ground level elevation	24.01 mAOD at base of depression
Additional Information	Approx. dimensions: 3m diameter, 2m depth. Very steep sides. Likely to be an old dug well.

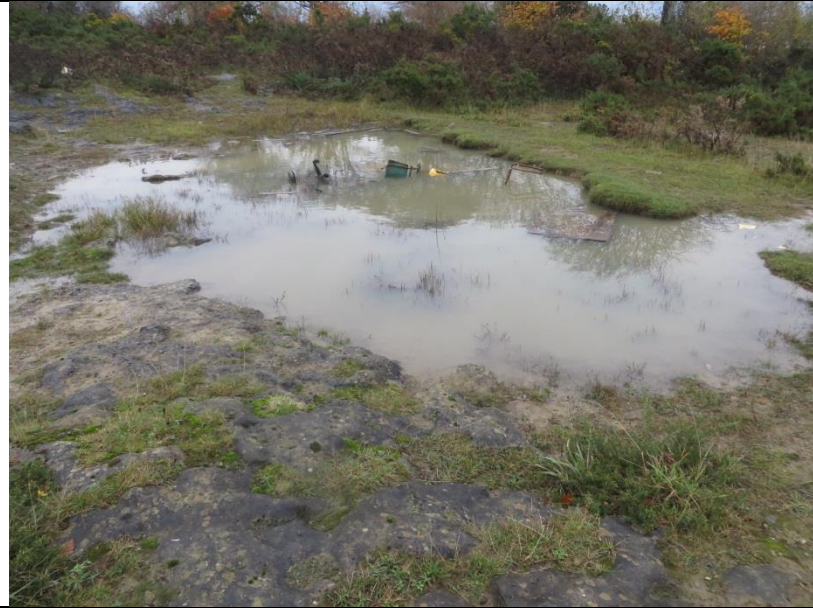
Field survey date	13/11/2014
Field survey status	Confirmed
Water present	Yes Electrical conductivity: 199 uS/cm Temperature: 7.1 °C pH: 8.13
Elevation levels	Base of enclosed depression: 54.74 mAOD Water level elevation: 55.01 mAOD
Additional Information	Enclosed depression filled with water from stream k314.

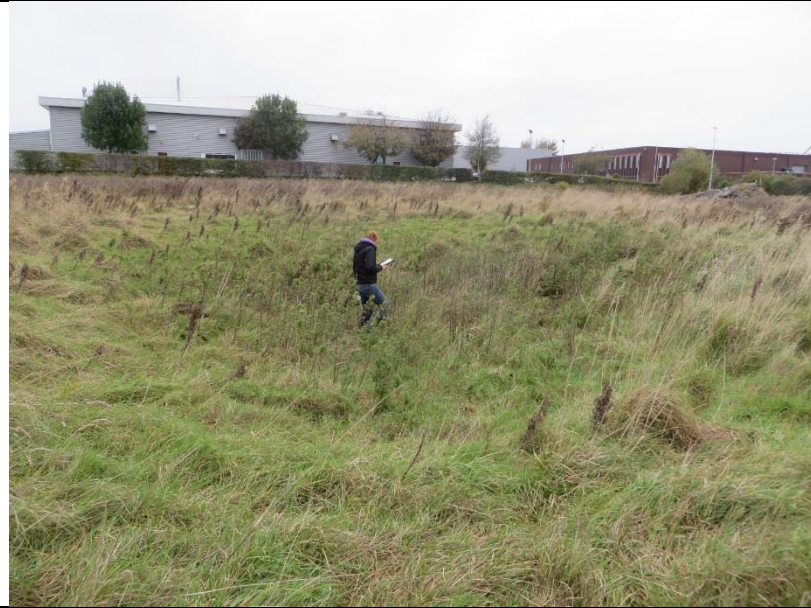
Feature ID	K131
Feature type	Enclosed depression
Coordinates	533815, 728265
Source	Lidar:  
	Bing maps:  
Field survey date	22/10/2014
Field survey status	Confirmed
Water present	No
Additional Information	Approx. dimensions: 10m diameter and 1.5m depth

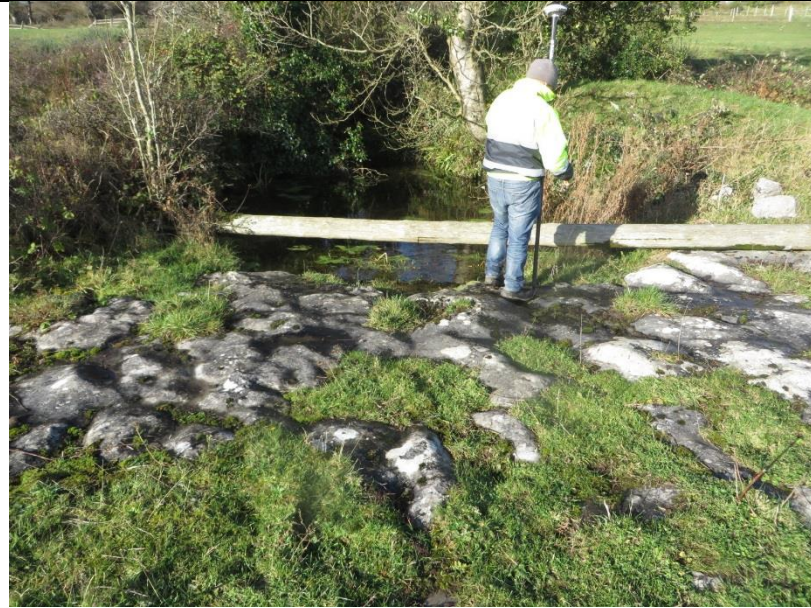
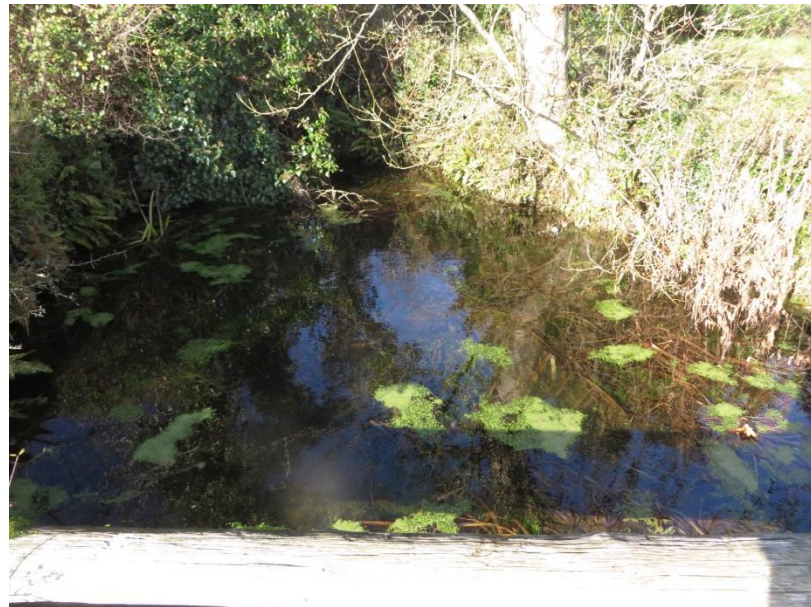
Field survey date	14/11/2014
Field survey status	Confirmed
Water present	Yes Electrical conductivity: 553 uS/cm Temperature: 11.5 °C pH: 7.27
Water elevation	46.03 mAOD
Additional Information	Initially identified in the desk study as a potential enclosed depression. Approx. 3m diameter pond.

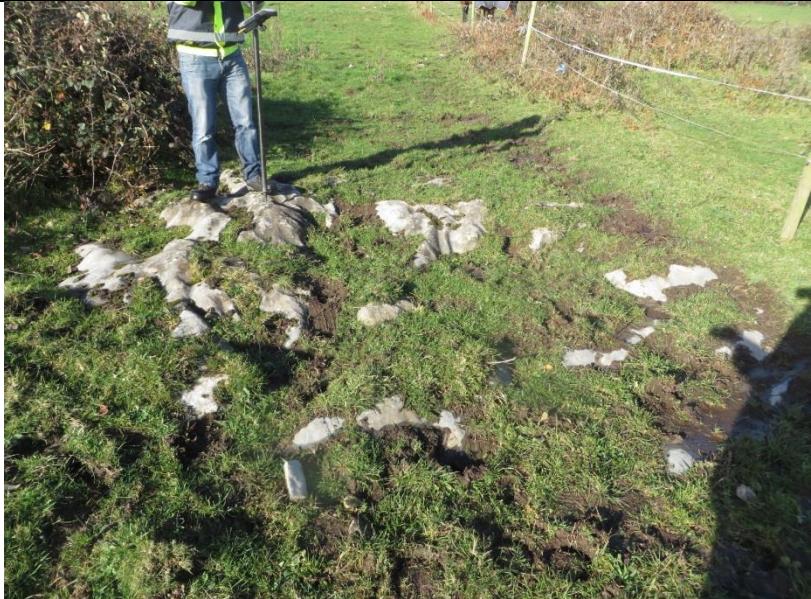
<p>The map shows a residential area with roads labeled R339, D6, and R466. A red circle highlights a cluster of pink icons representing superficial solution features. The 'Identify' window provides the following information:</p> <ul style="list-style-type: none"> Results Found 1 Karst Landforms Feature No.: 1121NEK044 Feature Type: SUPERFICIAL SOLUTION FEATURES Feature Name: Null Easting: 134100 Northing: 226700 Townland: DOUGHISKA County: GALWAY Grid Accuracy (metres): to within 100 m Stratigraphical Unit: BURREN LIMESTONE Lithology: Limestone, clean (>=90% CaCO3), bedded Comments: Data Source: ORE ARUP, Boston scientific corp., Ballybrit, Galway.
Field survey date	14/11/2014
Field survey status	Confirmed
Water present	No
Ground level elevation	44.19 mAOD
Additional Information	Area of superficial solution features noted by GSI database but not very obvious in field. Some rock visible with solution erosion, see photo.

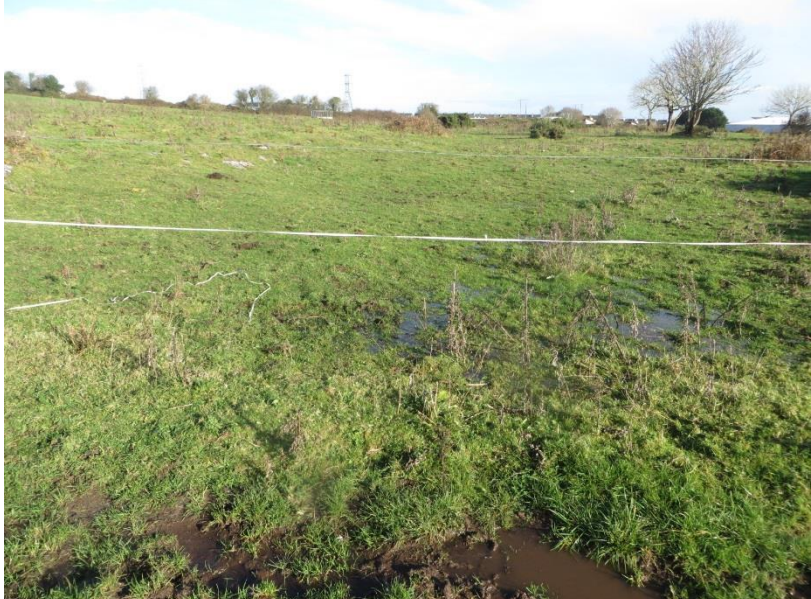
Feature ID	K135
Feature type	Enclosed Depression
Coordinates	533959, 726688
Source	Field Survey
Field survey date	14/11/2014
Field survey status	Confirmed
Water present	Yes
Additional Information	Very shallow and wide depression.
Site photos

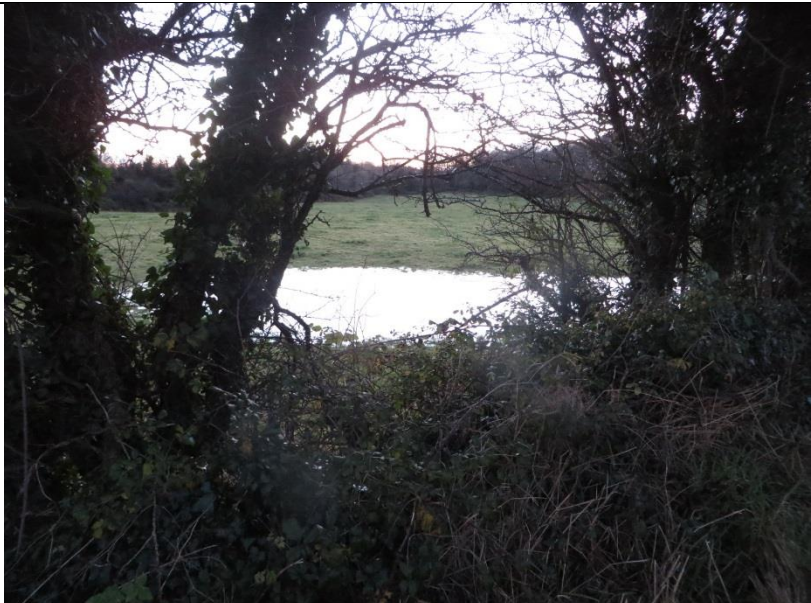
Feature ID	K140
Feature type	Flooded land (possible spring)
Coordinates	534085, 725198
Source	Field Survey
Field survey date	13/11/2014
Field survey status	Confirmed
Water present	Yes
Additional Information	Field with areas of flooding. A local informed that there were springs in the field.
Site photos

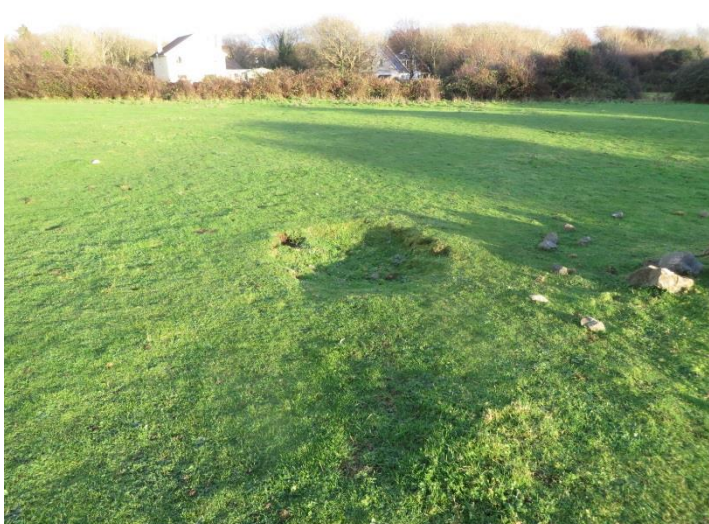
Feature ID	K142
Feature type	Enclosed Depression
Coordinates	534166, 724582
Source	Field Survey
Field survey date	13/11/2014
Field survey status	Confirmed
Water present	No
Additional Information	
Site photos

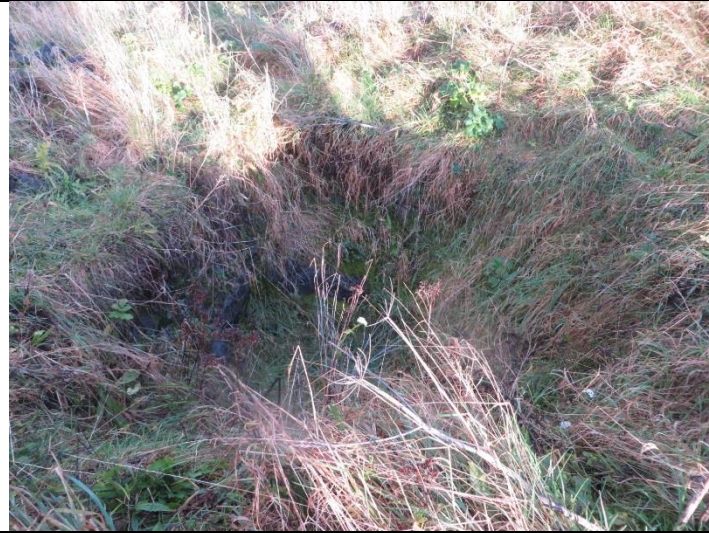
Field survey date	13/11/2014
Field survey status	Confirmed
Water present	No
Additional Information	Approx. 2 m in diameter and 1m deep

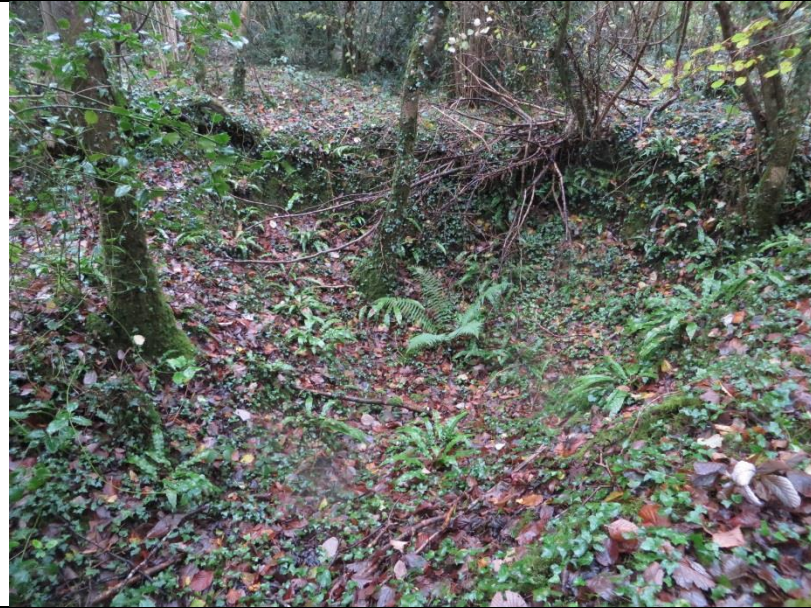
Field survey date	13/11/2014
Field survey status	Confirmed
Water present	No
Additional Information	Approx. 5m diameter, but not circular. Adjacent to K152.

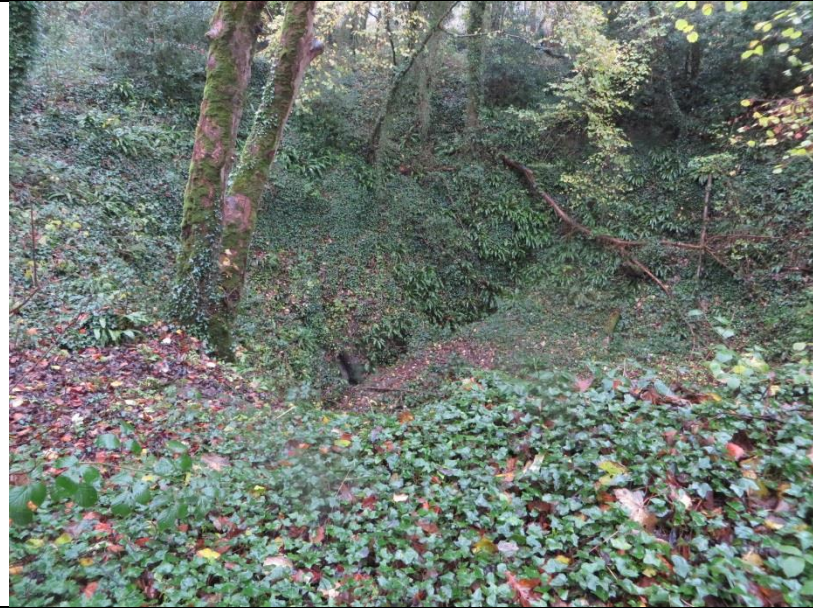
Field survey date	13/11/2014
Field survey status	Confirmed
Water present	No
Additional Information	Approx. 7m diameter. Adjacent to K151

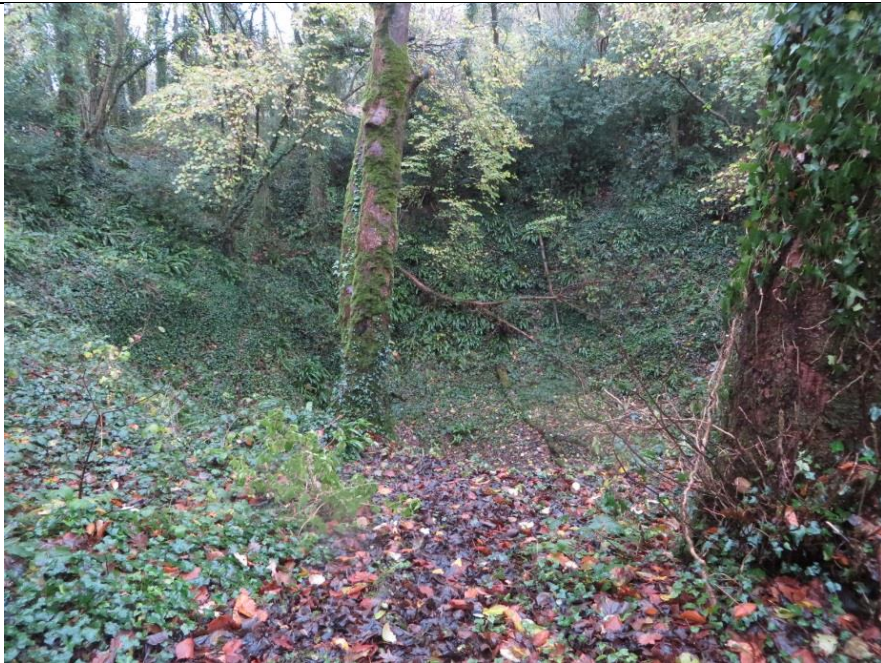
Field survey date	13/11/2014
Field survey status	Confirmed
Water present	No
Additional Information	Approx. dimensions: 40 m diameter 20 m deep. Potential plug hole evident The large enclosed depression is fenced off preventing access. A plug hole opening is evident at the base of the enclosed depression. This may contain water, however access is not possible due to protective fencing.
Site photos

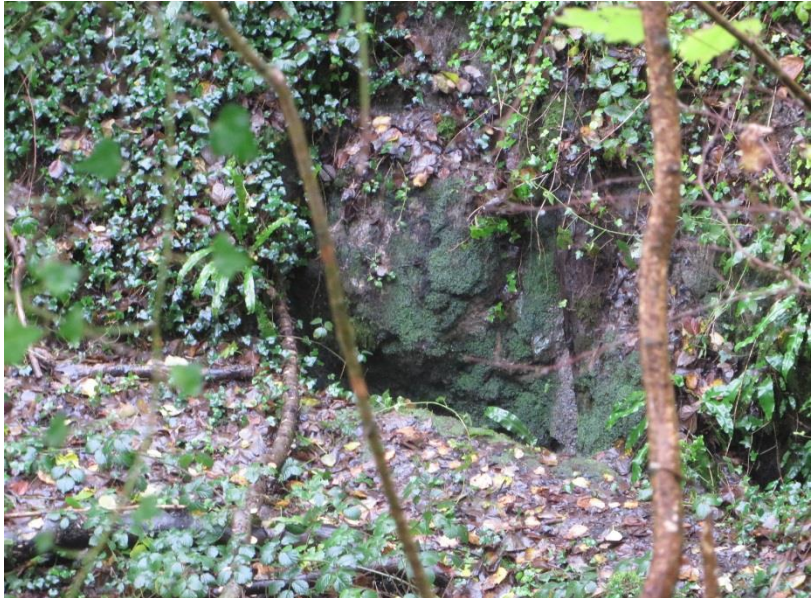
<p>Plug hole / opening at base of enclosed depression</p>

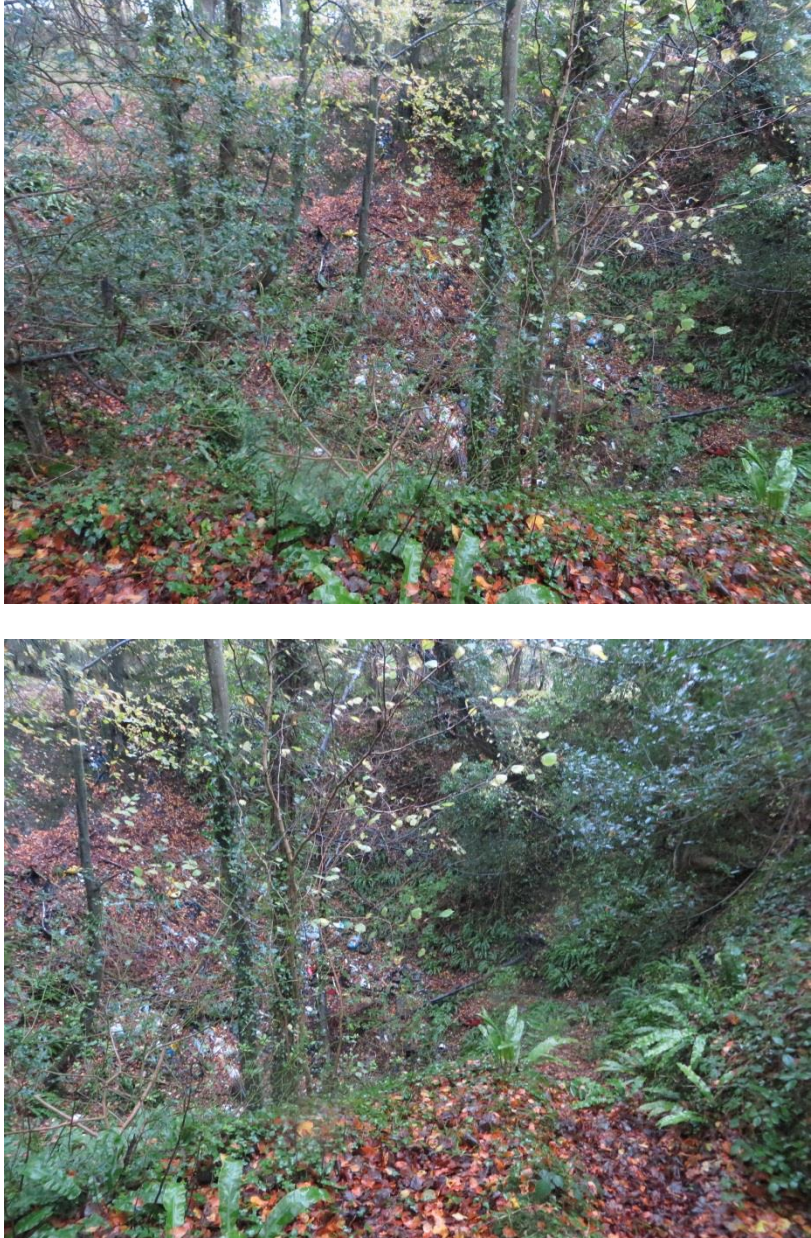
Field survey date	13/11/2014
Field survey status	Confirmed
Water present	No
Additional Information	Approx. dimensions: 30 m diameter 20 m deep. Contains waste Possible plug hole identified
Site photos

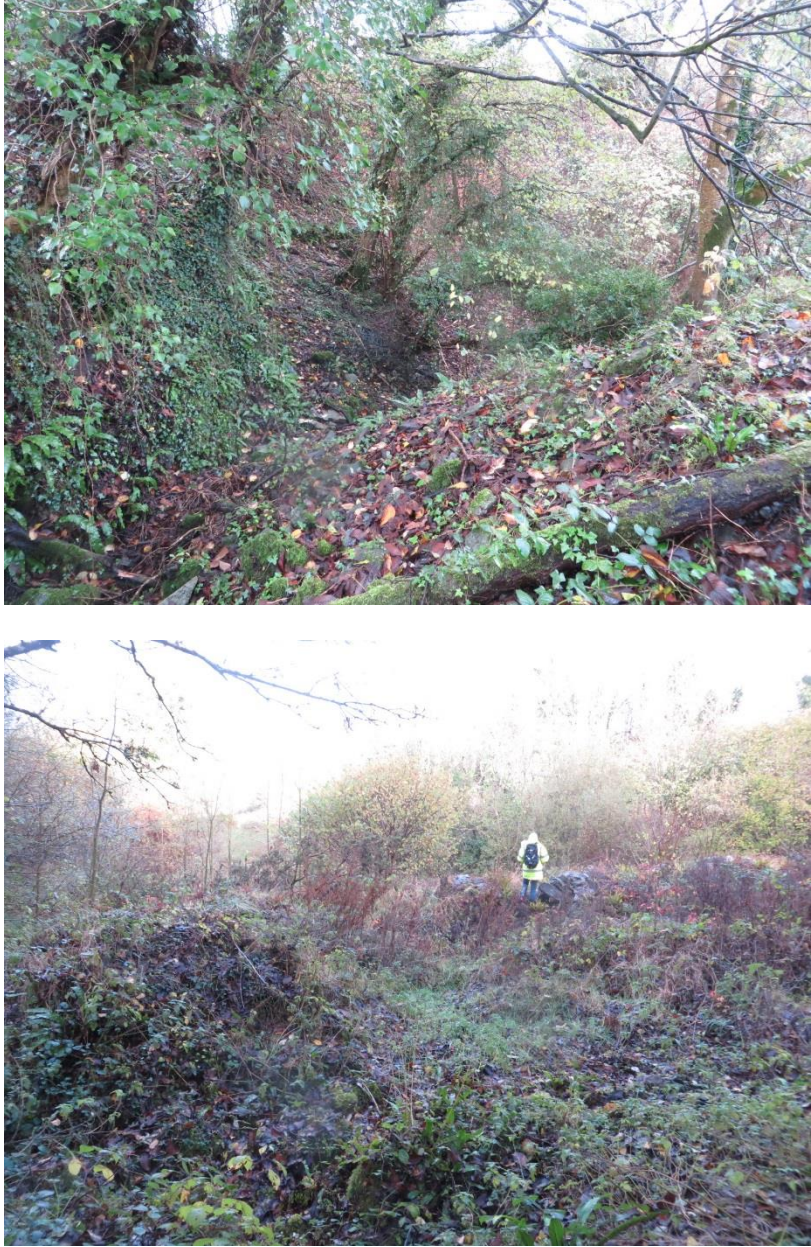
Field survey date	14/11/2014
Field survey status	Confirmed
Water present	No
Ground level elevation	Elevation within depression 13.39 mAOD. This is not the base of the depression
Additional Information	Very large depression. Large part of enclosed depression is filled in with waste and material.
Site photos

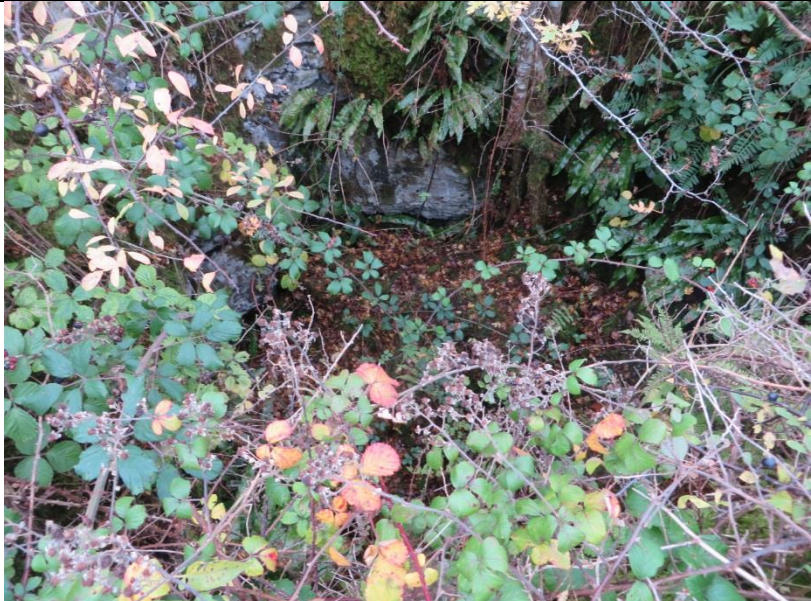
Feature ID	K170
Feature type	Well/enclosed depression
Coordinates	534787.19, 728293.49
Source	Field survey
Field survey date	22/10/2014
Field survey status	Confirmed
Water present	No
Additional Information	Dug well Approx. 3m diameter and 2m to base Base of well is covered in moss covered rocks
Site photos

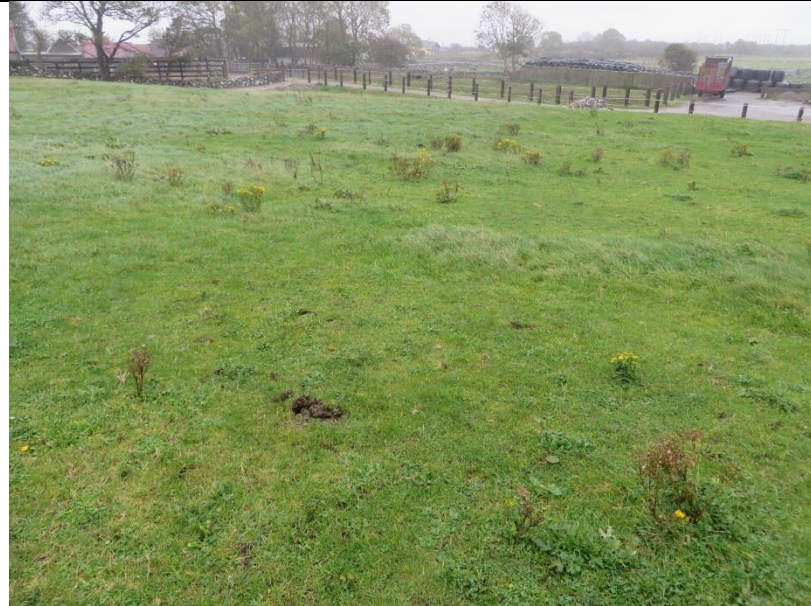
Site photos

Field survey date	23/10/2014
Field survey status	Confirmed
Water present	No
Additional Information	Very shallow depression

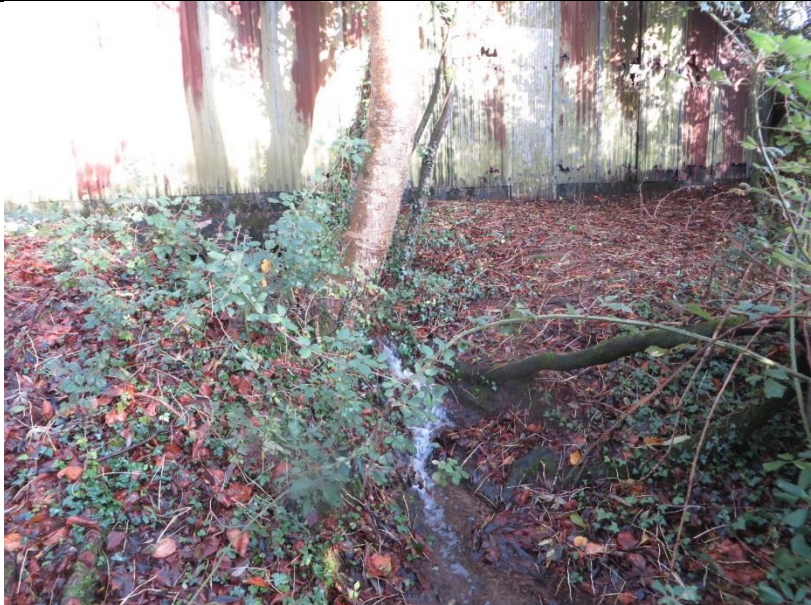
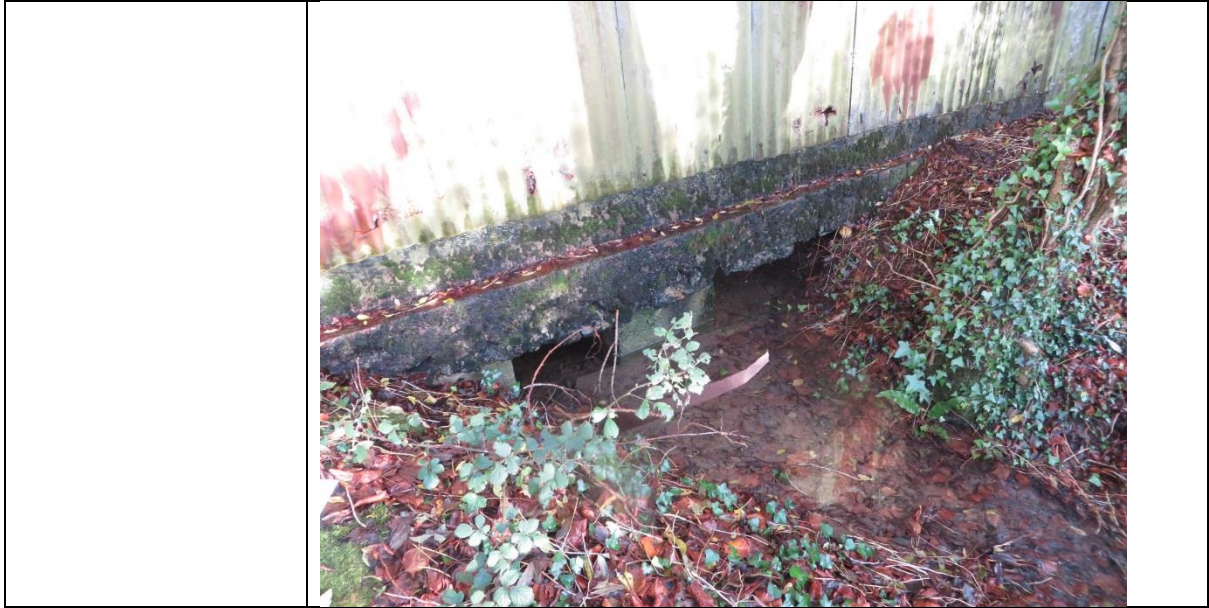
Field survey date	14/11/2014
Field survey status	Confirmed
Water present	Yes Electrical conductivity: 510 uS/cm Temperature: 9.7 °C pH: 7.88 Flow: 6.3 l/s
Water level elevation	25.22 mAOD
Additional Information	Spring discharges from under an old building.
Site photos

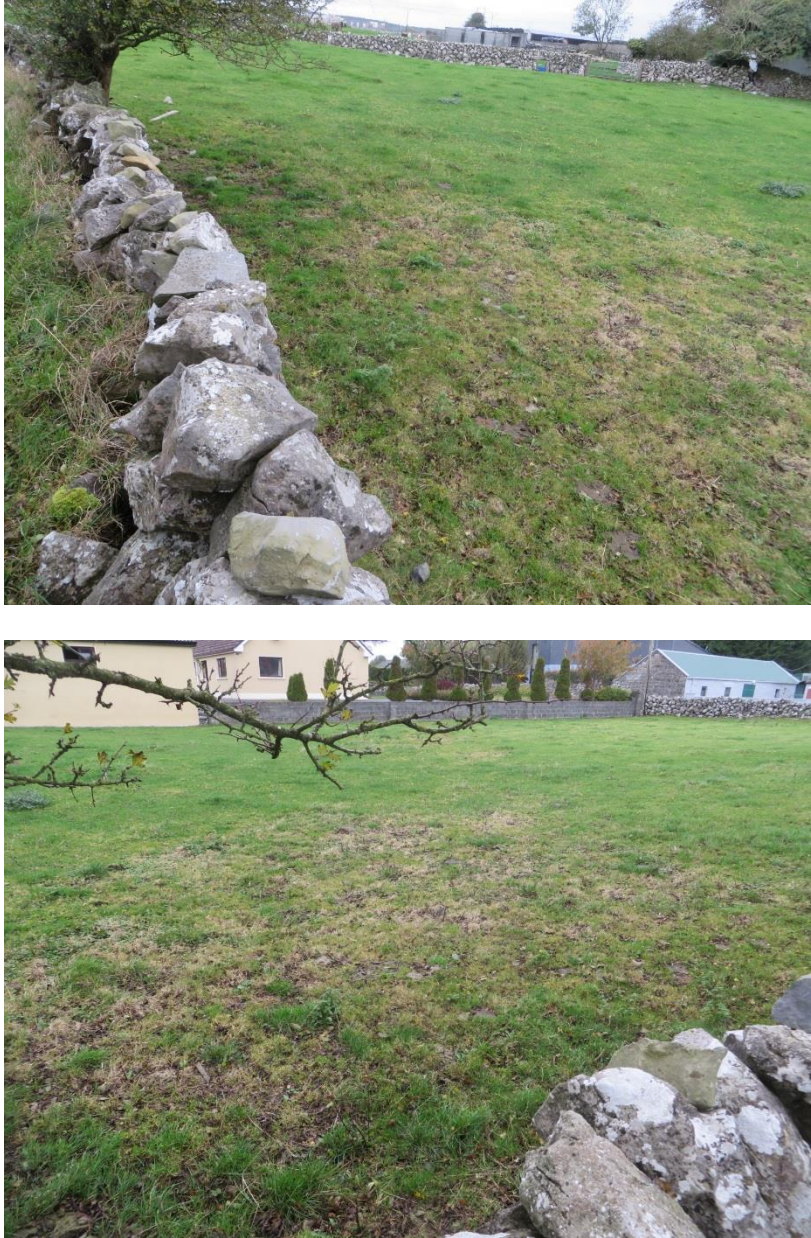
Feature ID	K179
Feature type	Enclosed depression
Coordinates	534990, 727121
Source	Field survey
Field survey date	23/10/2014
Field survey status	Confirmed
Water present	No
Additional Information	Approx. dimensions: 20m diameter semicircle. Shallow
Site photos

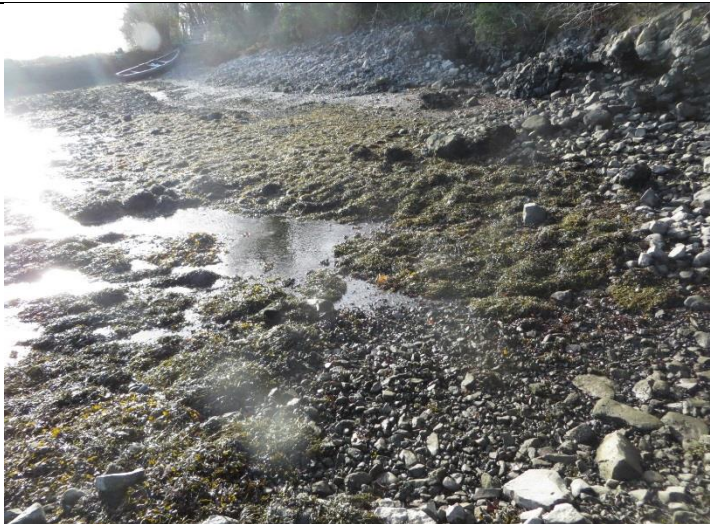
Field survey date	14/11/2014
Field survey status	Confirmed
Water present	Yes Electrical conductivity: Outside instrument range Temperature: 11.5 °C pH: 7.34
Additional Information	Flow from spring too wide to measure. Flow discharges directly to sea
Site photos

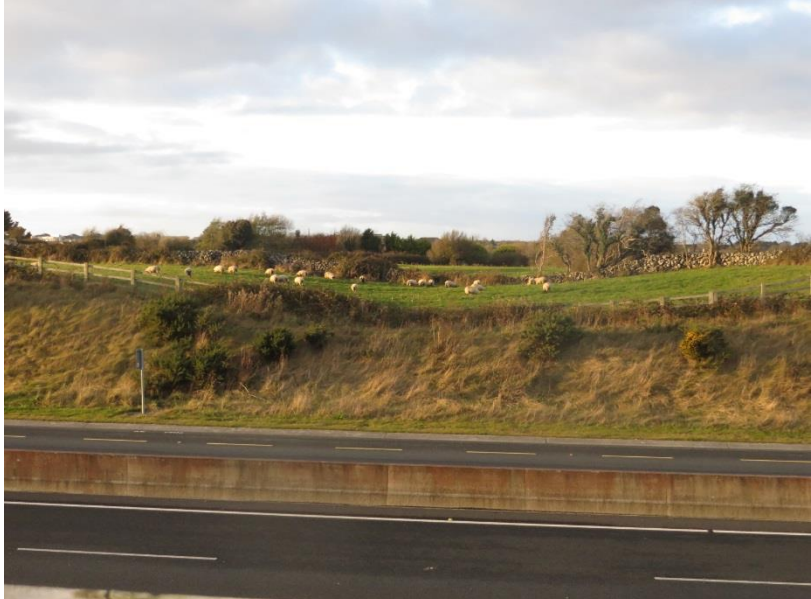
Feature ID	K193
Feature type	Enclosed depression
Coordinates	535482, 727051
Source	Field survey
Field survey date	17/11/2014
Field survey status	Confirmed
Water present	No
Additional Information	Approx. 30m diameter depression cut in half by M6 motorway
Site photos

A photograph showing a grassy embankment next to a road, with a depression visible in the background. The depression is a circular feature cut in half by the M6 motorway. The surrounding area is a mix of green grass and brown, dry vegetation. In the distance, there are trees and a stone wall. The sky is overcast with grey clouds.

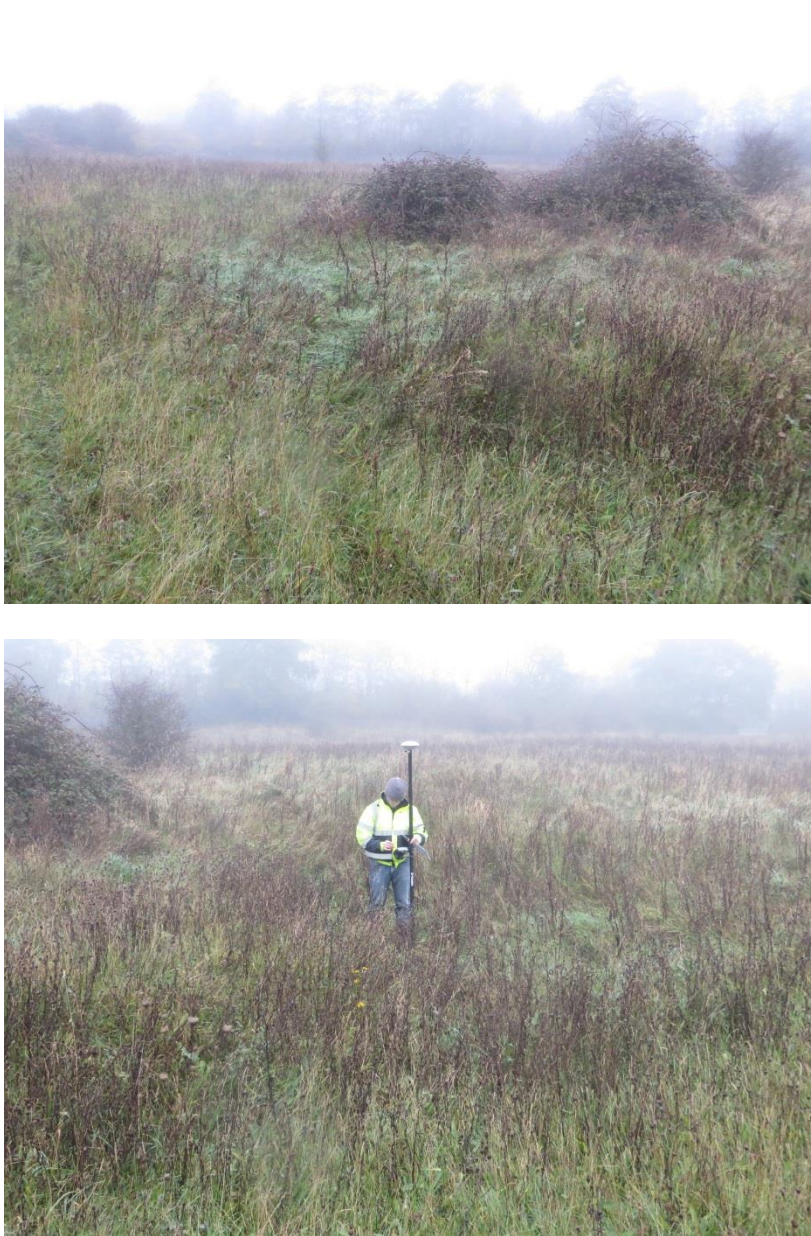
Feature ID	K201
Feature type	Enclosed depression
Coordinates	536027, 725739
Source	Field survey
Field survey date	18/11/2014
Field survey status	Confirmed
Water present	No
Ground level elevation	29.92 mAOD at base of enclosed depression
Additional Information	Approximate dimensions: 2 m diameter less than 1 m depth
Site photos
