Galway County Council
N6 Galway City Ring Road
Karst Survey Report

GCOB-4-03-0-6.2.8_010

Issue 3 | 26 July 2018

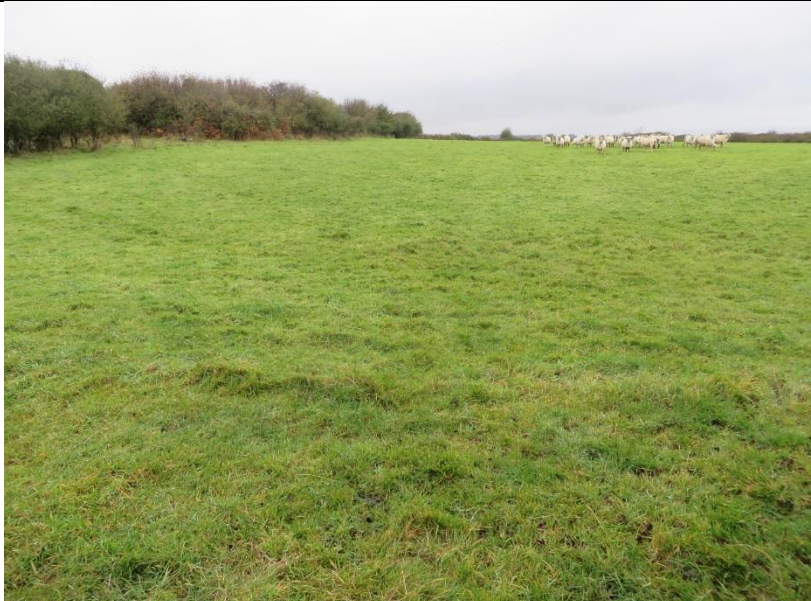
Feature ID	K202
Feature type	Enclosed depression
Coordinates	536033, 726313
Source	Field survey
Field survey date	23/11/2014
Field survey status	Confirmed
Water present	No
Additional Information	Very shallow enclosed depression Approx. 20m diameter
Site photos

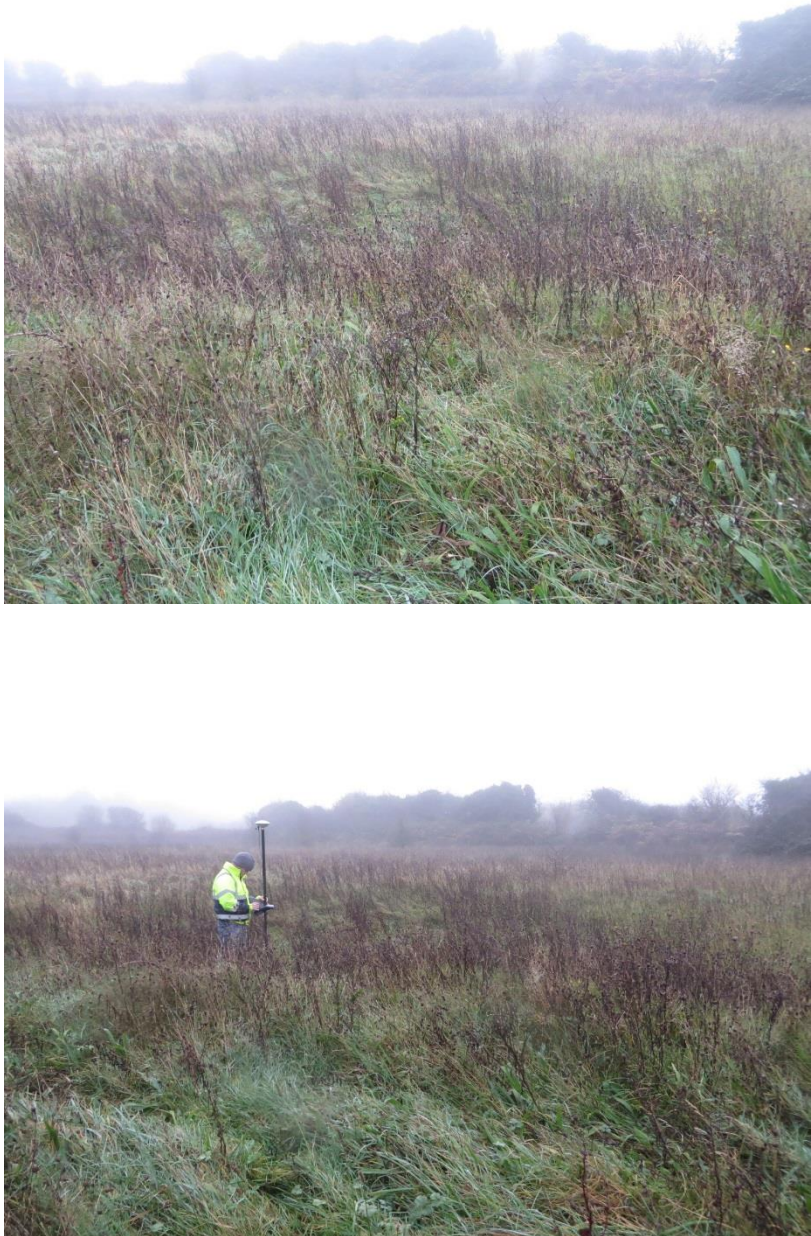
Feature ID	K203
Feature type	Enclosed depression
Coordinates	536033, 725740
Source	Field survey
Field survey date	18/11/2014
Field survey status	Confirmed
Water present	No
Ground level elevation	29.44 mAOD
Additional Information	Small enclosed depression Approximate dimensions: 5m x 2 m less than 1 m deep
Site photos

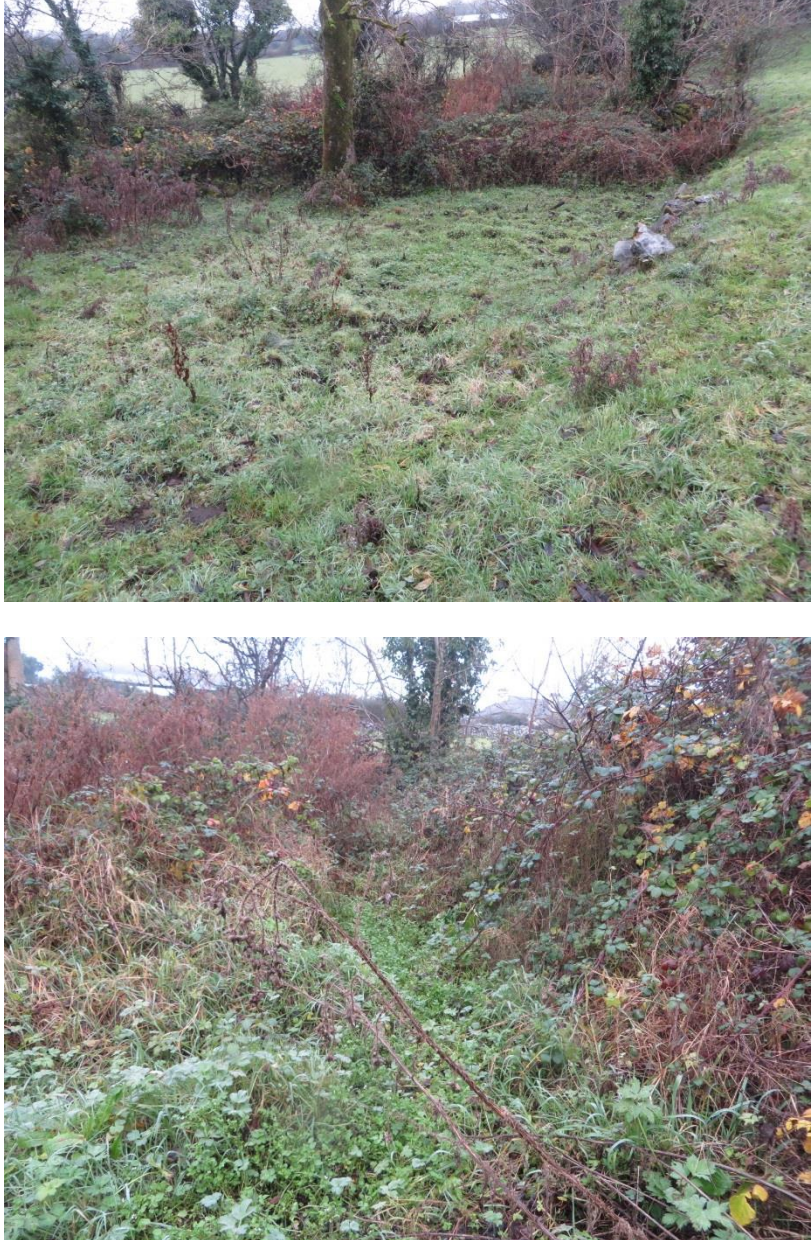
Field survey date	18/11/2014
Field survey status	Confirmed
Water present	Yes Electrical conductivity: 704 uS/cm Temperature: 9.8 °C pH: 7.88
Water level elevation	26.37 mAOD
Additional Information	The spring is at the base of a depression. The ground is very soft and covered in vegetation. Water is present, however due to the low water

<p>levels and vegetation flow not measurable. The spring discharge area is approx. 20 m diameter.</p> <p>The landowner lives in the house across the road and informed us that the spring has been used in the past as the drinking water supply but is currently not in use.</p>
<p>Site photos</p>

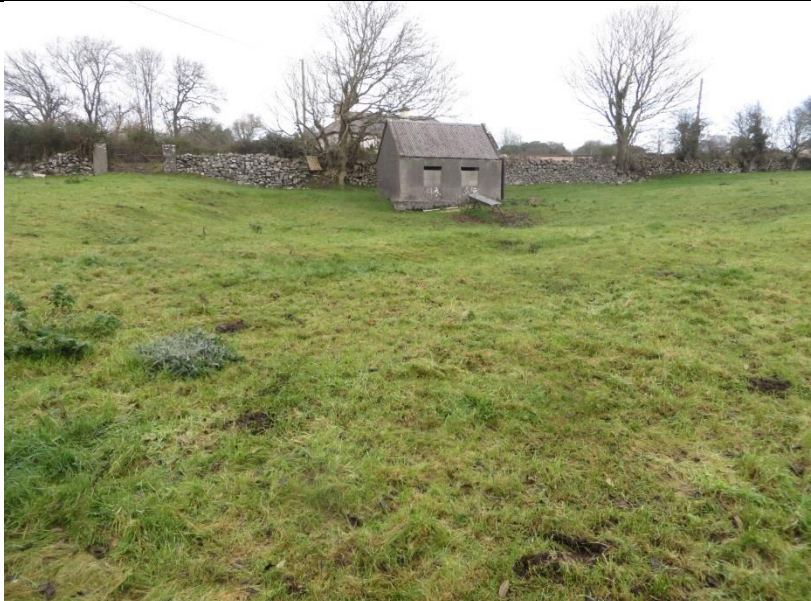
Feature ID	K213
Feature type	Enclosed Depression
Coordinates	536132, 726003
Source	Field survey
Field survey date	18/11/2014
Field survey status	Confirmed
Water present	No
Additional Information	Approx. dimensions: 20 m diameter. The depression may contain some fill or modification
Site photos

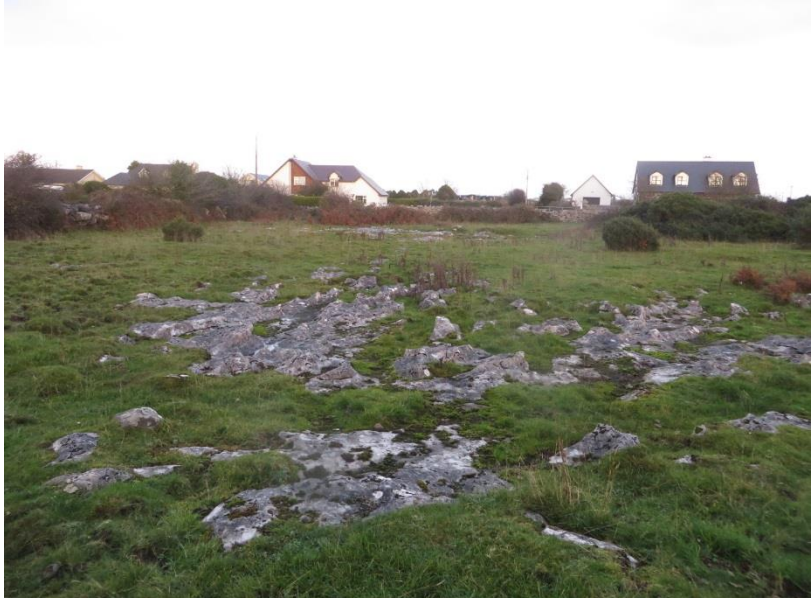
Field survey date	17/11/2014
Field survey status	Confirmed
Water present	No
Additional Information	Superficial solution features. Small shallow dips and small patches of outcrop.
Site photos
